EAST OF ENGLAND

| HERITAGE AT RISK | 3 |
|--|--|
| THE REGISTER | 12 |

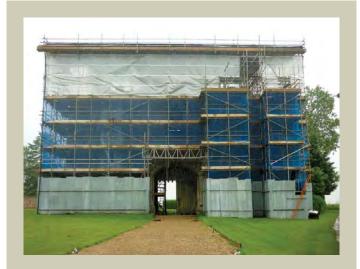
PENTNEY PRIORY GATEHOUSE, NORFOLK

The roofless gatehouse of this Augustinian priory has been on the Buildings at Risk Register since its launch in 1998. Now, an imaginative new owner plans to carry out major structural repairs and re-roof the building in order to secure it a viable and useful future.
