Exercise Tally Ho!

Archaeological Project Report

For the Recovery of Spitfire P9503 at Lidbury, near
Upavon Wiltshire under the Protection of Military
Remains Act (1986)

Site Code: P9503UP

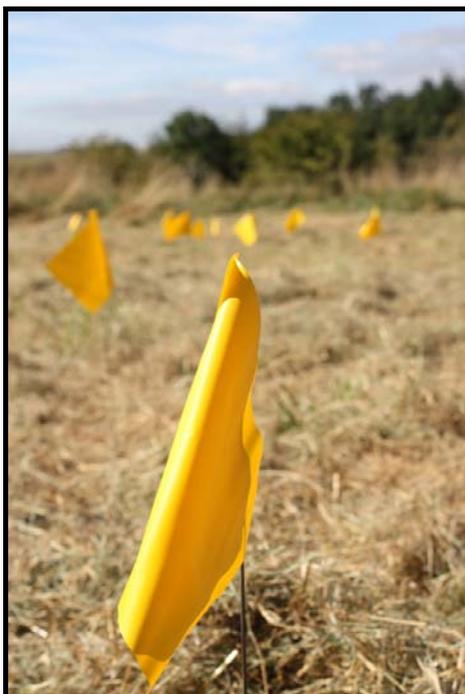
Figure 3: Locating the Debris Field

The author took a Foerster magnetometer to the region and there were major readings in the presumed area of the crash site. This will be backed up by a further, measured metal detection survey. During the first day of any fieldwork project, as part of the site gridding exercise, a non-intrusive metal detecting survey took place to examine the presence of aluminium. Each reading was flagged and the location plotted, this was intended to illustrate the debris field and possible direction of impact if the aircraft did not come down vertically.

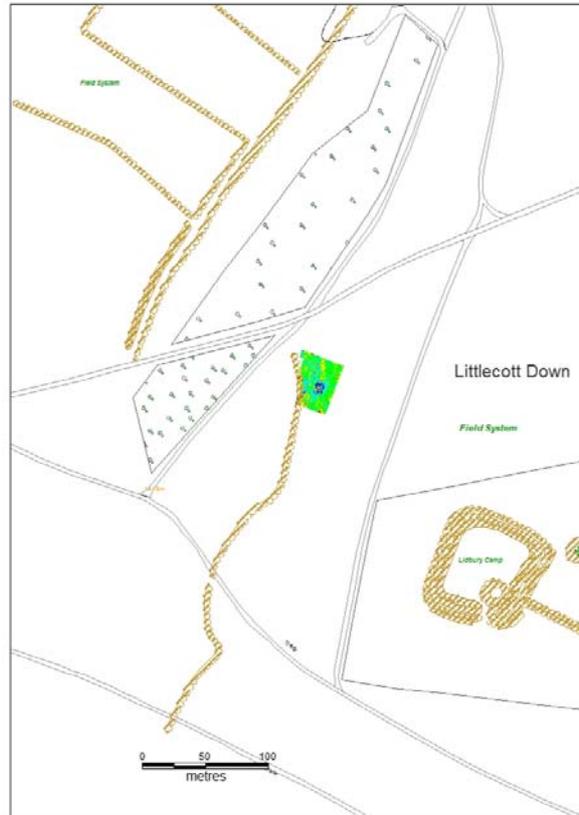
Figure 4: Location of impact of Spitfire P9503 showing the efficacy of magnetometry. © Peter Masters

A magnetometer and ground-penetrating radar survey was carried out by Mr Peter Masters of Defence Academy/Cranfield University on Friday 7th June 2013. This was hugely successful both in determining location and also depth of the deposits.

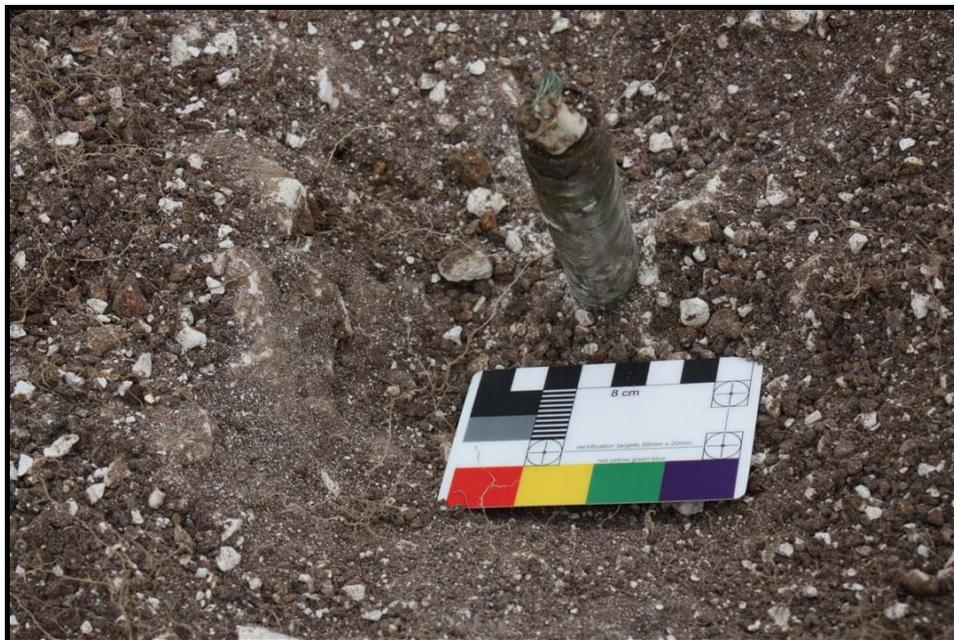
Figure 6: Pitot tube in situ illustrating vertical nature of crash

The Pitot tube was present in the port wing of the Mk1a Spitfire and was used to measure air speed. Its *in situ* presence on the excavation enabled the team to precisely demarcate the area of the airframe and also illustrated the vertical nature of the crash..

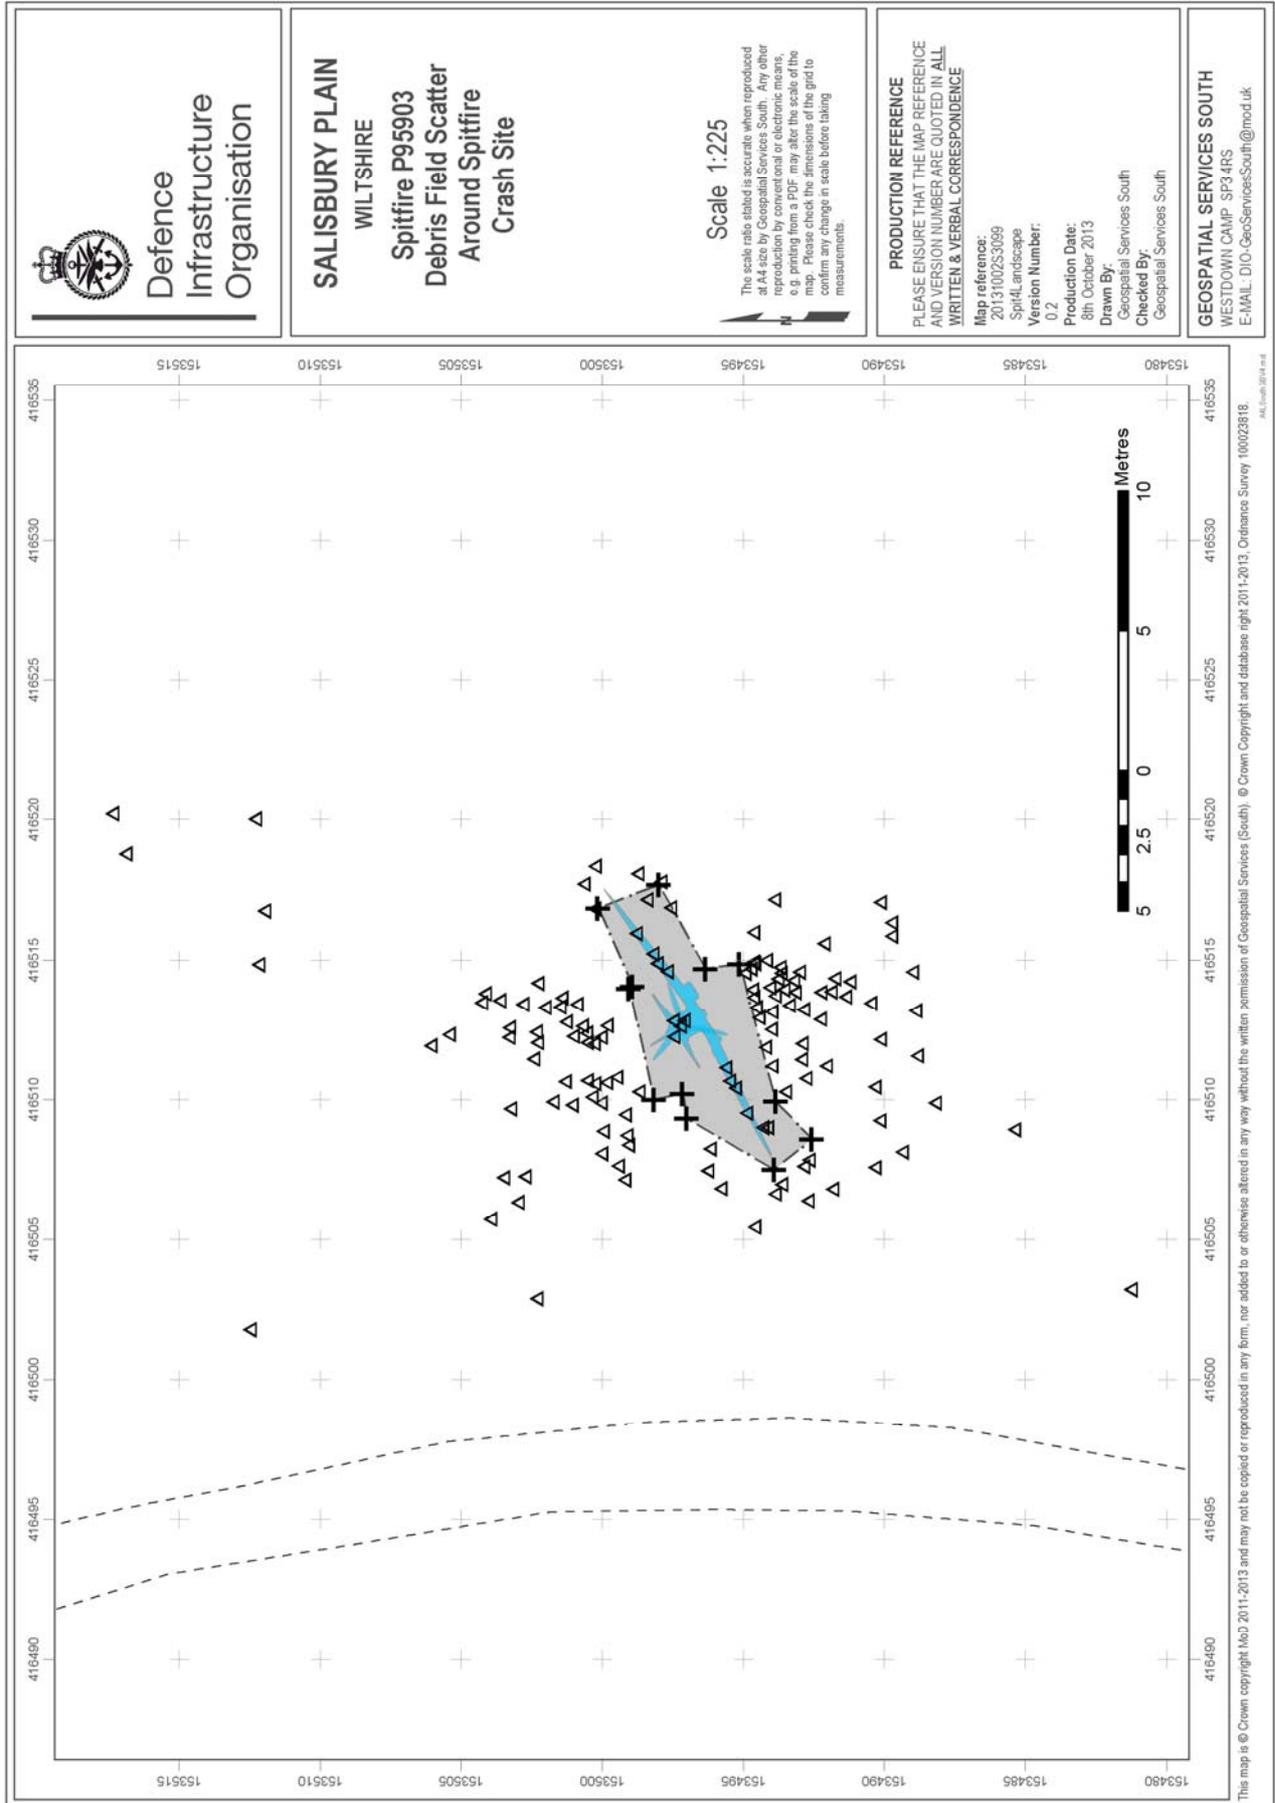
Figure 5: Location of crash site excavation trench, debris spread around it (each triangle = crash-related find), and superimposed silhouette of a Spitfire for reference

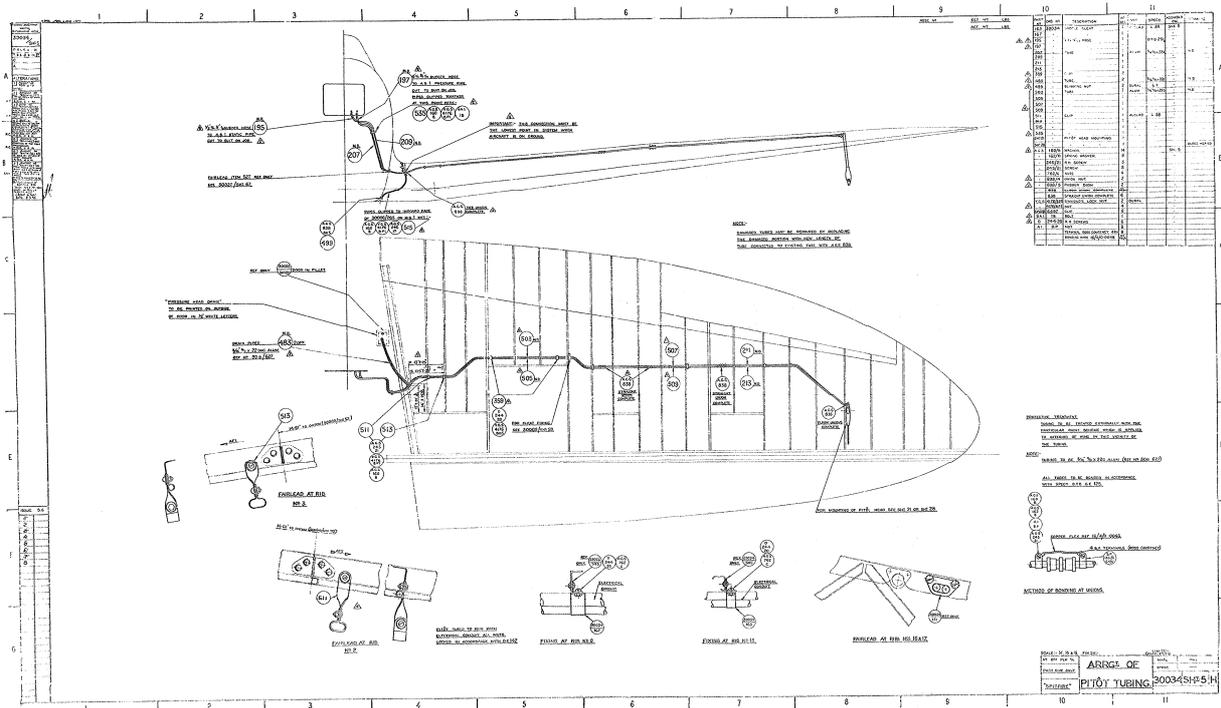
Figure 7: Original Blueprint drawing of the Mk1 Spitfire illustrating position of pitot tube (from Dominic Berry)

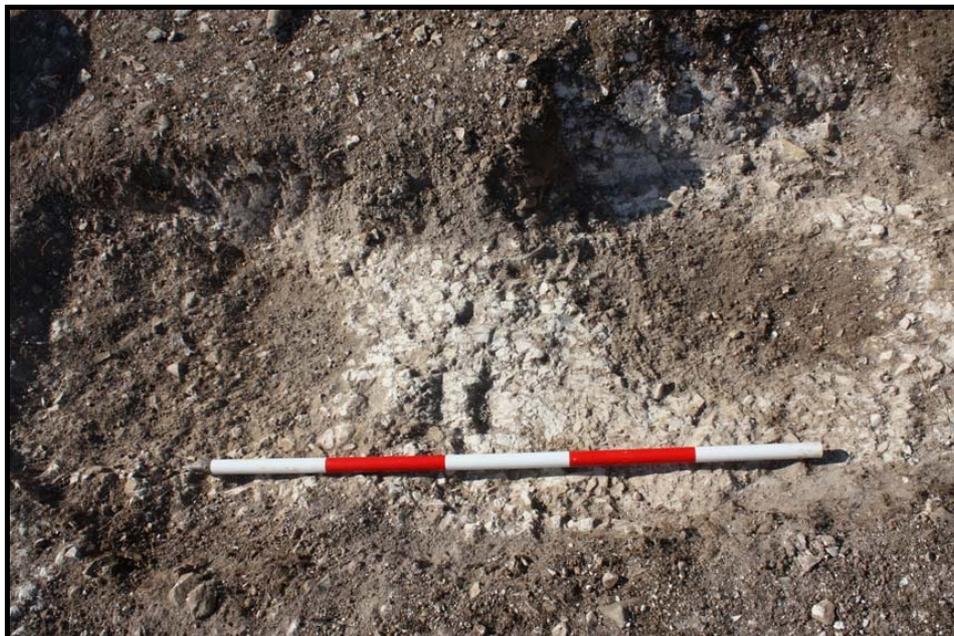
The team looked for the starboard wing of the aircraft in Trench 3 to the north east of Trench 1. As similar pattern to Trench 2 was found with a linear spread of metallic small finds just below the turf representing this wing. All finds from this area were denoted as having derived from **Layer 201**.

Figure 8: two impact marks of gun clusters in the starboard wing, Trench 3 (forms layer 201)

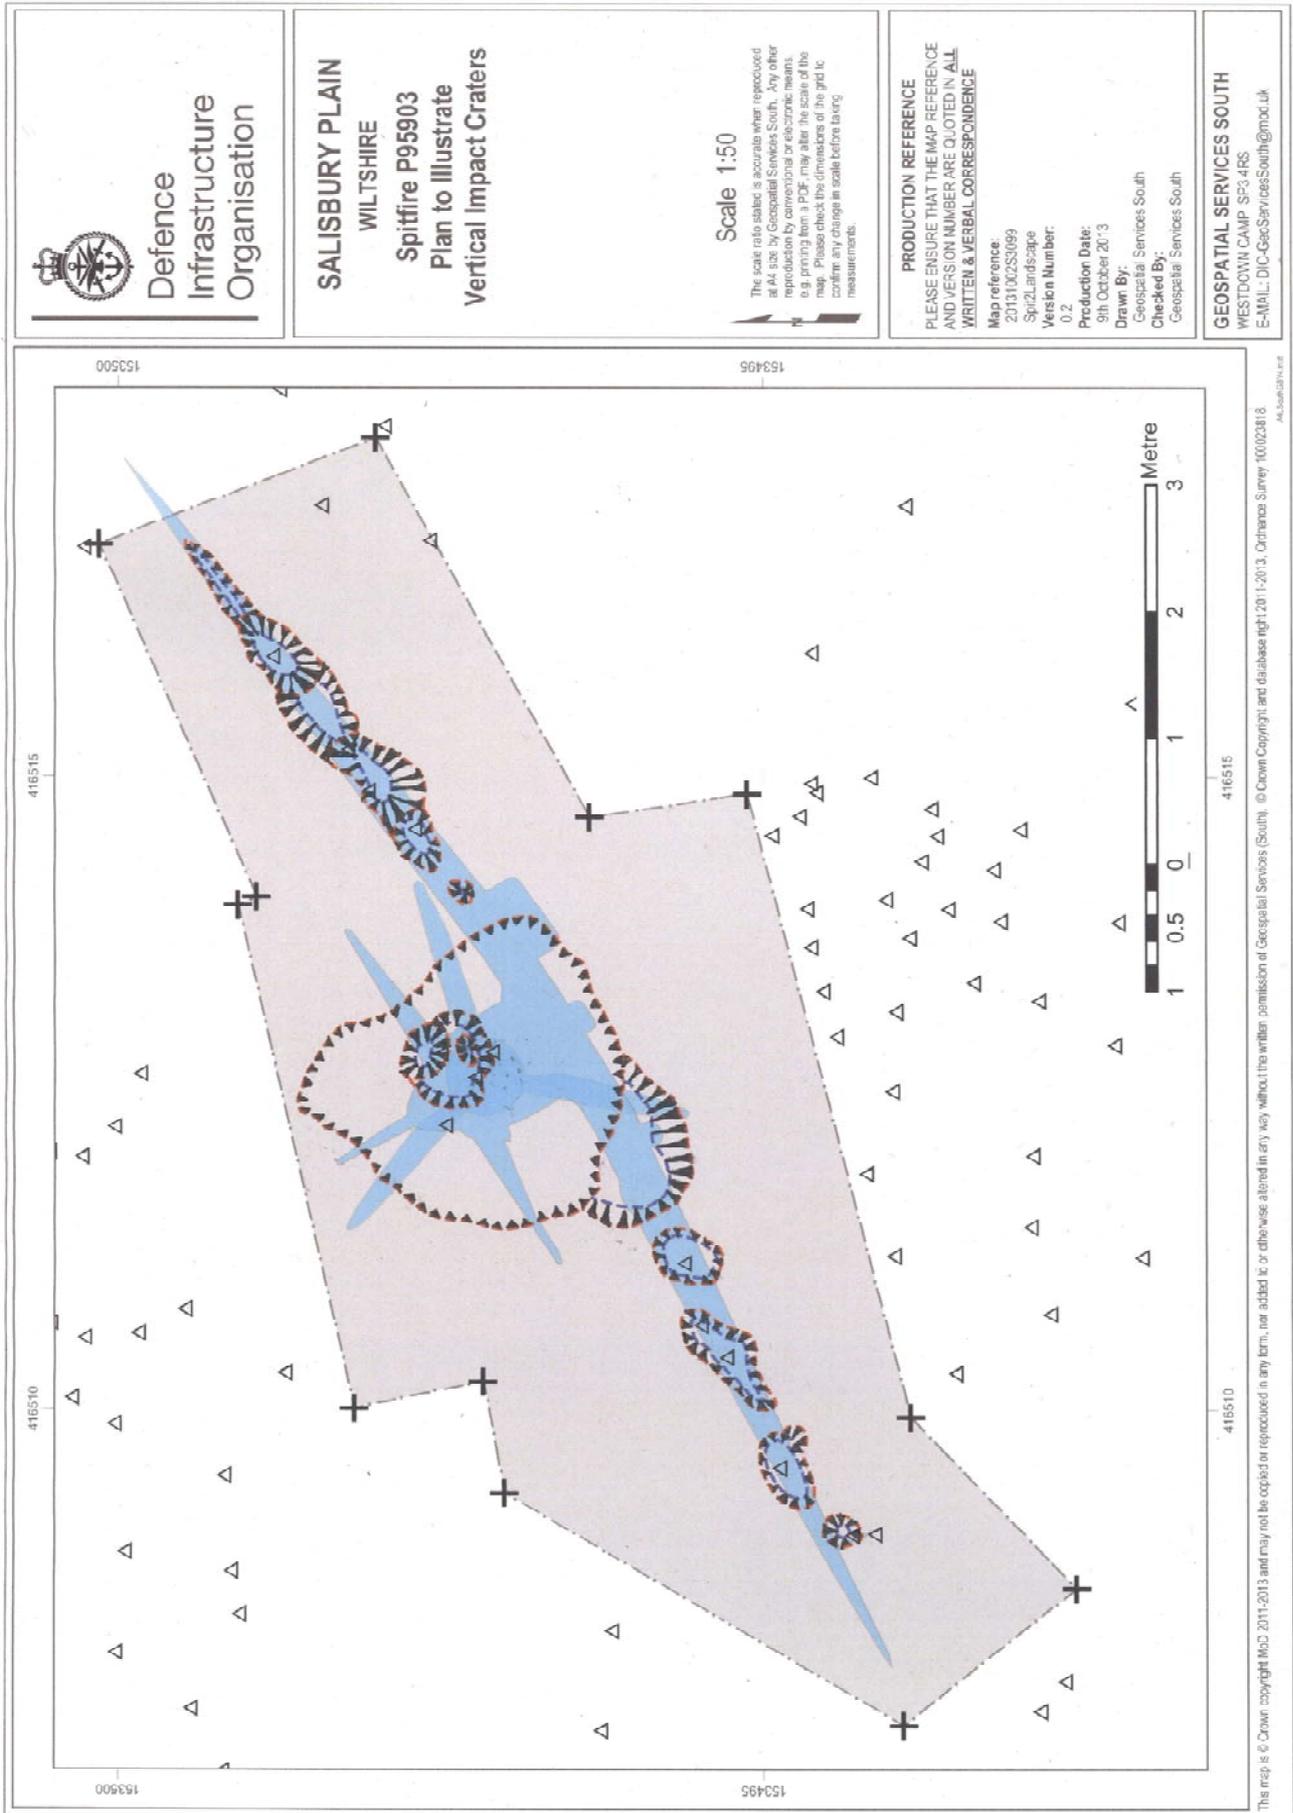
Figure 9: Plan of crash site excavation with Spitfire silhouette as guide

Layers 003, 101 and 201 were undisturbed and presumably were equivalent to one another as the immediate impact locations of Spitfire P9503. Layers 001 and 002 represented re-deposited impact crater fill.

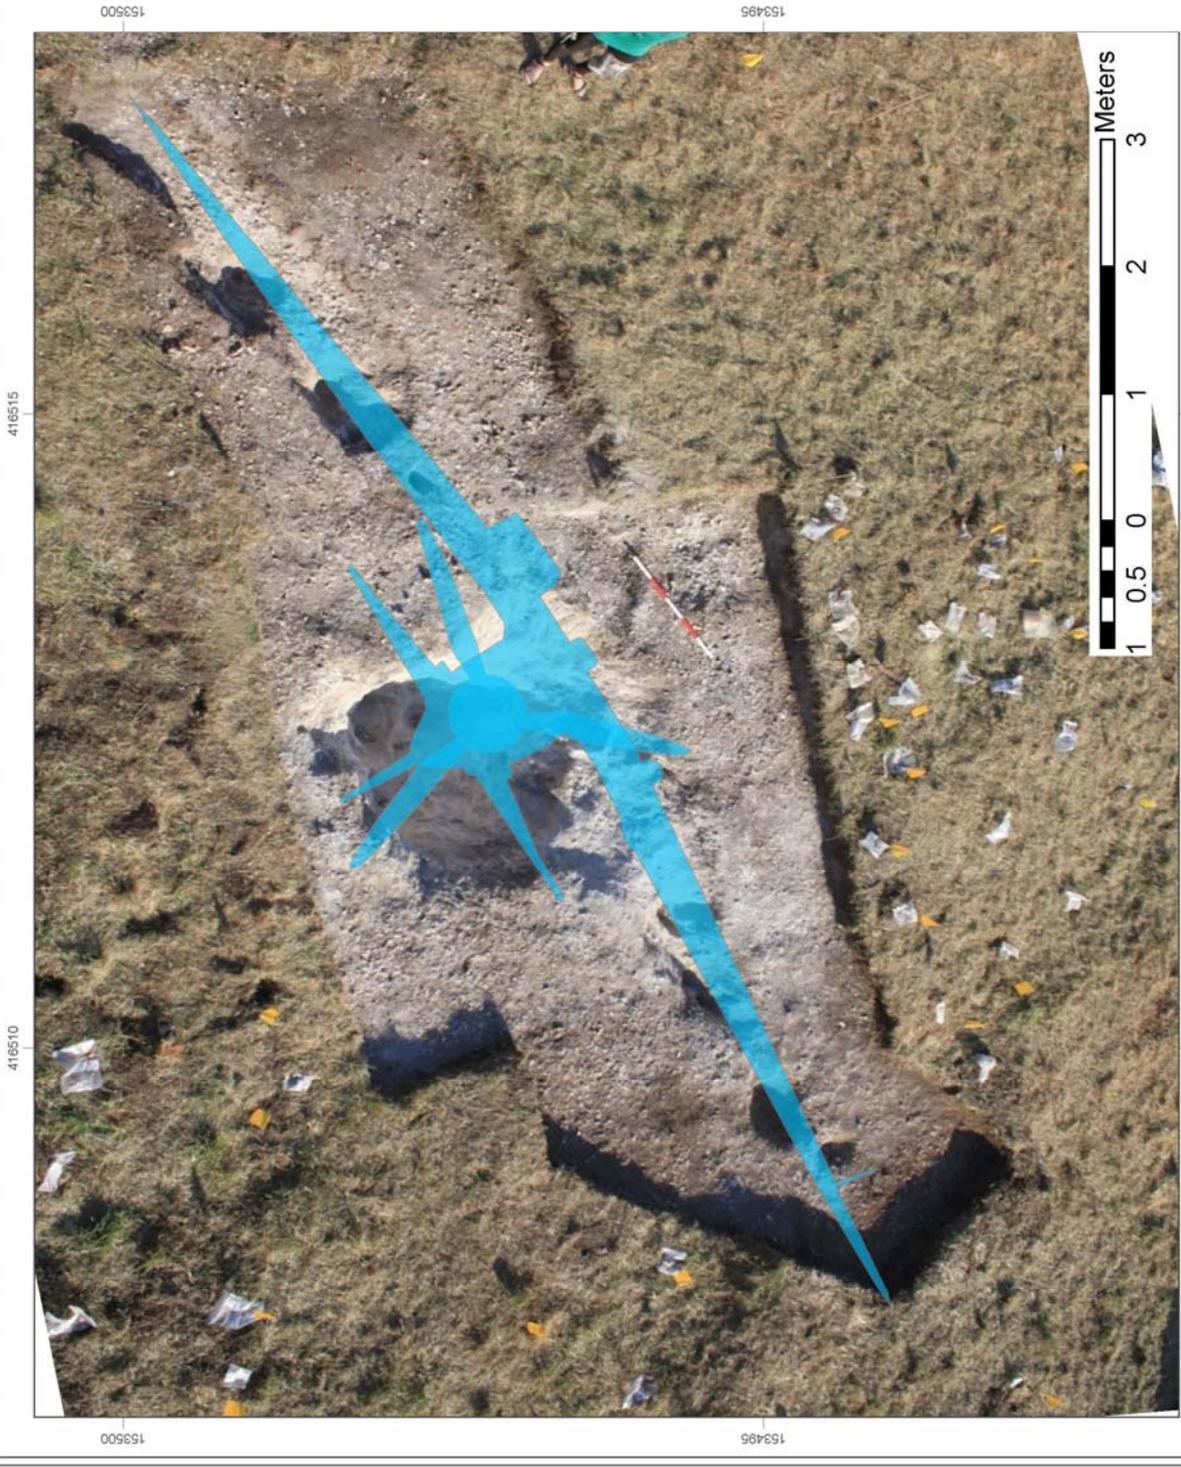
Figure 10: Aerial photo of excavation site, with Spitfire silhouette as guide

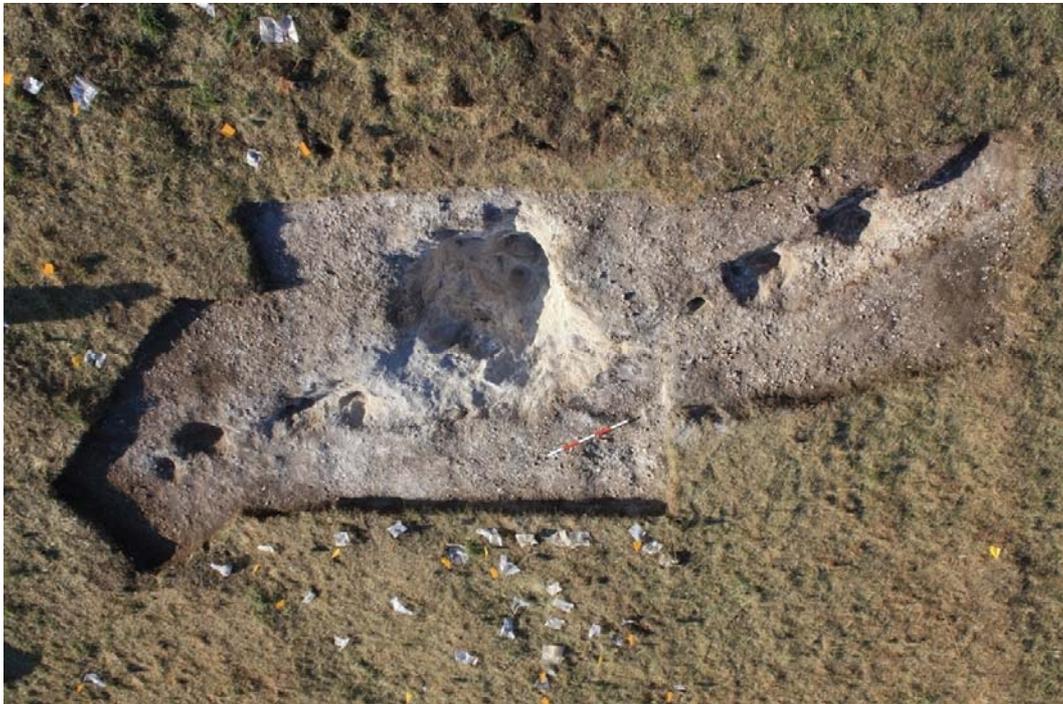
Figure 11: The impact crater of Spitfire P9503 with 1m scale. Note central crater (engine and fuselage) with port wing (gun clusters and pitot tube impact) to the left, and starboard wing (gun clusters impact) to the right. All bags and yellow flags around the excavation indicate some of the debris field

- What was the precise cause of the crash?
There were no clues as to the cause of the crash – simply that it crashed in a vertical dive; the central fuselage/engine area causing a major central impact crater, with the starboard and port wings and their associated gun clusters (four guns in each wing) causing more ephemeral impact marks (see Figures 9-11). The accounts of pilot and his colleagues remain the only evidence for events we have. It should be noted that this site had already been partially disturbed hence perhaps removing the opportunity to uncover the information that would have revealed the cause of the crash. The excavation team have liaised with the Portsmouth-based team responsible for air crash investigations to attempt to gain further insight into crashed using modern data techniques.

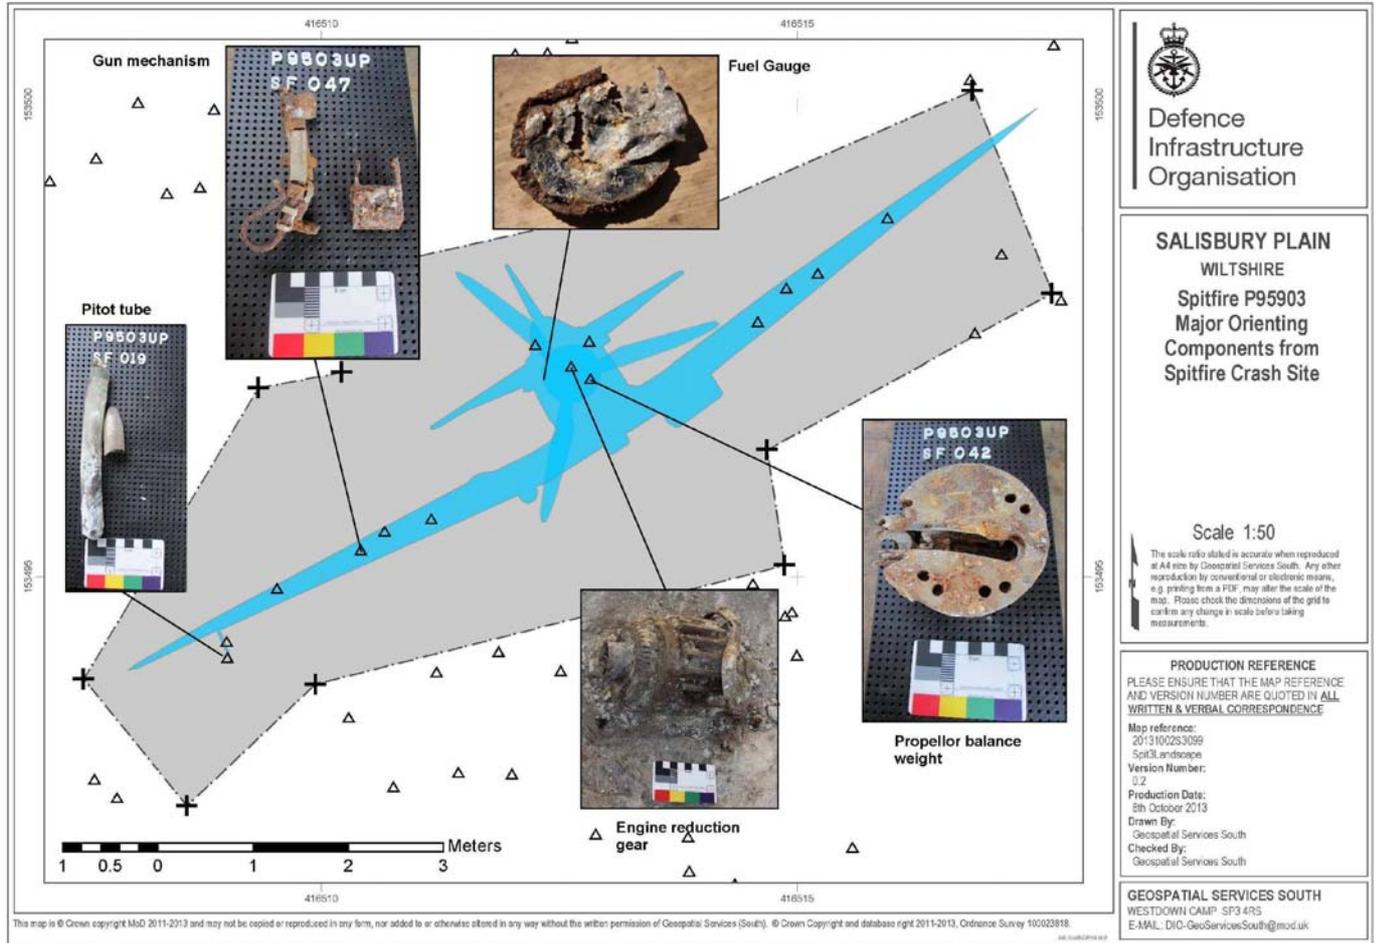
Figure 12: Location of some of the major finds within the excavation area

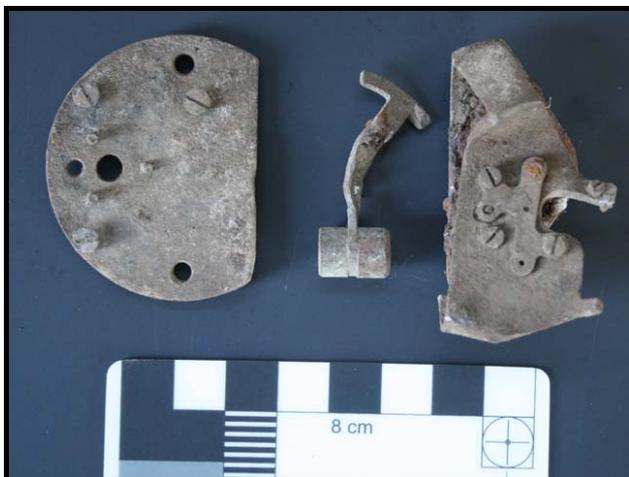
SF 002, Tr1 Layer 001. Cockpit Clock

The remnants of the cockpit clock were broken into three individual components. The face, hands and mechanism have not survived.

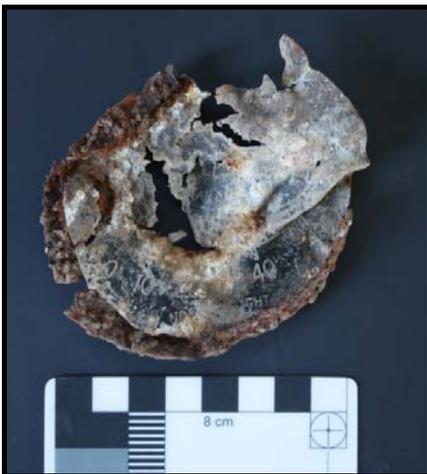
SF 012, Tr1 Layer 002. Fuel dial

This dial is situated in the lower right of the instrumentation panel in the Spitfire cockpit

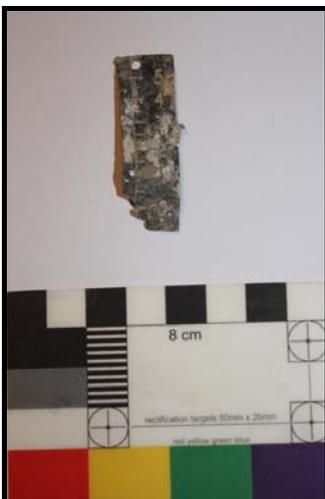
SF 027, Tr1 Layer 002. Cockpit Label. A linear gauge which is rectangular in form and descending from 5 in units down to 0. This is the fuel pressure gauge.

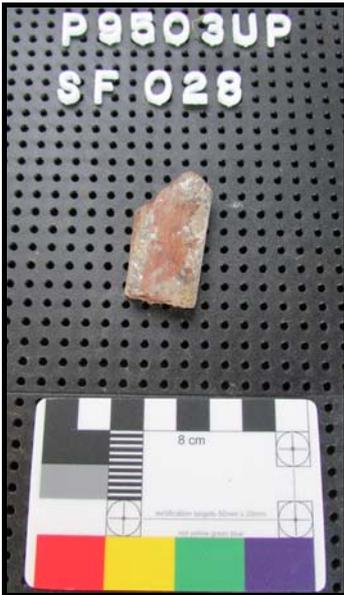
SF 028, Tr1 Layer 002. Wooden component – possible seat fragment

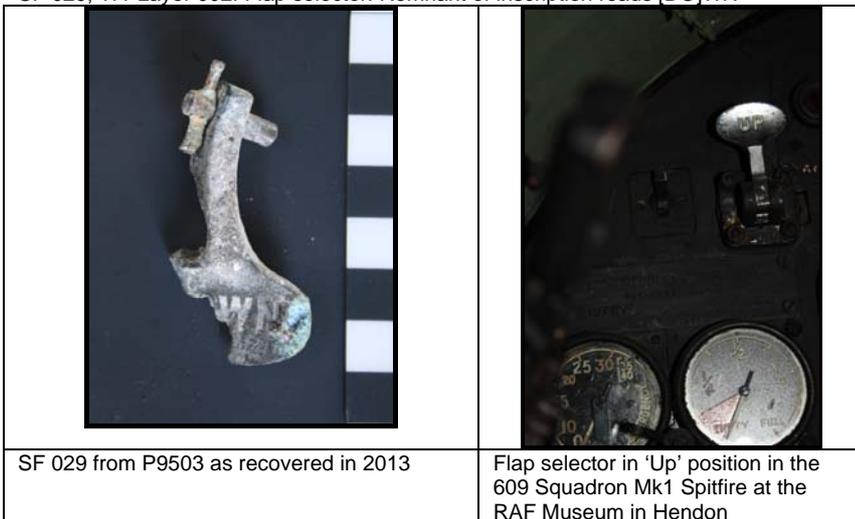
SF 029, Tr1 Layer 002. Flap selector. Remnant of inscription reads [DO]WN

The flap selector is situated in the lower left section of the instrumentation panel of the Spitfire.

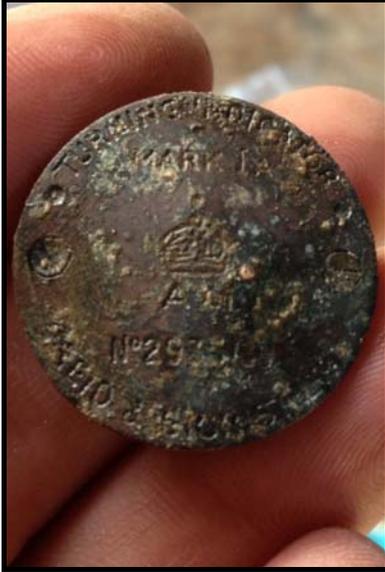
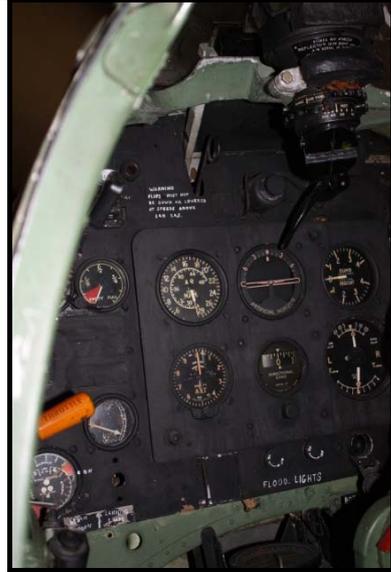
SF 075, Tr1 Layer 002. Turn and bank indicator

SF 075 as recovered from P9503 in 2013

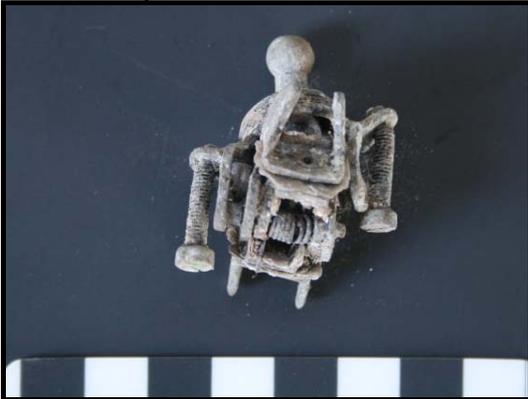
SF 101, Tr1 Layer 101. Instrument switch

Possibly the switch for the magneto.

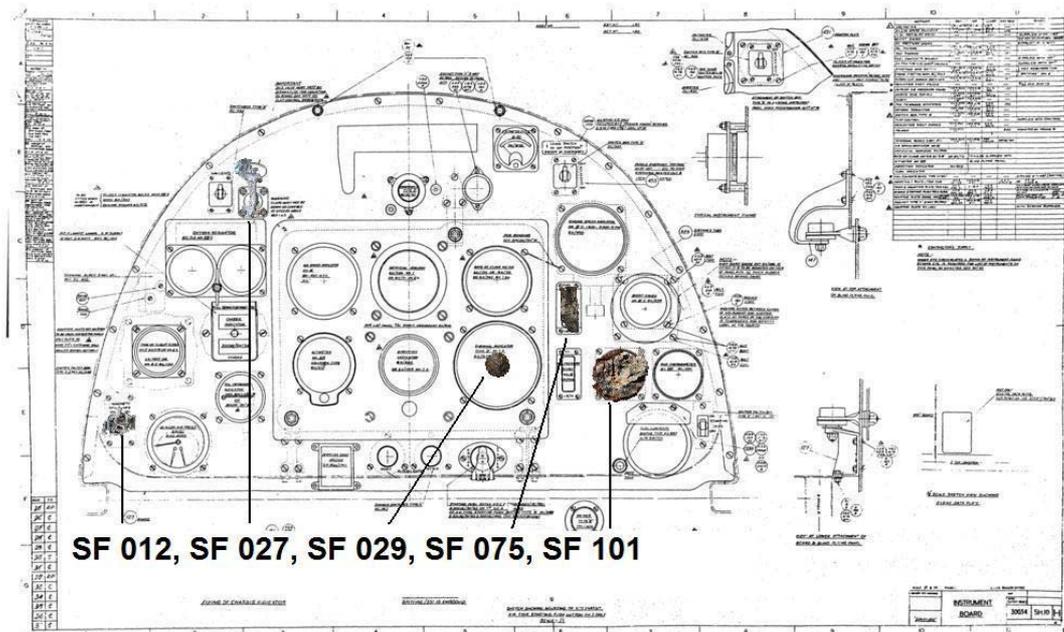
Not given SF numbers – large quantity of Perspex of the canopy, and armoured glass of the front windscreen

Figure 13 : Locations of cockpit finds

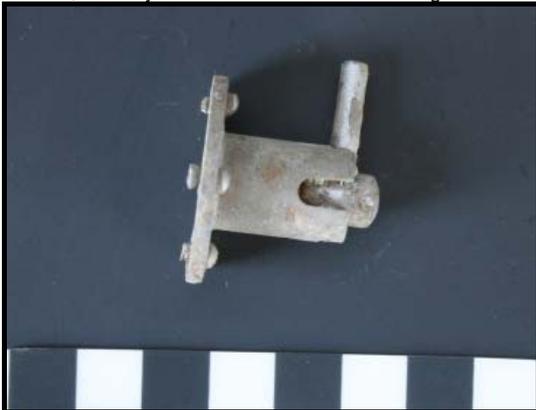
SF 014, Tr1 Layer 002. Quick release Cowling Fastener

This was one of a number of cowling and panel fasteners that were recovered on the excavation. Several of these still had the original paint scheme adhering to the external face.

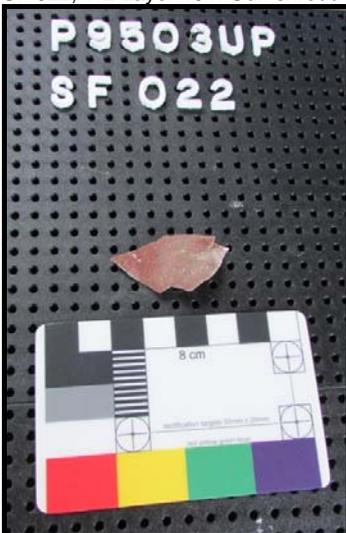
SF 022, Tr2 Layer 101. Gun shroud with red paint

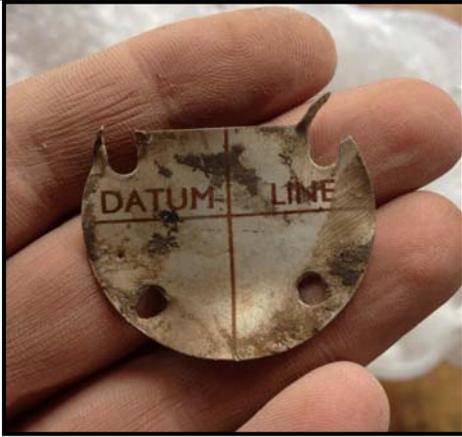
SF 096, Tr1 Layer 001. Datum line marker

SF 096 – a datum line recovered from the excavation of P9503 in 2013

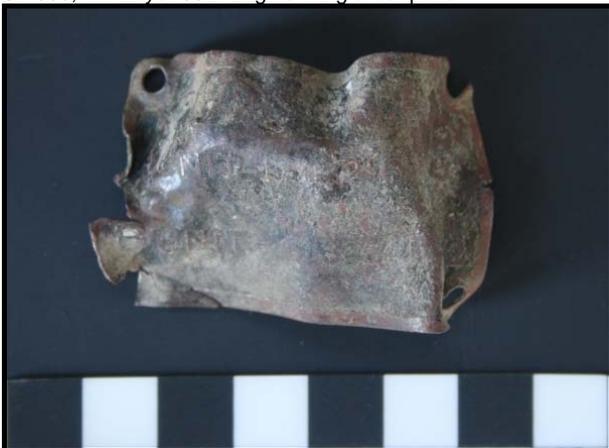
SF 005, Tr1 Layer 002. Engine firing order plate

With annotation 'FIRING ORDER, AUNIT - 1635, BUNIT -6542

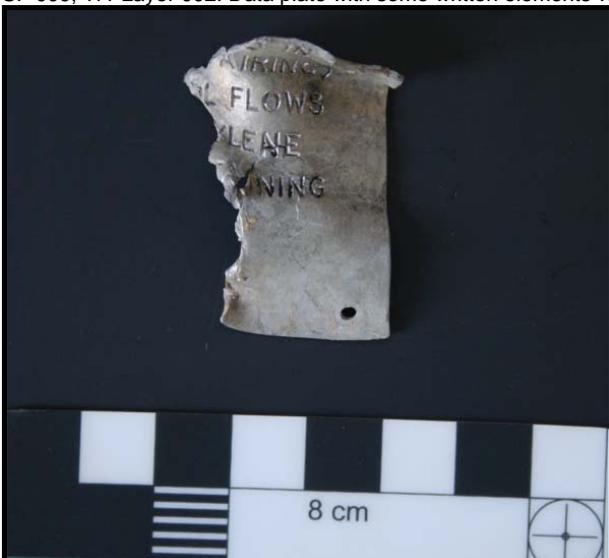
SF 009, Tr1 Layer 002. Data plate with some written elements visible

Wording includes '...AIRING,...L FLOWS, ...YLENE,...INING

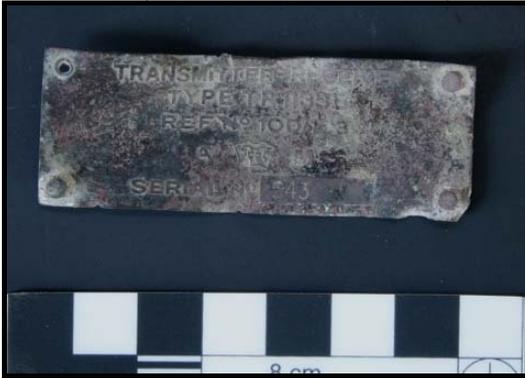
SF 023, Tr1 Layer 002. Radio transmitter data plate

Script reads 'Transmitter receiver, Type T.R. 1133, Ref No. 10D/?3, AM, Serial 543

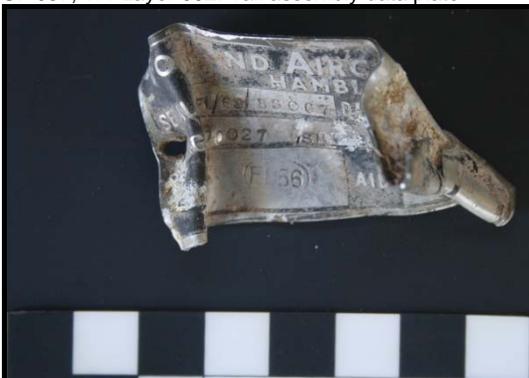
SF 037, Tr1 Layer 002. Tail assembly data plate

Annotation reads 'FOLLAND AIRCRAFT, HAMBLE, SERIAL...68/56067, DATE 02/40, 00027/SB 2..., FL26, AID. This indicates the manufacture of the tail assembly by Folland's of Hamble, near Southampton. The Folland works manufactured the majority of this portion of Spitfires throughout the war.

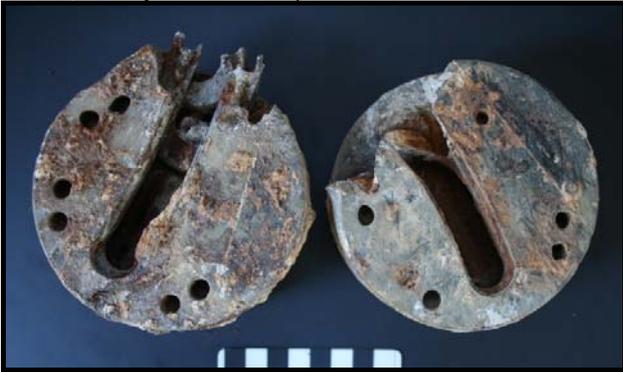
SF 042, Tr1 Layer 002. 2 x Propeller Balances

The milled sides of these two artefacts had impacted (and left a cross-hatched indentation) upon the remnants of the spinner of the propeller unit which was painted black.

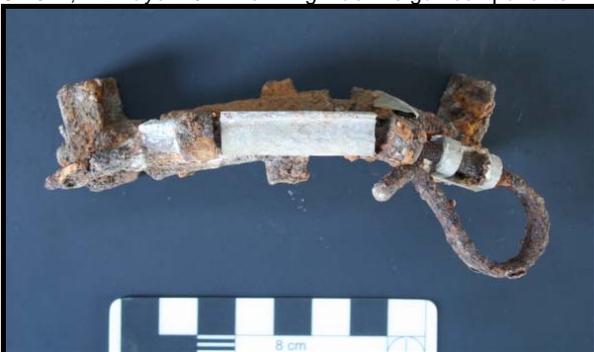
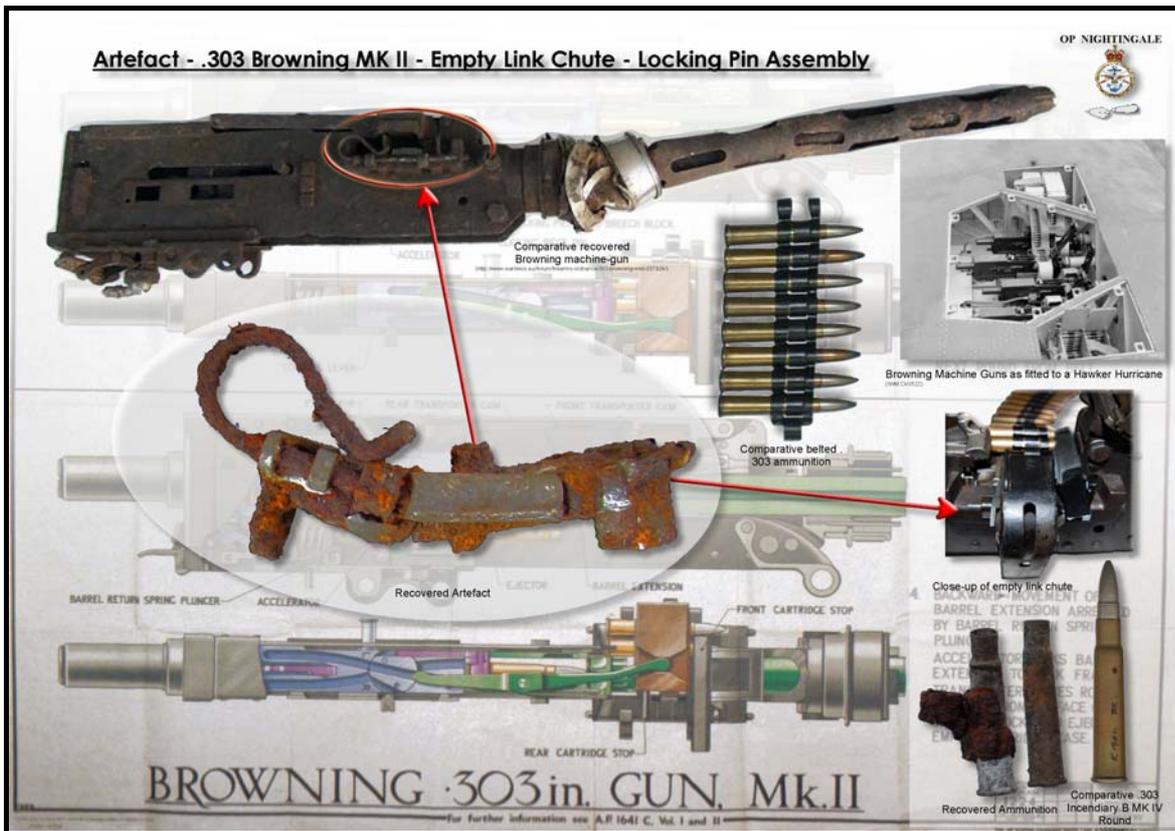
SF 047, Tr2 Layer 101. Browning machine gun components

Figure 15: Position of the Browning component from the excavation in relation to the overall gun assemblage. © Mark Khan

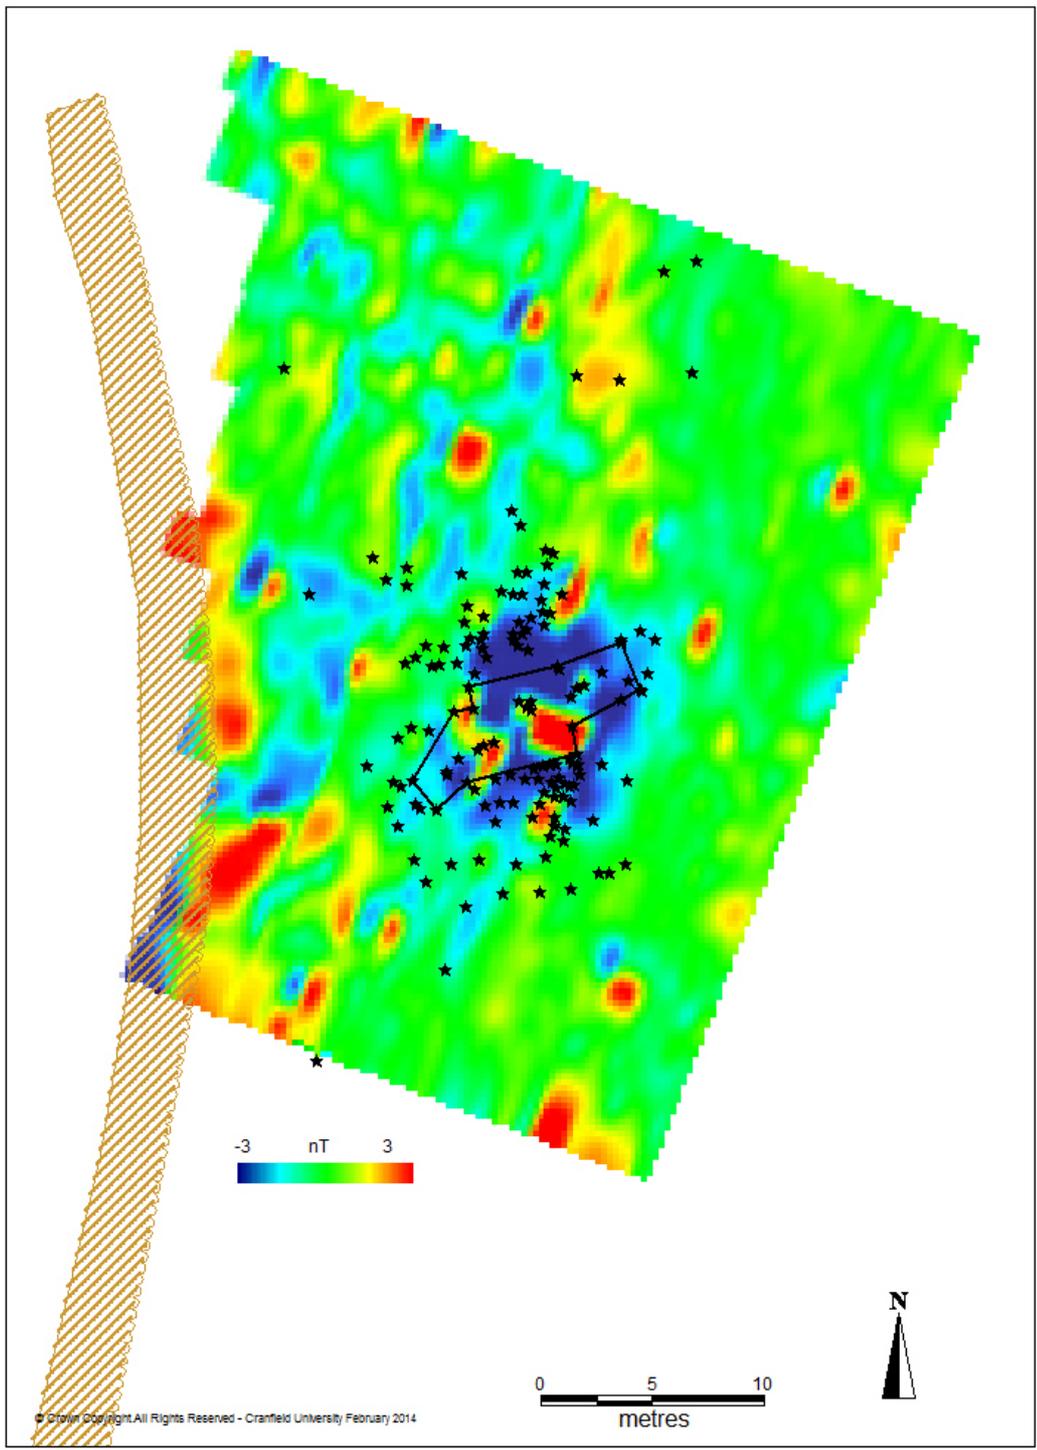
Figure 17: Magnetometer survey results of P9503UP with the excavation trench superimposed, and outlying stray finds marked as stars. Note the darker area of the crater with high central reading of engine components. © Peter Masters
