EAST OF ENGLAND

HERITAGE AT RISK	3
Reducing the risks	6
Publications and guidance	9
THE REGISTER	11
Content and assessment criteria	11
Key to the entries	13
Bedford (UA) Cambridgeshire Central Bedfordshire (UA) Essex Hertfordshire Luton (UA) Norfolk Peterborough, City of (UA) Southend-on-Sea (UA) Suffolk Thurrock (UA)	16 18 28 30 37 42 42 53 55 55

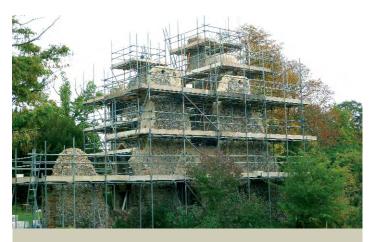
METTINGHAM CASTLE, SUFFOLK

The walls and towers of this I4th century castle now lie within the moated gardens of a domestic house. The ruins had been in rapid decline, but an English Heritage grant has helped the owners achieve an immense repair project in the midst of recession.
