Heritage at Risk

There are **682** assets on the **London** Register, **12** more than in 2015

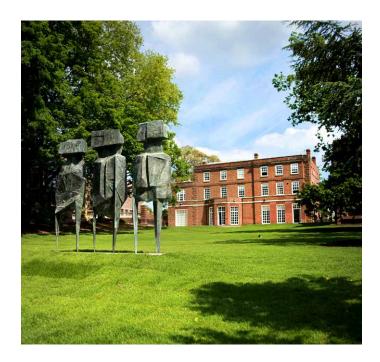
Public art was commissioned for all to enjoy, adding colour to our local places and daily lives. But our great outdoor public art gallery is under threat. In 2006 one of the three figures from 'The Watchers' was stolen. It was sawn off at the legs and police estimate that it would have taken at least eight people to carry the artwork away. A decade after the crime, the sculpture featured in an exhibition about missing post-war public art curated by Historic England. To this day the original has not been found.

To restore 'The Watchers' to their former glory, Roehampton University asked relatives of the artist for permission to re-cast the stolen figure. In February 2016 the newly cast figure was reunited

with the original two, now restored, and once again they stand proudly in the grounds of the university. The grade II listed sculpture has been removed from the Heritage at Risk Register this year.
