Heritage at Risk

There are 299 assets on the North East Register, 1 fewer than in 2016

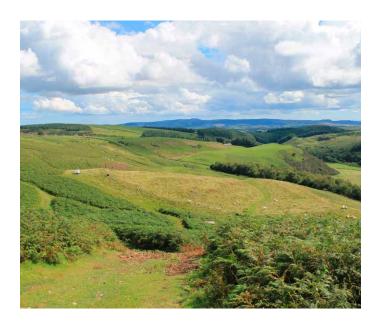
Situated on a promontory, on the south-facing slope of Hart Heugh hill, these earthworks are all that remains of a small native homestead dating from the Roman period. There are numerous well-preserved archaeological sites like this surviving all over Northumberland's uplands. These small settlements normally contain the foundations of one or two houses within a stone or timber enclosure. In this example, the settlement is enclosed within a roughly circular bank of earth and stone with an entrance on the south side. Native settlements like this contain significant archaeological deposits, but they are under threat from the uncontrolled advance of bracken. Bracken fronds obscure the visibility of archaeological sites and their root systems (rhizomes) damage important buried archaeological deposits.

and bashing (with specially designed equipment), and animal grazing. To support this work we are also carrying out research that tests the effectiveness of all the available treatments and their potential impact on a range of archaeological sites across the country.
