Heritage at **Risk**

London Register 2018

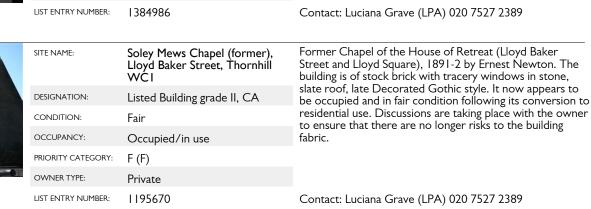
K	SITE NAME:	Odeon Cinema, Holloway Road N7	Cinema, built as the Gaumont 1937-8, architect C Howard Crane of Chicago. Poor general condition, with cracking
-	DESIGNATION:	Listed Building grade II, CA	and damage to faience. Inappropriate modern shop fronts in poor condition undermine the design aesthetic.
	CONDITION:	Poor	
	OCCUPANCY:	Occupied/in use	
	PRIORITY CATEGORY:	C (C)	
	OWNER TYPE:	Commercial company	
	LIST ENTRY NUMBER:	1384986	Contact: Luciana Grave (LPA) 020 7527 2389

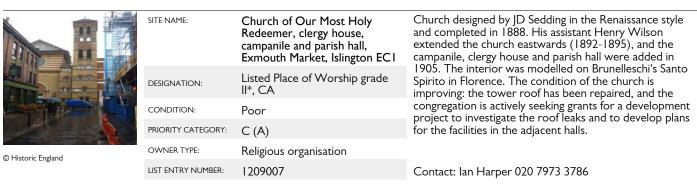
MINIMUM INTERNET	SITE NAME:	Former Mecca Bingo, 161-169, Essex Road NI	Built as the Carlton Cinema in 1930 by George Coles, previously a bingo hall and now in use as a place of worship
	DESIGNATION:	Listed Place of Worship grade II*	by Resurrection Manifestations. The building has black, white and coloured faience to the Essex Road front, the
	CONDITION:	Poor	rest being of yellow brick with a slate roof. The façade to Essex Road is in Egyptian style. The church has temporary
	PRIORITY CATEGORY:	C (C)	consent for its use of the building, including the temporary division of the main auditorium. Some repairs and restoration have been carried out, but there is evidence o
	OWNER TYPE:	Religious organisation	
	LIST ENTRY NUMBER:	1292870	damage to the faience tiles. Proposals for re-use are currently being explored.
© Historic England			Contact: Verena McCaig 020 7973 3718

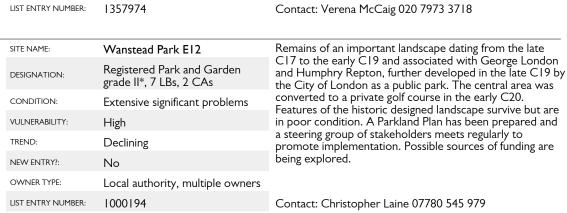
North Contraction of the Institute of th	SITE NAME:	The Grotto, Wanstead Park EII	Ruined grotto boathouse of circa 1762. It consists of a large honeycomb rockwork facade of segmental plan with
102	DESIGNATION:	Listed Building grade II, RPG grade II*, CA	several arches at lake level, and window openings above. The area is fenced off from public access. The grotto has been managed as a ruin for many decades and has had a
	CONDITION:	Poor	number of different repair interventions. However, there are areas of mortar failure and further loss of rockwork,
	OCCUPANCY:	N/A	and self-sown vegetation threatens to cause further
	PRIORITY CATEGORY:	F (New entry)	instability. The City of London commissioned a survey in 2017 and the works identified are now being carried out.
	OWNER TYPE:	Local authority	, i i i i i i i i i i i i i i i i i i i
© Historic England	LIST ENTRY NUMBER:	1183624	Contact: Bruce Edgar (LPA) 0208 708 2013
