HERITAGE AT RISK REGISTER 2009 / NORTH WEST

HERITAGE AT RISK IN THE NORTH WEST

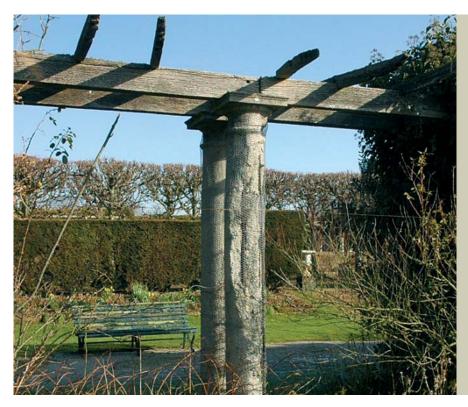
THORNTON MANOR, CHESHIRE

The park and gardens, commissioned in 1905, were the first of a series of three major private gardens designed by Thomas Hayton Mawson in collaboration with William Hesketh Lever, later first Viscount Leverhulme. The formal gardens around the house include a large rectangular area known as the Forum, which is delineated by a concrete columned pergola, now suffering problems of decay. English Heritage is working with the owners to establish conservation priorities for this important registered site.

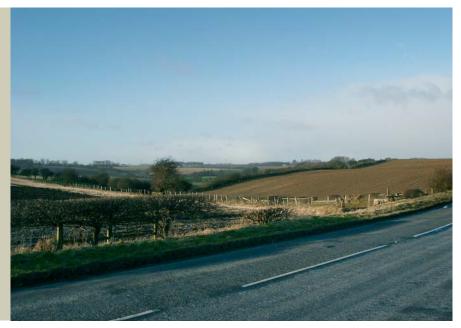
TOWTON BATTLEFIELD, NORTH YORKSHIRE

High, bleak, arable land near Tadcaster was the scene of a ten-hour battle on 29 March 1461 during the Wars of the Roses. Fought in a snow storm, the battle is said to have claimed 28,000 lives. Artefacts and arrowheads from the battle have been consistently targeted by metal detectorists, some unauthorised and working independently of any agreed archaeological survey. At least one episode of deep ploughing may have disturbed a possible mass grave. Today, the Towton Battlefield Society has a strong and active membership that seeks to protect the battlefield and promote research and education. © Glenn Foard

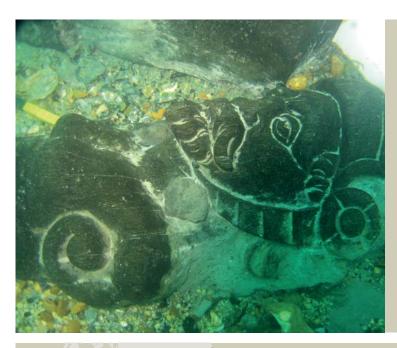
SWASH CHANNEL WRECK, DORSET

In October 2004, archaeological assessment work in advance of channel deepening in Poole Harbour led to the discovery of this previously unrecorded wreck. A recovered fragment of Rhenish stoneware and the general form of the surviving structure of the vessel both suggest an early 17th-century ship, probably an armed vessel. Because of its national significance, the wreck was designated in December 2004. However, it is unstable and subject to dramatic shifts in exposure. Monitoring by Bournemouth University showed that 300mm of sediment had been lost across the site in just two years, resulting in the exposure of further sections of the ship to the destructive force of the sea. The vessel is now deemed to be at risk and English Heritage is working with Bournemouth University to implement a management plan to mitigate the loss. © Bournemouth University

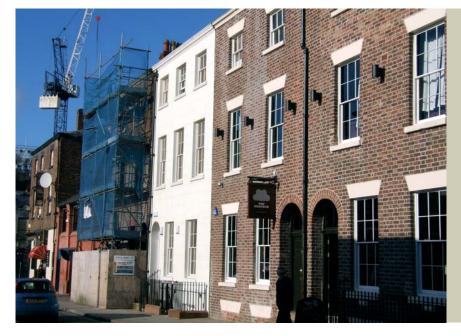
SEEL ST, LIVERPOOL

Seel Street is part of the Duke Street conservation area in Liverpool and epitomises the threats and opportunities confronting many conservation areas at risk. The area was developed in the 18th century following the construction of the first dock in 1715 and is characterised by a complex mix of retail, commercial, warehouse and residential developments. The area currently contains examples of high-quality public spaces, some good new design, imaginative conversions and persistent derelict buildings and sites. The Ropewalks Steering Group is working to secure a positive future for the area.
