## Lead roofs on historic buildings

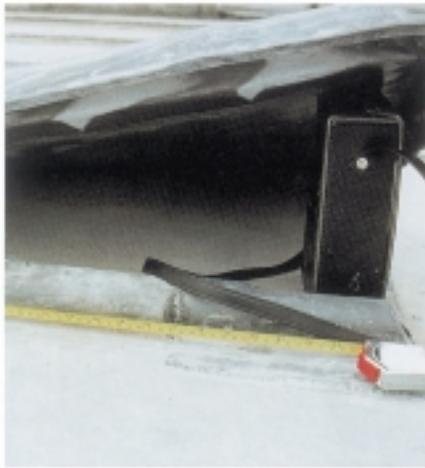
*Figure 8 A historic house by the Thames, now used as offices. One October fresh lead was laid over new geotextile felt on the original softwood boarding. This photograph taken three weeks later shows how the autumn dew initiated ULC above the gaps between the boards. Note the characteristic 'fish-tailing' of white Type II corrosion product on the underside of the lead to the inside of the rolls. This is where moist air from within the building rises into the rolls and sometimes condenses. Above the decking, the lead is not corroded because moisture cannot reach it so easily and some has been absorbed by the boarding.*

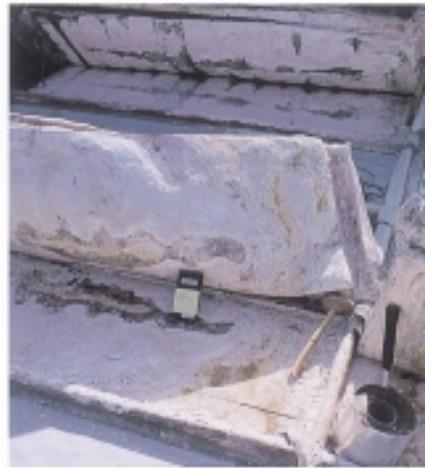
*Figure 9 After forty years, ULC has consumed, on average, about one-quarter of the thickness of the lead here, and the roof is beginning to fail. Here, and frequently when ULC is severe, the prime cause is trapped moisture plus organic acids from the substrate: in this case hardboard over oak, which are both aggressive to lead. The rather less corroded stripes running up the sheets show where the rafters come.*

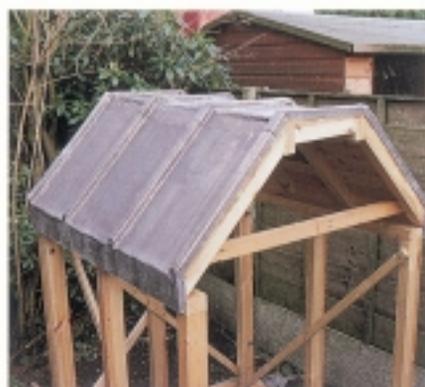
Figure 13 This outdoor test rig near Manchester has 100% outside air ventilation. Little ULC has been found here, apart from an area of the flat central section above which a shallow puddle of rainwater collects. Evaporation from this cools the lead in windy conditions (increasing the risk of condensation) and lengthens the drying-out period when it is warm. In an enclosed roof or a VWR, a small amount of moist air or water vapour entering the ventilated airspace can have a similar effect.

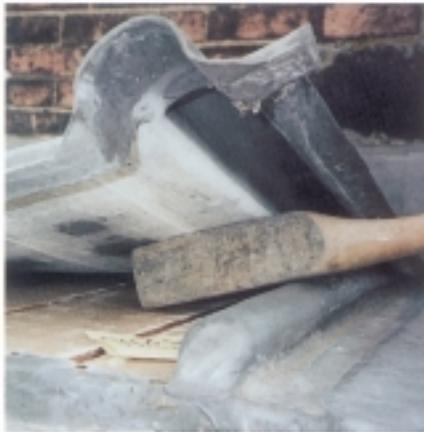
*Figure 14 Gratuitous ventilation may sometimes increase corrosion. When this roof of a historic house in the Midlands was repaired, insulation faced with a vapour control membrane was fitted between the ceiling joists and outside air ventilation was introduced. Since the membrane was not continuous under the joists, it did not stop water vapour and moist air rising from the building into the roof (which was also now colder in winter owing to the additional insulation and ventilation). There is active ULC over the board joints where transient condensation occurs, and over the boards themselves which are now damper than before. A later phase of work did not add ventilation and is uncorroded. In both phases an initial underside coating would have been a useful precaution.*

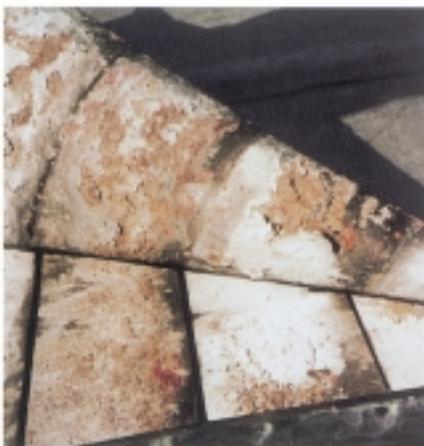
*Figure 15 Village churches with oak ceilings which have lead laid directly above them are particularly susceptible to ULC. The reddish-brown coloration of lead oxide here is quite common, as are the passivated areas near the gaps where the acid vapours can disperse. In situations like this, where it is important to retain an oak ceiling, a Ventilated Warm Roof above may be the only answer.*

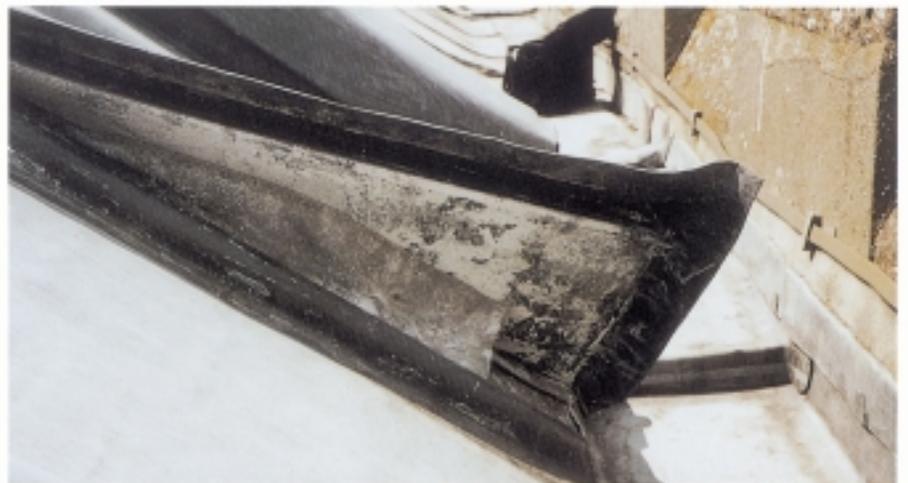
*Figure 16 This early example of a VWR was ventilated from side to side, rather than from bottom to top. ULC has occurred in the less well-ventilated area near the eaves between the two bottom vents.*

It is important for the ventilation to run through all parts of the roof from bottom to top. (*The lead sheet manual*, vol 3, pages 62-63, shows some ventilator details.) In roofs which do not have through-ventilation, corrosion is often found in the dead spots. Occasionally the ventilation has become restricted owing to

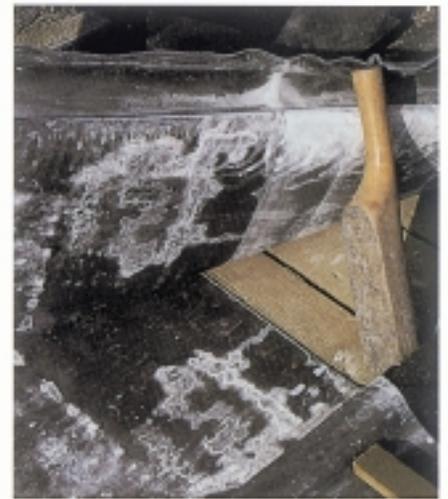
Figure 18 In this VWR, the AVCL terminates some distance short of the abutment. The lead nearby has corroded underneath, which is to be expected in the circumstances. Some condensate has also entered the lap and caused local corrosion.

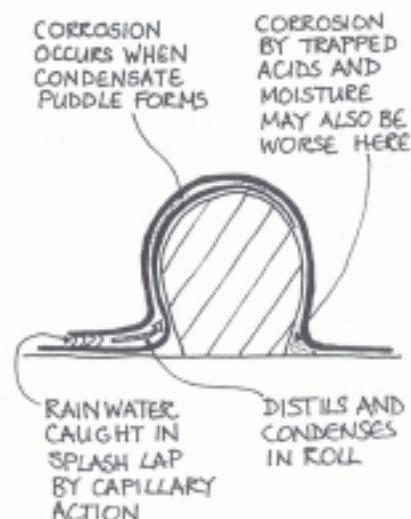
*Figure 19 Corrosion in splashlaps. This diagram illustrates two types of ULC which tend to be exacerbated by splashlap detailing. The left hand side shows where rainwater can cause small amounts of ULC, particularly where the undercloak and overcloak come sufficiently close together to trap their own capillary 'puddles' of distillate. On the right, trapped moisture from within the construction finds it more difficult to emerge and can be destructive if acids are present. Occasionally the acids find their way over the top and both sides become badly corroded.*

Sometimes distillation of trapped rainwater may also cause some ULC

in laps and splashlaps, as sketched left: this occurs independently of conditions inside the building, and is seldom serious except where organic acids also accumulate. Preliminary tests suggest that coatings can also help to reduce it.
