A RETROFIT OF A VICTORIAN TERRACE HOUSE IN
NEW BOLSOVER:
A WHOLE HOUSE THERMAL PERFORMANCE ASSESSMENT

RESEARCH REPORT

EXECUTIVE SUMMARY

Soki Rhee-Duverne and Dr. Paul Baker

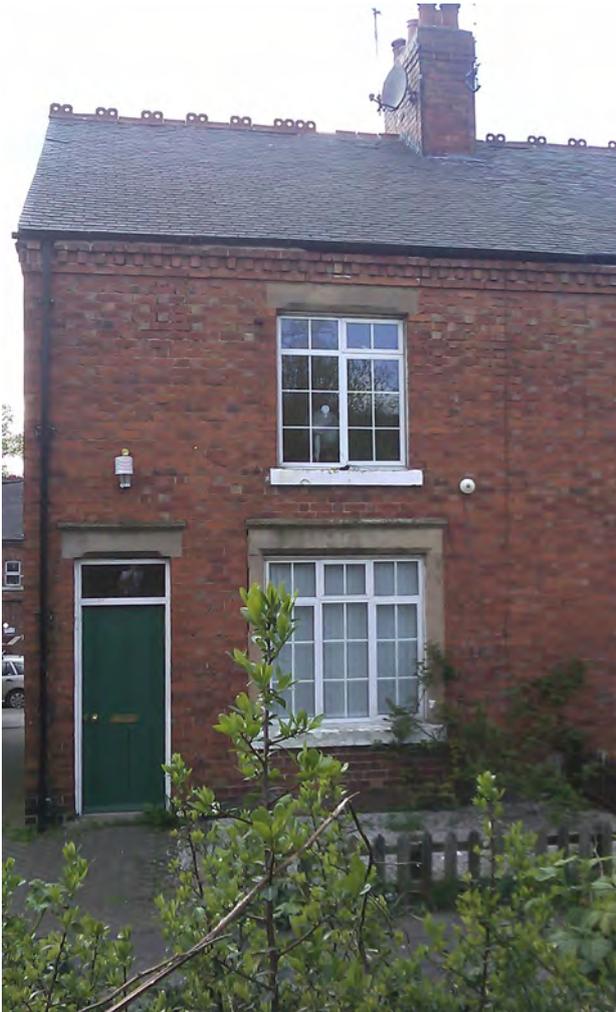
Figure 1: Front elevation, before refurbishment

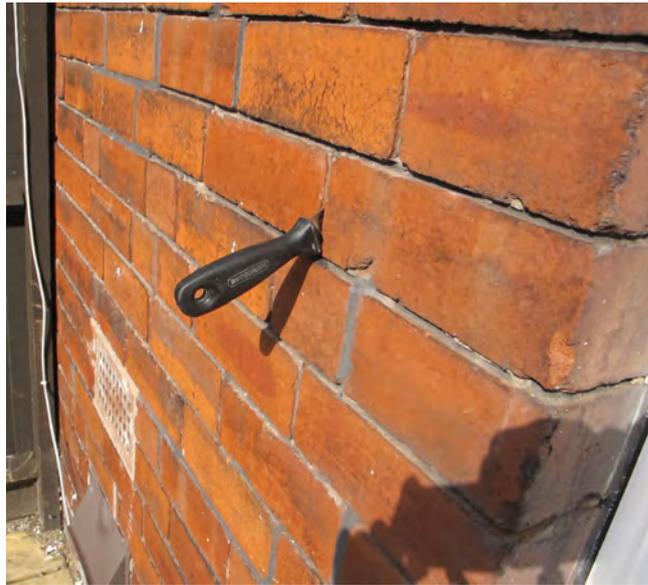
The property was constructed of solid masonry walls in a Flemish bond with a red dense, clay brick. The brickwork was largely undamaged and in good condition, however the pointing generally required renewal. The original mortar was a lime ash, which lay beneath a poorly executed cement mortar repointing. The latter was failing in some areas, see Fig. 3.

Figure 3: Deteriorated mortar joints

Most of the perpend were open along the lowest course of brickwork. In particular, the top half of the gable wall had been extremely poorly re-pointed in cement in recent years. Dense mortar pointing is likely to have a detrimental effect on the brickwork in the future, and this was recommended for removal if damage to the brick could be avoided.

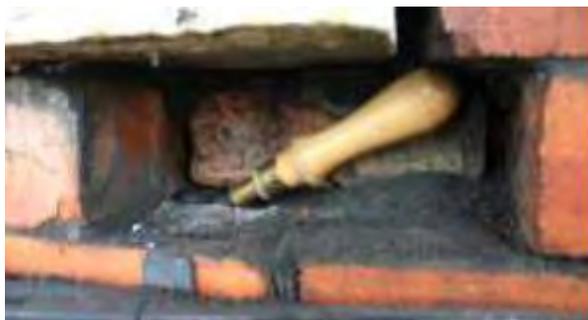
A narrow small cavity in the wall was noticeable on removal of one of the bricks however it was not possible to determine whether this was as a result of natural deterioration, poor workmanship or part of the original design, see Fig. 4.

Figure 4: Small cavity in the wall

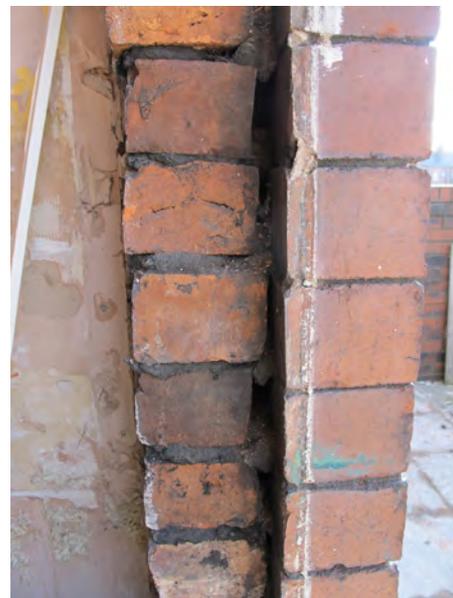
Figure 5: Removal of the door frame revealing a cavity in the wall

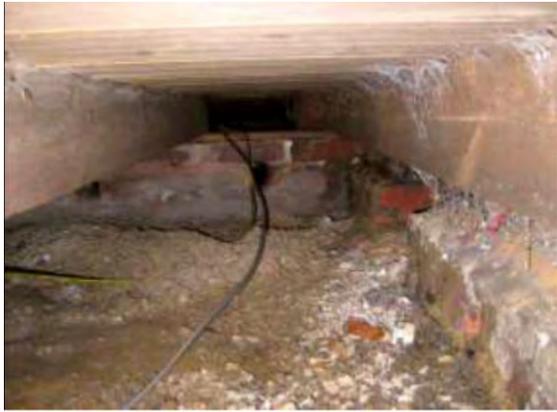
Vegetation at the base of the walls suggests that rainwater, which has accumulated in these areas, has saturated the brickwork. The east wall has been laid with a plastic membrane and gravel allowing water ingress at the base of the wall but preventing trapped moisture escaping. A short period of damp monitoring of the subfloor space undertaken prior to the refurbishment works suggests that there has been water penetration in recent years due to the high ground levels, the laid polythene sheet and open joints, see Figs. 6 & 7.

Figure 6: Illustration of sub-floor space

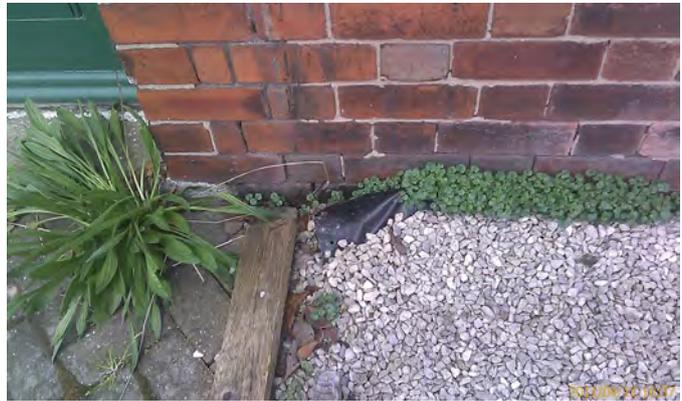
Figure 7: Vegetation at the base of the front elevation

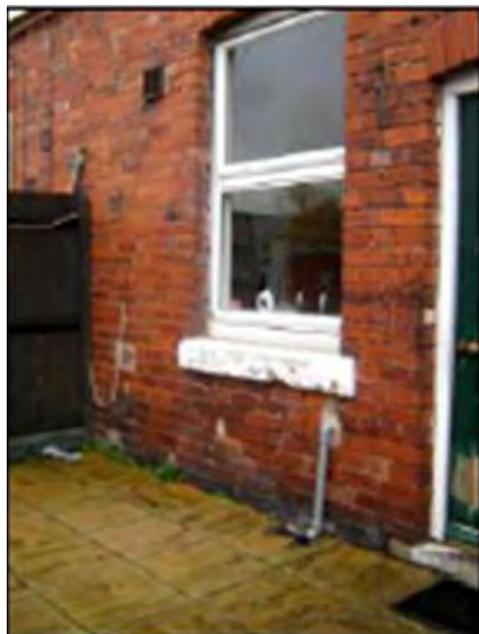
Ground levels at the rear west wall of the building were nearly at internal floor level and a damp proof course had been injected into headers at the wall base. Paving slabs were irregularly laid and channelled water towards open joints in the wall, see Fig. 8. A sample taken from the lower west wall during the damp survey indicated high moisture content due to the high ground level and the drainage problems. However, this was the only damp sample suggesting the house did not at the time exhibit general problems with moisture.

Figure 8: Irregularly laid paving slabs at the rear of the house channelling water to base of the rear elevation

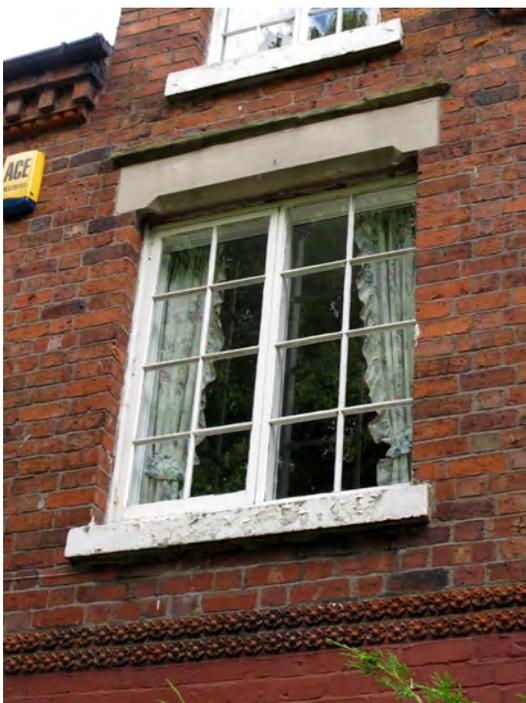
Figure 10: Original timber casement window on a neighbouring house

The original timber single glazed windows had been removed during the 1980s and had been replaced with plastic coated aluminium windows: double-glazed casement windows on the front elevation and single-glazed sash windows to the rear, see Figs. 10-13.

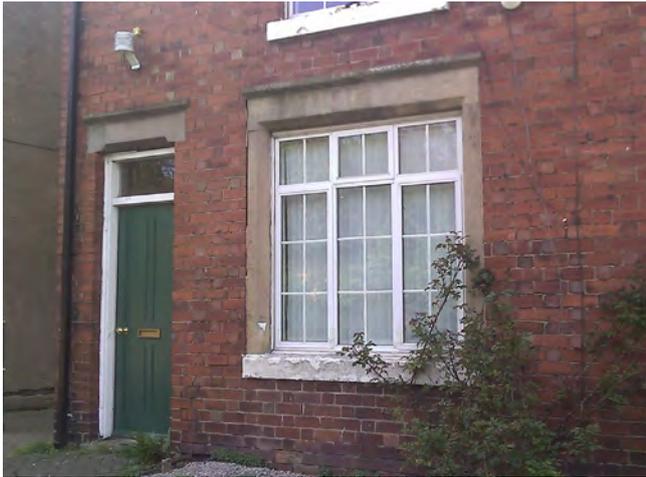
Figure 12: Plastic coated double glazed aluminium window on the front elevation

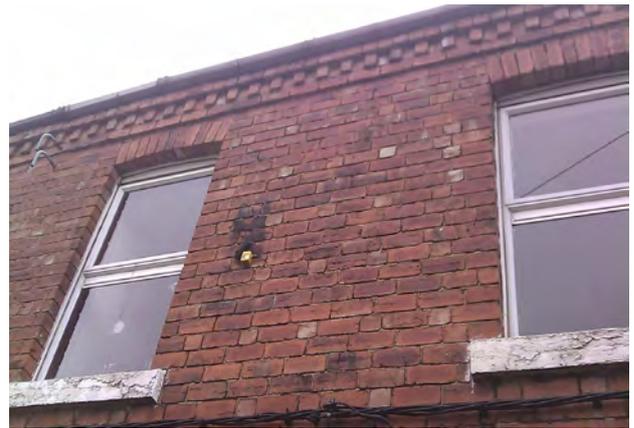
Figure 13: Plastic coated single glazed aluminium window on the rear elevation

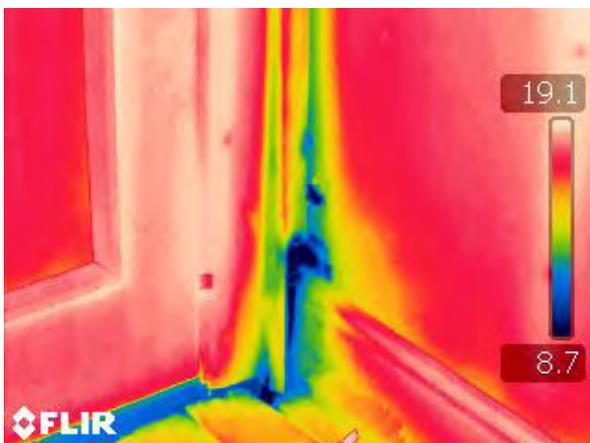
16

The doors were also poorly sealed and air cracks were visible as illustrated from the infrared images of thermal bridging, see Fig. 16.

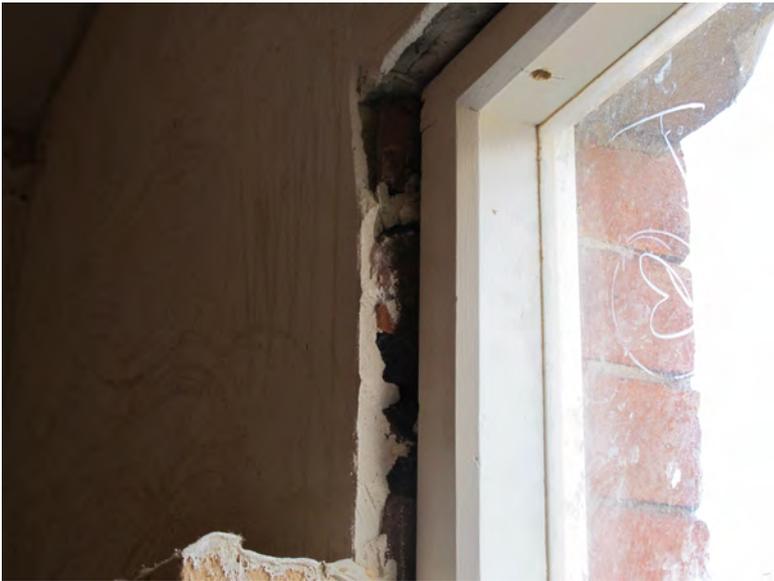
2. On the first floor, a vapour permeable system based on a wood fibre insulation was used (Type C). The system comprised of a lime plaster levelling coat for bonding specified with a 9mm thickness however in practice the thickness, applied to the walls varied between 9-25mm due to the uneven surface of the inner brickwork, see Fig. 20.

Figure 20: Varying thickness of the bonding coat of lime plaster

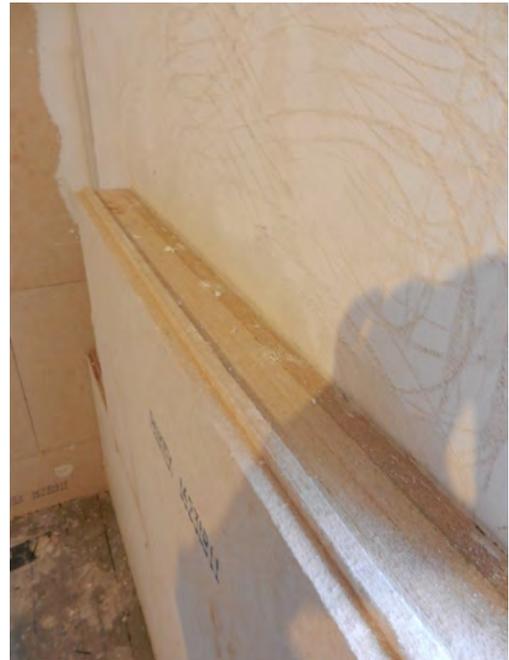
Figure 21: Lime plaster sandwich of the 100mm wood fibre insulation

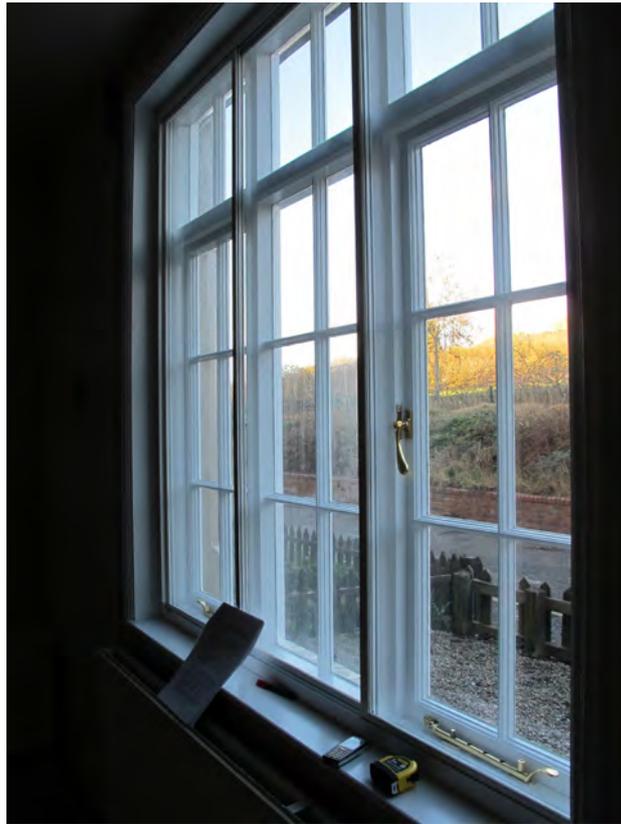
The plastic coated aluminium windows were replaced with single glazed accoya wood windows conforming to the original design. Two types of high specification secondary glazing were installed: a low emissivity secondary glazing on all the windows with the exception of one window in the gable bedroom where an experimental secondary glazing system using a slim profile vacuum glazing was installed, see Figs. 22-25.

Figure 23: Secondary glazing on the casement window

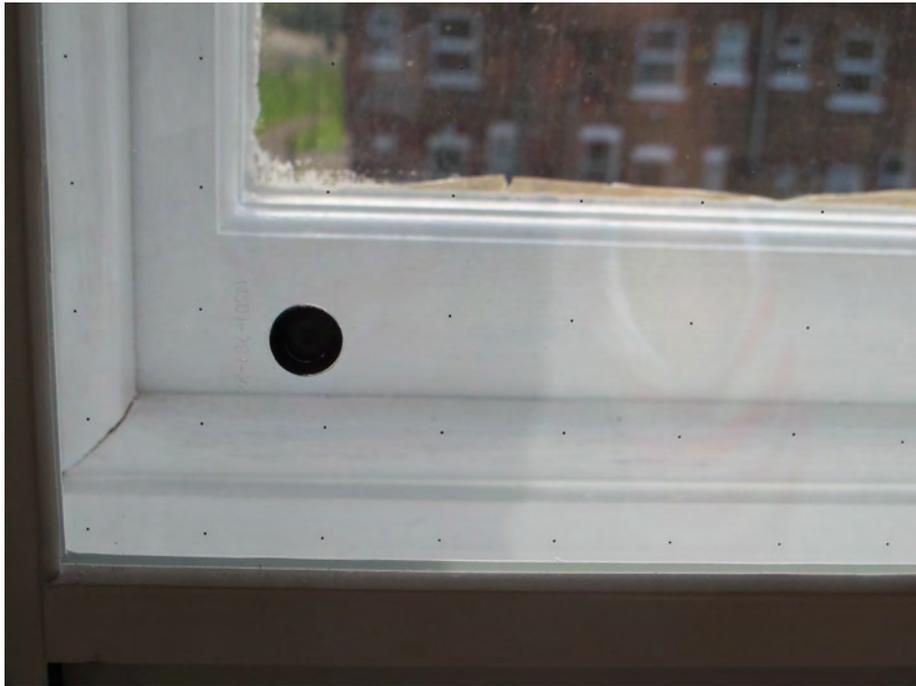
Figure 25: Detail of the slim profile vacuum glazing

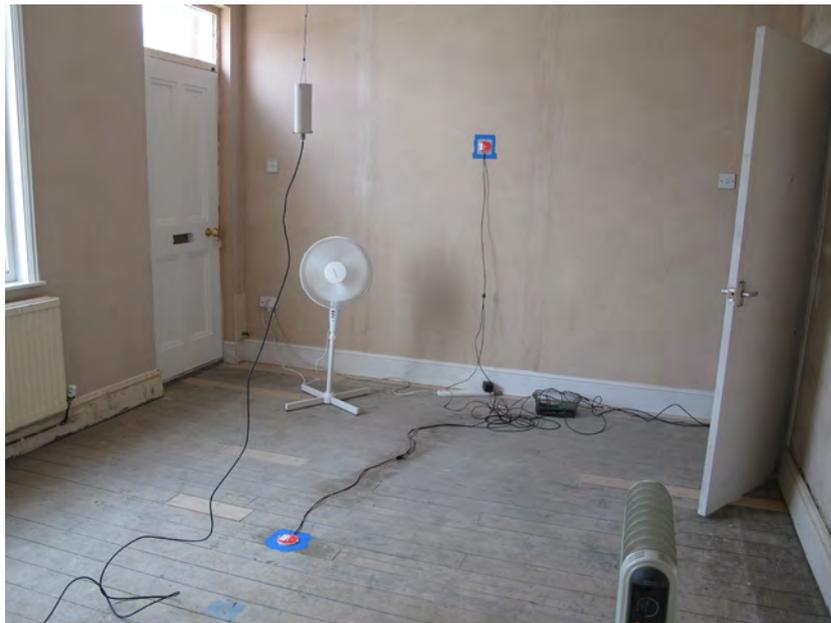
Analysis of the co-heating test data was initially undertaken using a steady state method which was refined using a dynamic model based on the LORD program^{xiii} reducing the uncertainties found in co-heating test method and improving the reliability of the data. Further details on the dynamic analysis of the data are given in the Appendix A of the research report.

Figure 26: Co-heating test set-up

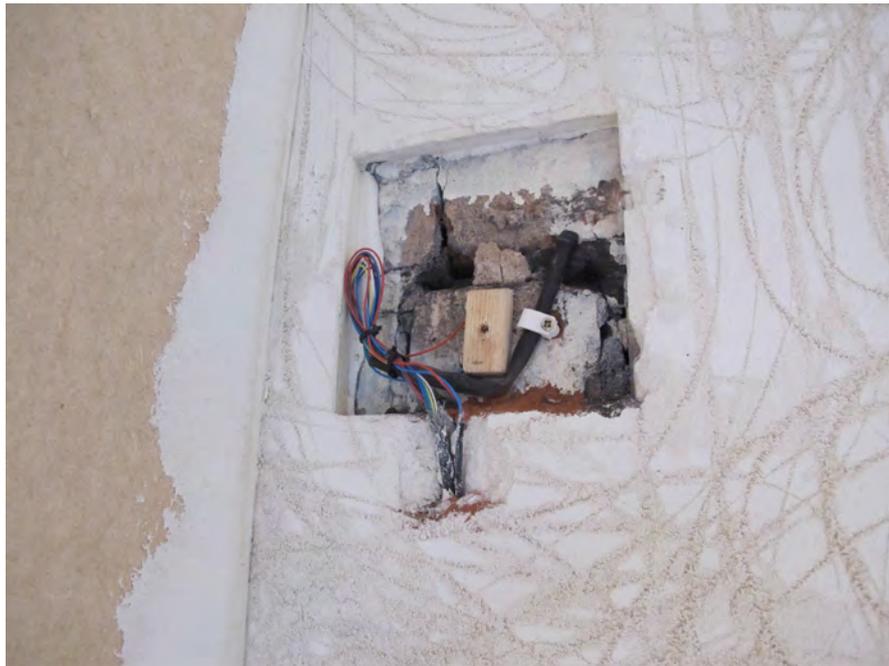
Figure 28: Relative humidity/temperature and resistance sensors fixed on the wall prior to the installation of internal wall insulation

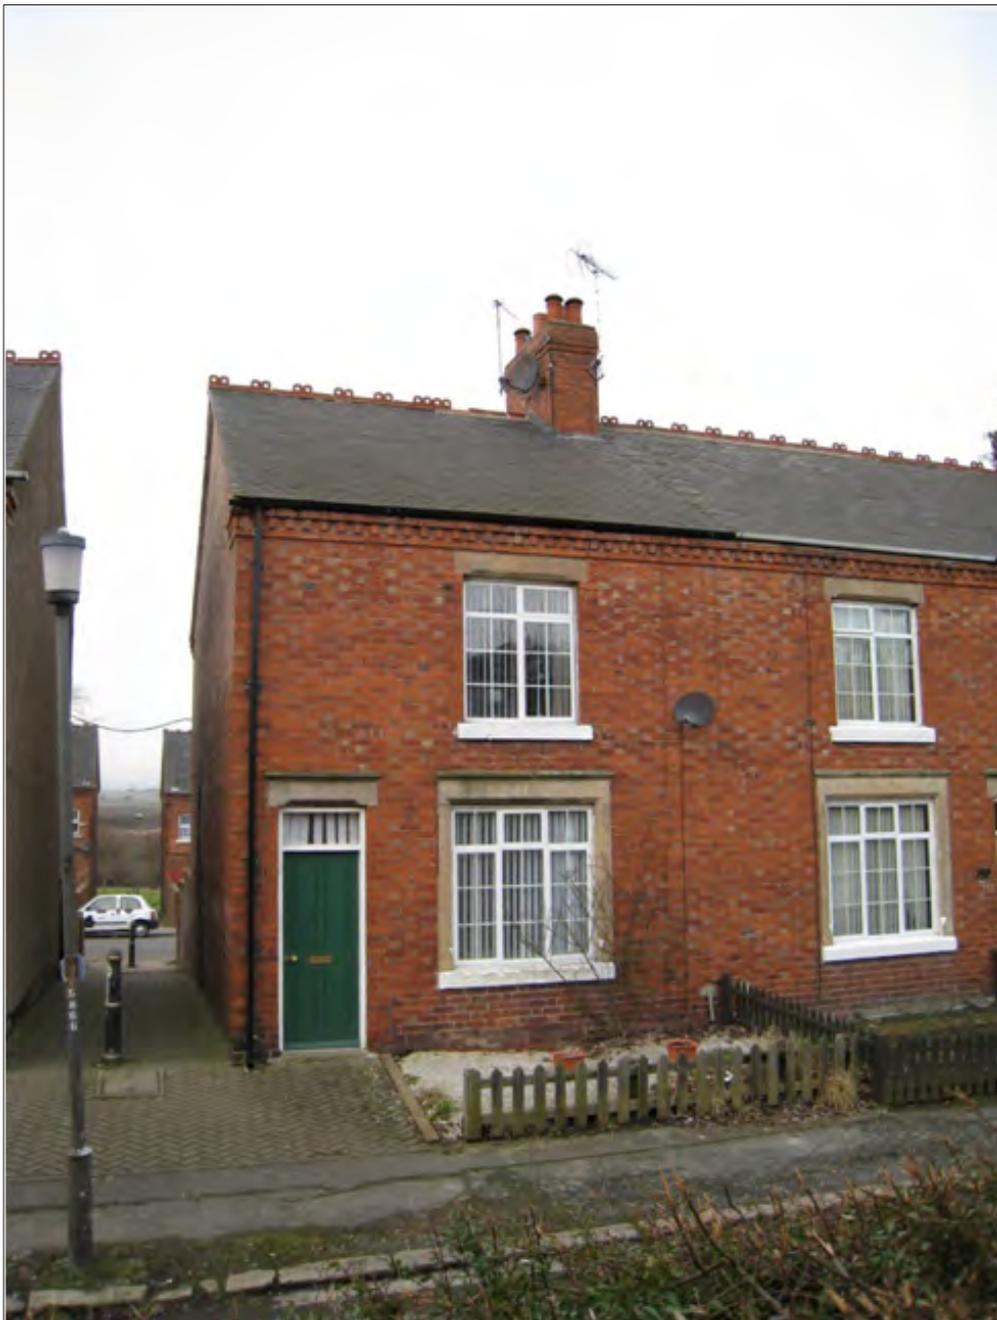
Figure 1: The New Bolsover house front elevation

This report presents the results and analysis of the thermal performance measurements made in a brick built end terrace house in New Bolsover, Derbyshire. The house (Figure 1), constructed in 1891 has a total floor area of 88m² and comprises a living room, kitchen/dining room and bathroom on the ground floor and three bedrooms on the first floor. The work was carried out by Historic England and Glasgow Caledonian University, before and after the installation in December 2011 of a package of interventions, including internal wall insulation, improved loft insulation, insulation of the suspended timber floor and reinstatement of single-glazed timber framed windows with high specification secondary glazing systems behind them. Before the intervention, the house had only loft insulation of varying thicknesses and a variety of single and double glazed replacement aluminium framed windows.

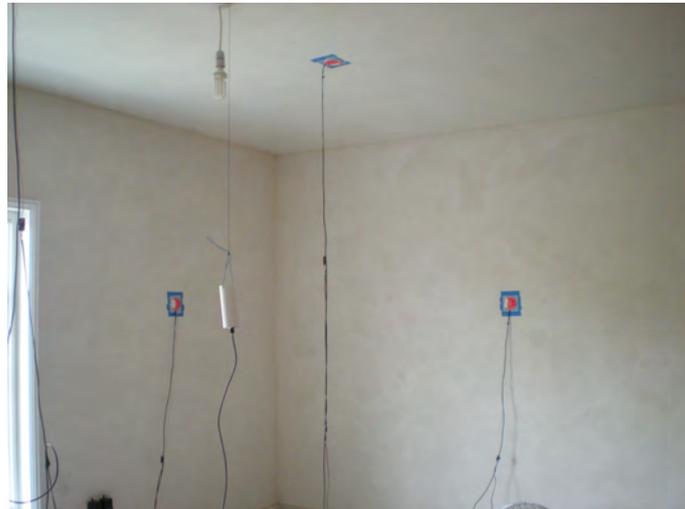
Figure 5: In situ U-value measurements in main bedroom: front elevation, gable wall and ceiling.

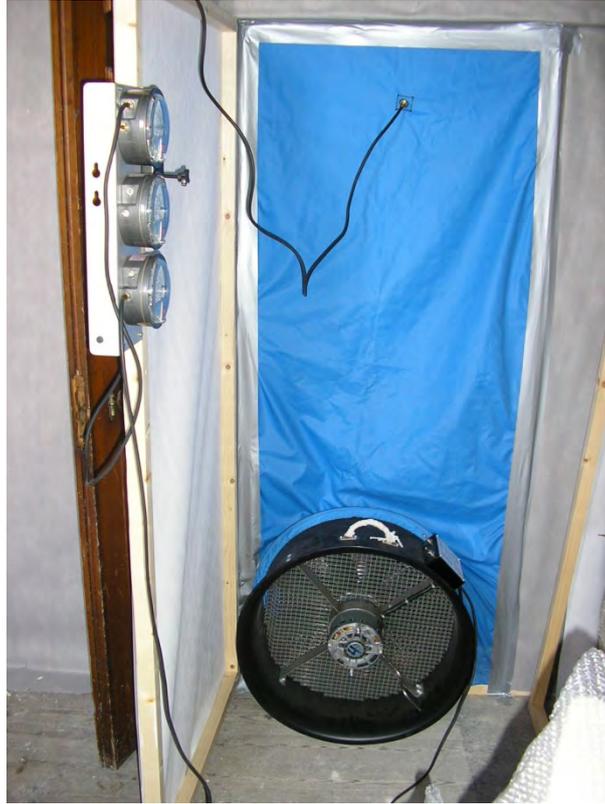
Figure 7: Blower door assembly for building pressurisation test.

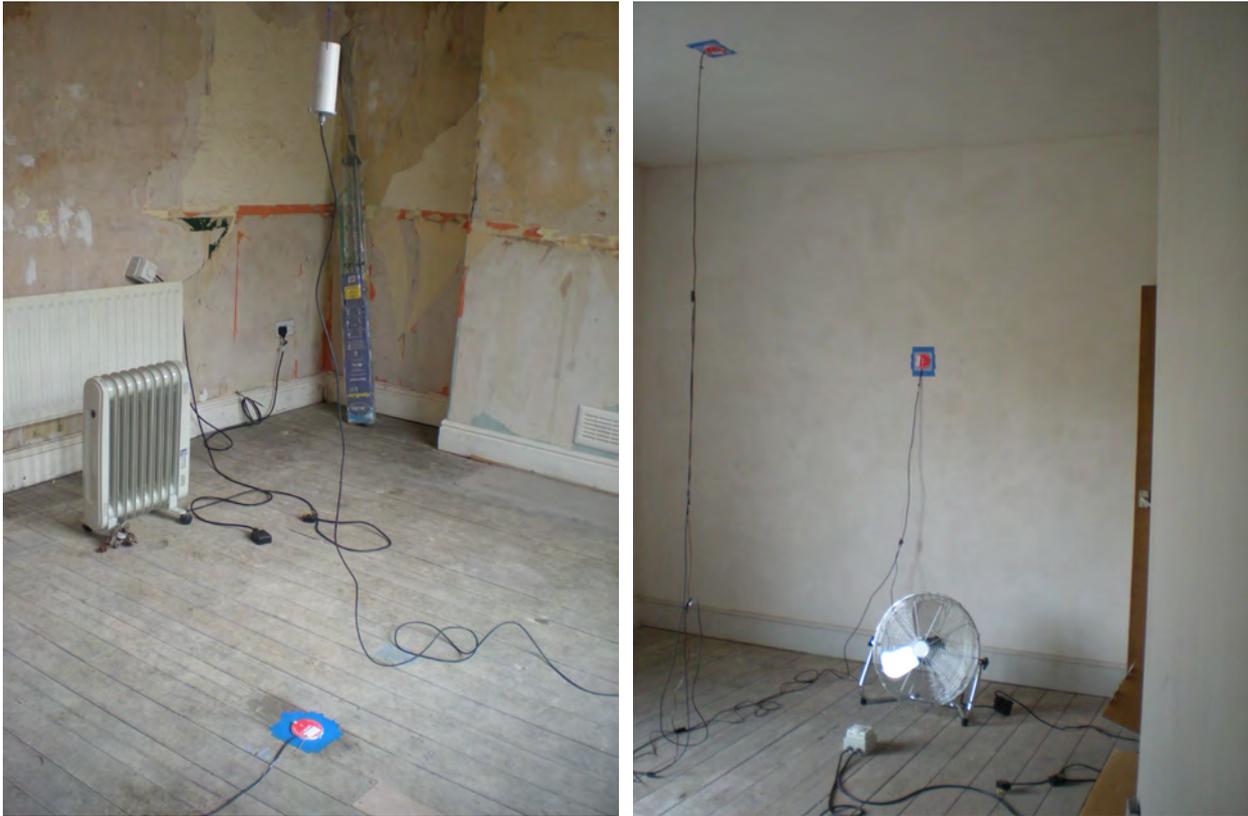
Figure 9: Co-heating test set-up with heater, fan & thermostat.

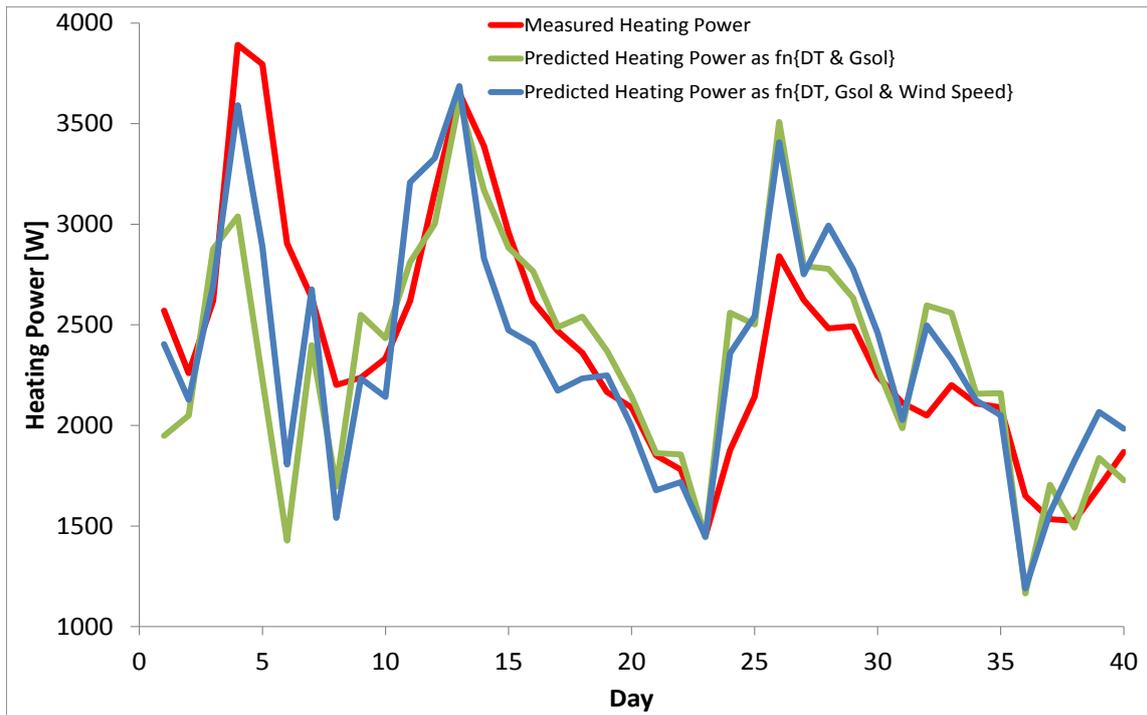
Figure A13: Before-intervention case. Measured and predicted heating power using (a) ΔT and G_{sol} as the independent variables (Equation A1) and (b) ΔT , G_{sol} and wind speed (Equation A4).
