ENGLISH HERITAGE  
PRACTICAL BUILDING CONSERVATION

# STONE

ASHGATE

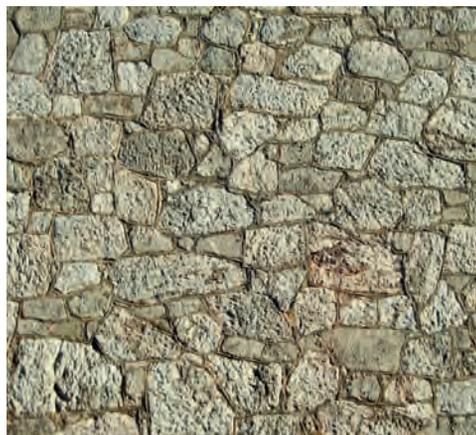
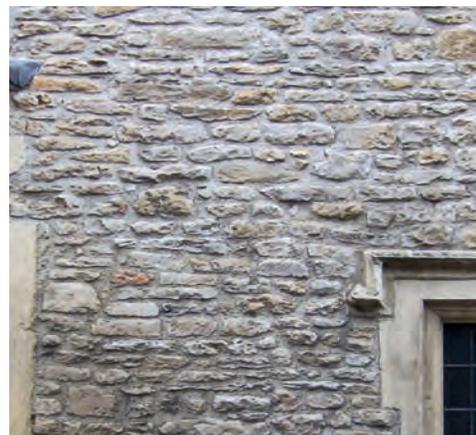
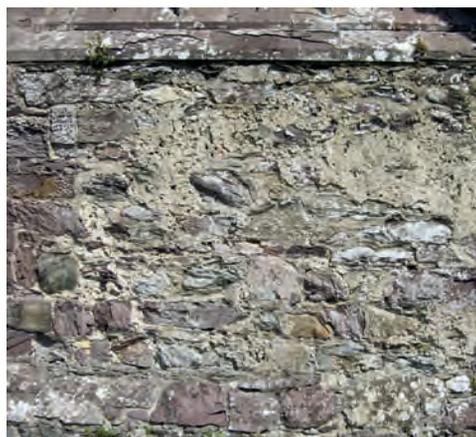
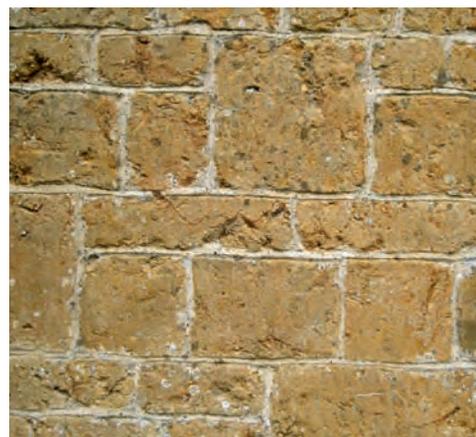
#### Rubble walls

*Clockwise from top left:*

Some hard, intractable stones broke naturally into random shapes, which were laid closely-jointed to form polygonal or rag walling.

Other stones were of more regular shape and could be roughly coursed.

Some rubble stones were dressed to form rectangular blocks that could be laid in even courses.

Many rubble walls were originally lime-rendered for essential protection. Fragments of such renders sometimes survive in sheltered areas.

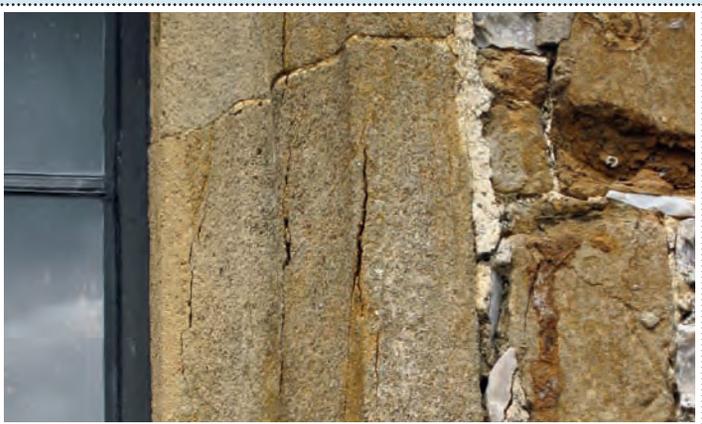
<p><b>Delamination</b> Detachment along the bedding planes of the stone, which can occur whether or not the stone is subject to compressive load</p>	<p>Weathering of weaknesses related to the bedding, such as layers of clay or mica, resulting in water ingress and increased weathering due to wetting/drying stress, salt crystallisation or frost action</p>

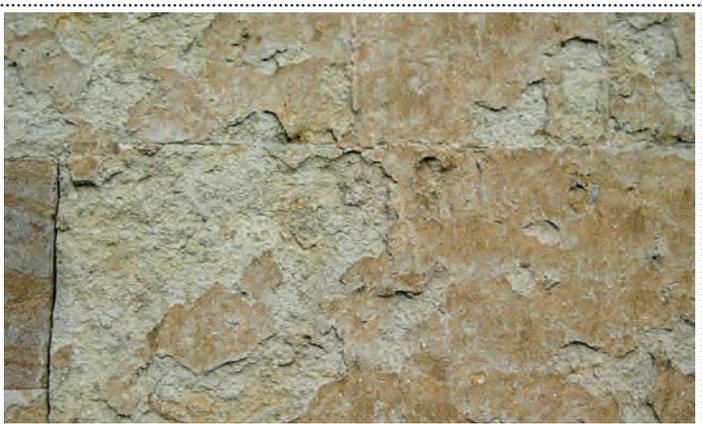
<p><b>Exfoliation</b> A form of delamination in which the stone breaks down into one or more very fine layers, often curling and twisting</p>	<p>Failure of surface crust in some sandstones and limestones; usually due to hardening of surface resulting in restriction of moisture movement Thermal stresses between the surface and underlying stone</p>

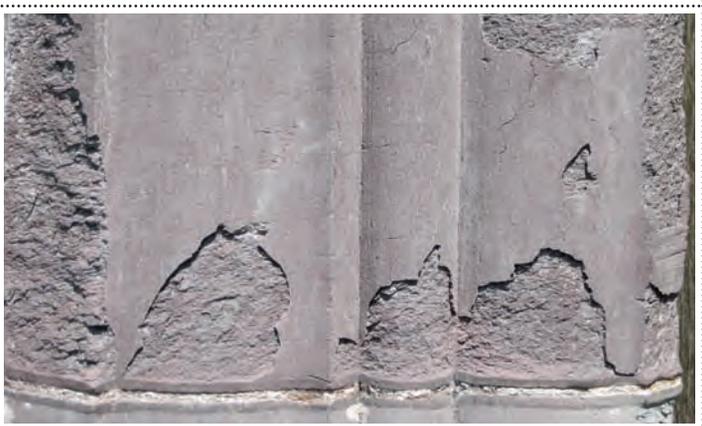
<p><b>Contour scaling</b> Separation of outer layer of stone parallel to surface contours of stone (independent of the bedding), occurring almost exclusively in sandstones  The detached layer can be from about 2 mm up to 20 mm thick</p>	<p>Differential thermal movements in denser surface layers of sandstone Salt crystallisation behind surface</p>

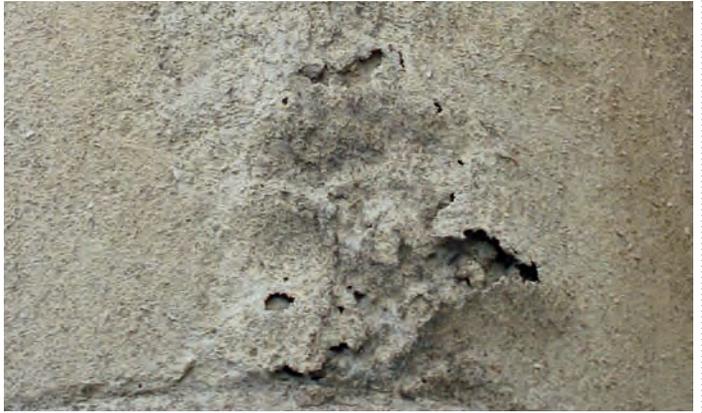
<p><b>Blistering</b>            Raised, rounded, hollow swellings on the stone surface, varying in size from &lt;1 mm to several millimetres in diameter, often accompanied by hairline cracks and sometimes broken (burst) in the centre</p>	<p>Thermal stress in surface layer, such as a sulphate crust on limestone            In sandstones, more likely to reflect a concentration of salts rather than even distribution of salts (as in contour scaling)            Crystallisation of salts behind a water repellent coating or paint layer (usually forms small blisters but can sometimes result in larger areas of detachment)</p>

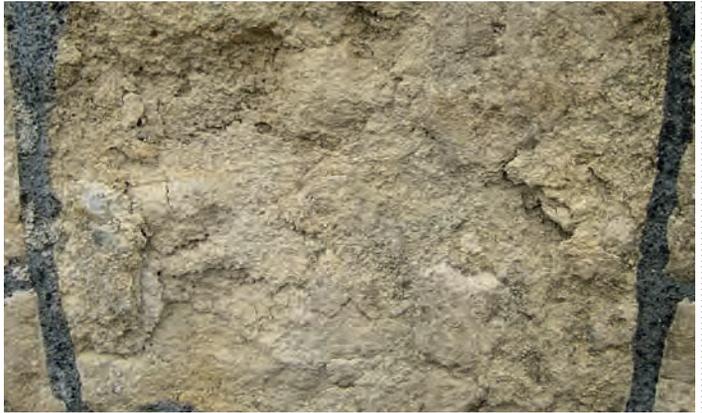
<p><b>Crumbling and flaking</b>            Breakdown of stone into friable small fragments or slivers</p>	<p>Expansion of clay in argillaceous sandstones and limestones            Dissolution of binder in calcareous and argillaceous sandstones            Salt crystallisation in surface pores of stone</p>

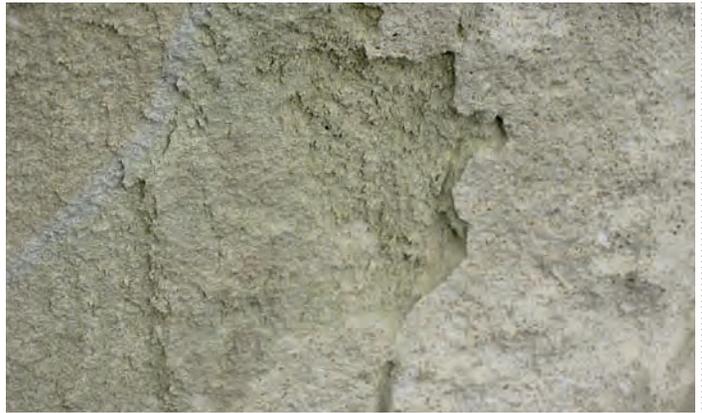
<p><b>Granular disintegration</b></p> <ul style="list-style-type: none"> <li>• Powdering (fine grained stone)</li> <li>• Sanding (sandstone and granite)</li> <li>• Sugaring (marble)</li> </ul> <p>Breakdown of stone into individual grains of stone or minute fragments, forming a friable surface</p>	<p>Dissolution of binder in calcareous and argillaceous sandstones            Salt crystallisation in surface pores of limestones and sandstones            Breakdown of kaolinite in some granites            Dissolution of calcite along grain boundaries due to action of acidic rain on marble</p>

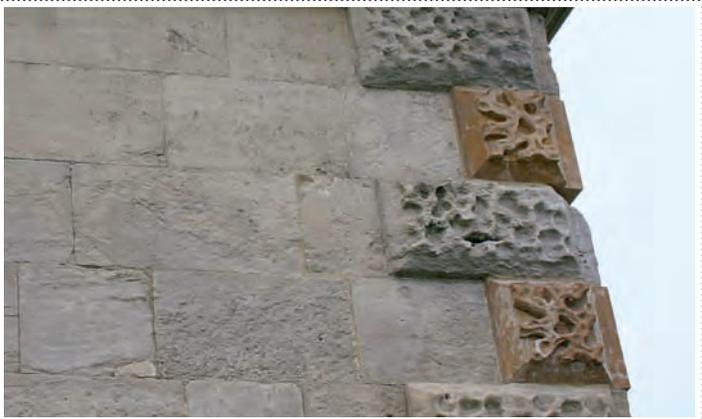
<p><b>Discolouration: orange/brown</b></p> <p>General deepening of the colour of stone over time</p>	<p>Weathering and oxidation of iron minerals in the stone</p>

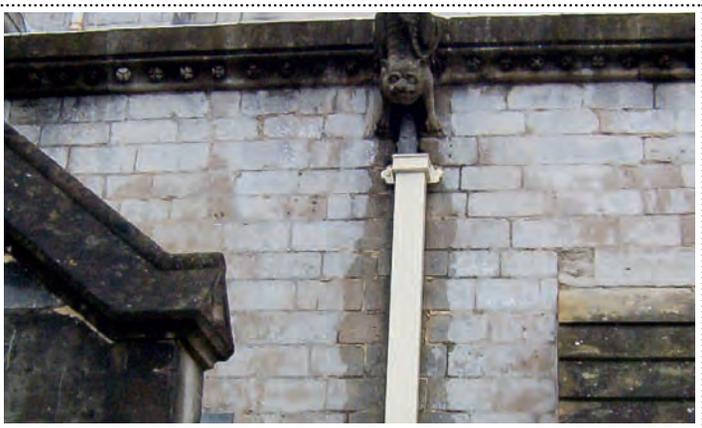
<p><b>Discolouration: moist area</b></p> <p>Wetting and darkening of the stone surface in discrete areas</p>	<p>Dampness concentrated in a particular area, emanating from sources such as groundwater, leaking rainwater goods, seepage of rainwater via core voids or blocked drains</p>

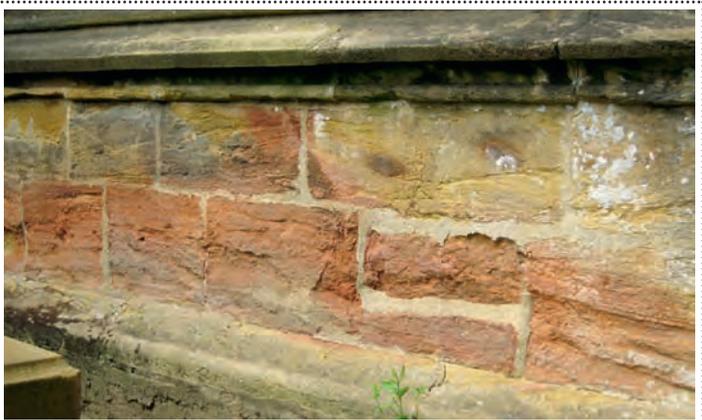
<p><b>Discolouration: reddening</b></p> <p>Reddening of block of stone</p> <p>May affect isolated blocks of stone, or all the blocks in an area</p>	<p>Oxidation of iron minerals to ferric oxide caused by exposure to fire.</p> <p>Discolouration of isolated blocks suggests re-use of stone from an earlier structure. Discolouration of an area of blocks indicates alteration <i>in situ</i></p>

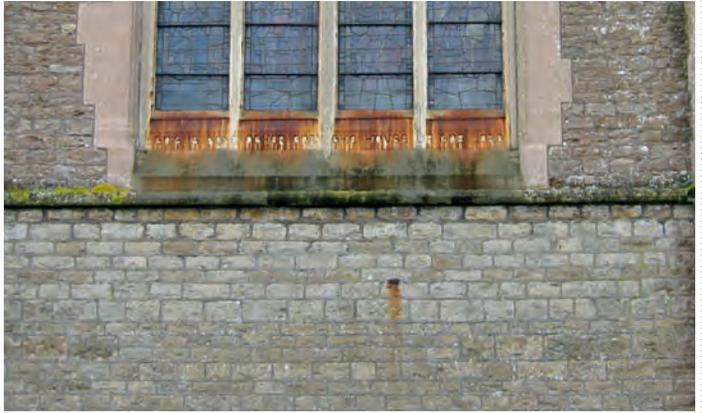
<p><b>Staining: orange/brown</b></p> <p>Streaks or patches of orange/brown discolouration, usually close to a joint or adjacent to an iron component such as window frame or railings</p>	<p>Iron oxide from rusting of iron fixings</p>

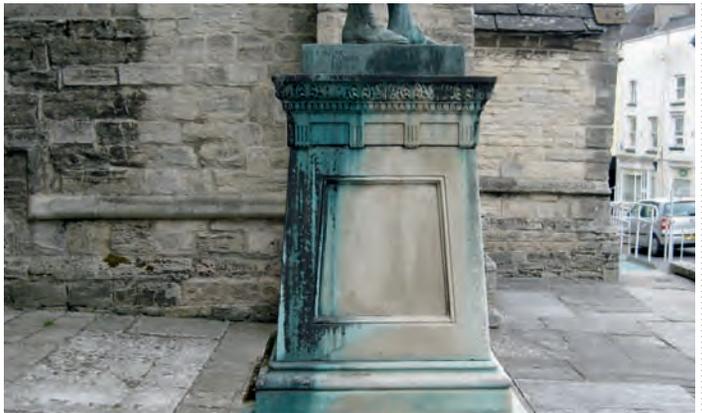
<p><b>Staining: blue/green</b></p> <p>Blue/green streaks, often immediately below copper, bronze or brass elements</p>	<p>Run-off (usually copper carbonate or copper sulphate) from corroding copper, bronze or brass elements</p>

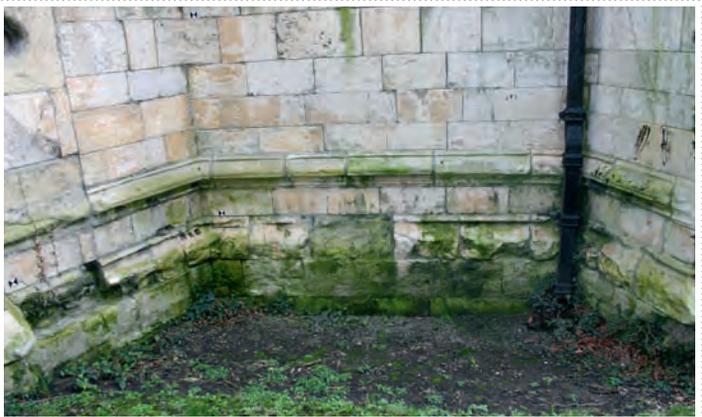
<p><b>Staining: bright to very dark green</b></p> <p>Areas of green staining, varying from bright green to very dark green (almost black)</p>	<p>Algal growth usually indicative of high levels of dampness, nutrients or both. Usually associated with rising damp or with concentration of run-off caused, for example, by defective rainwater goods or poor detailing of masonry. May also indicate run-off from accumulations of bird guano</p>

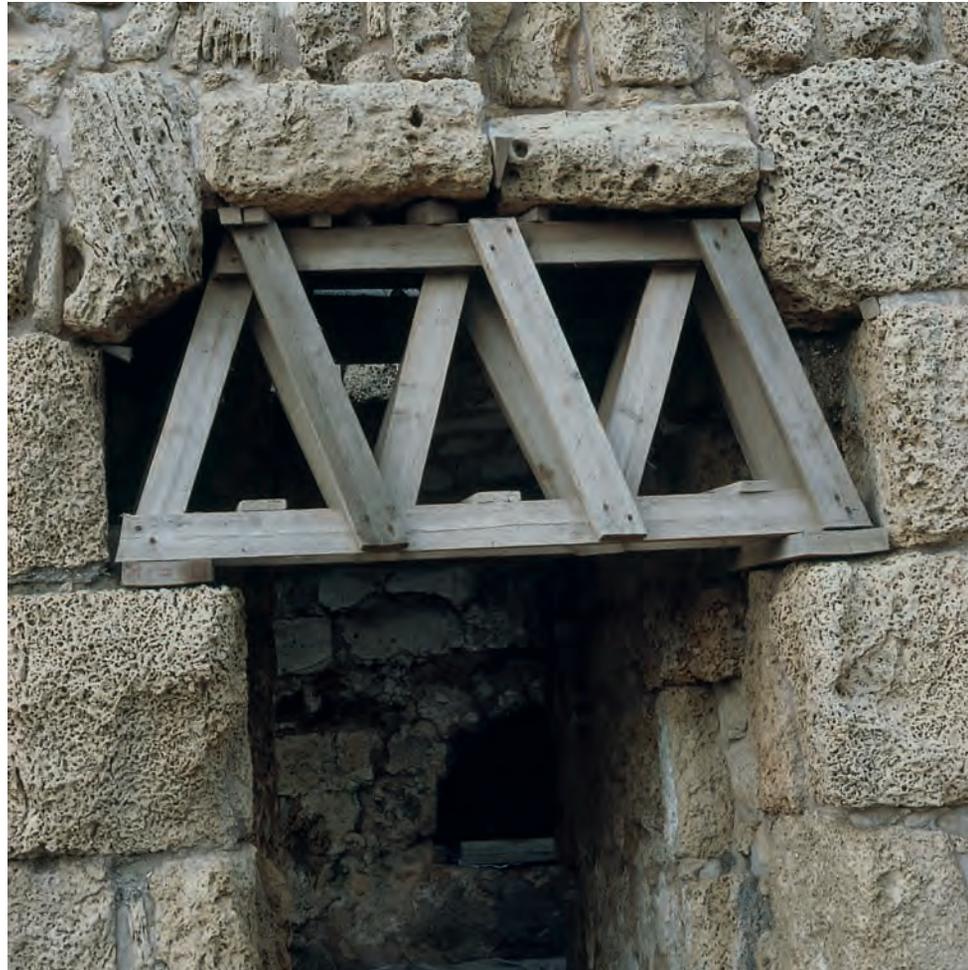
Decayed or missing jambs, lintels or mullions may require temporary support, either to allow further investigation or as part of the repair process. This is best done with timber struts or pins supported on either side of the opening.

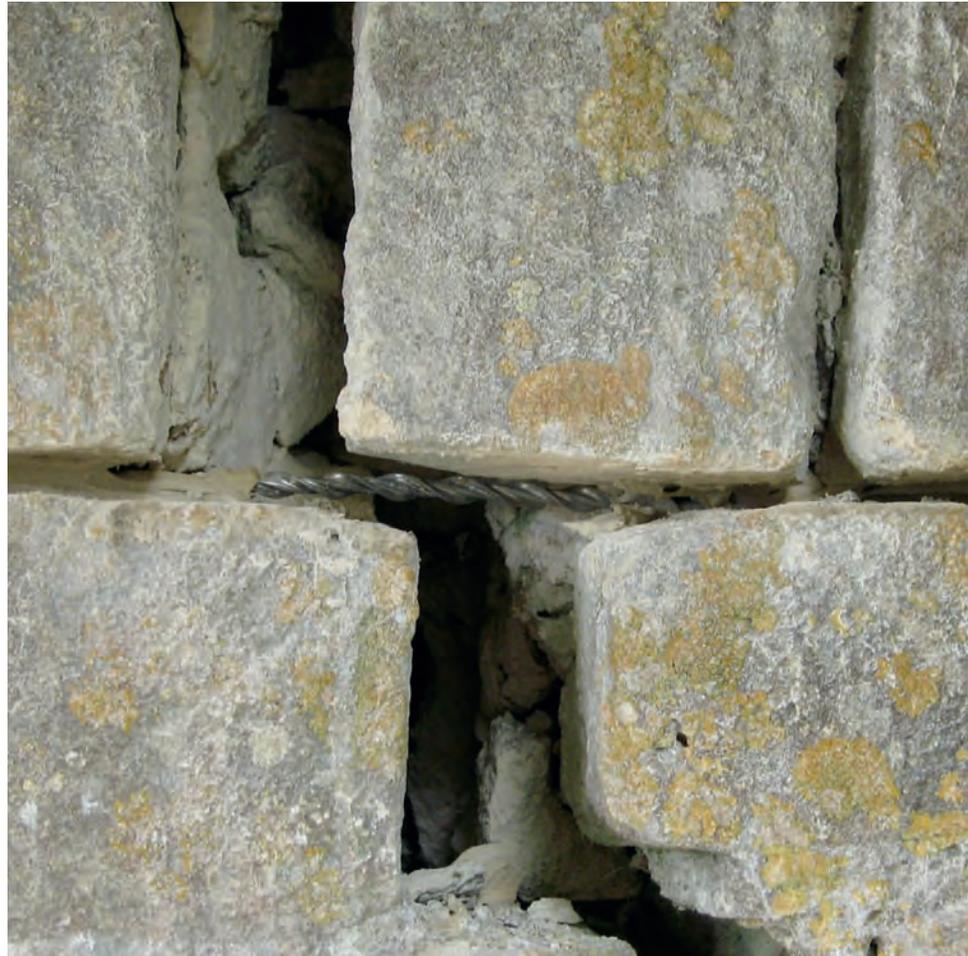
Helical ties or twisted wires can be inserted into a horizontal joint to tie across vertical cracks and act as a restraint for further movement.

The diameter of the dowels will depend on the particular application, but can often be minimised by careful choice of location and direction. Helical ties, as their name suggests, are engineered uniform spiral dowels (usually galvanised steel or stainless steel) that, when fixed with grout or resin into a pre-drilled aperture, provide a strong, even anchorage into the masonry. They are available in various lengths and diameters.

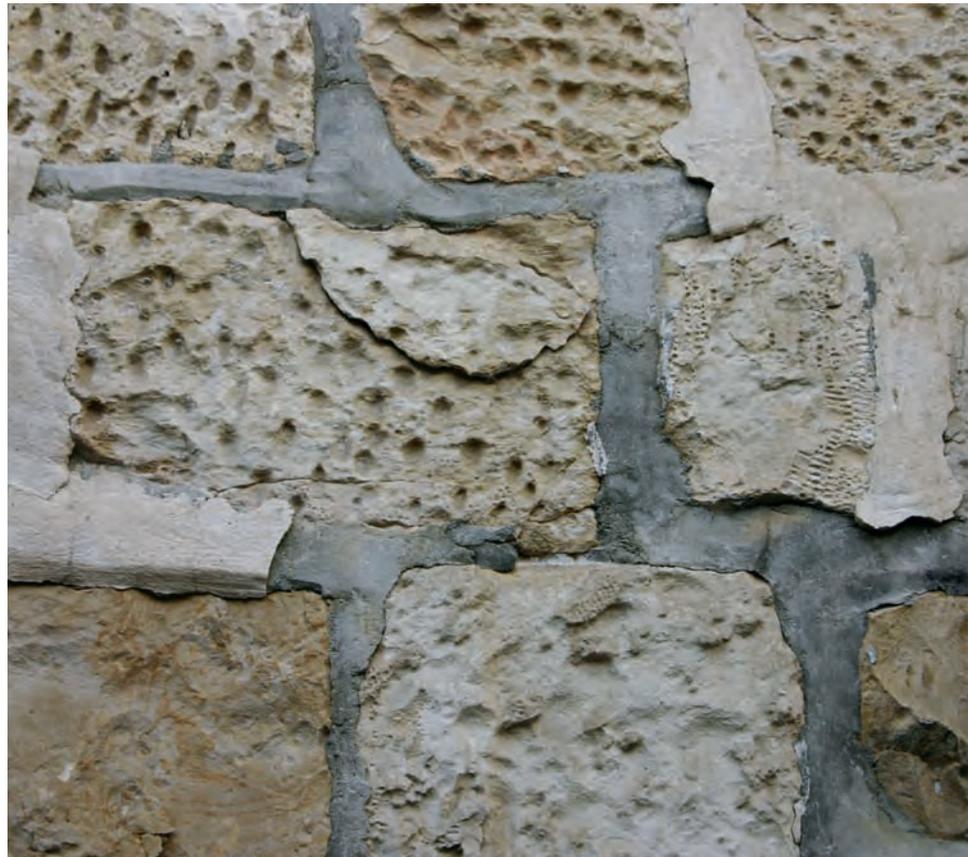
Pointing is often replaced unnecessarily when the original mortar is still sound

Here the thin joint between the stones visible in the centre of the picture appears sound, but it has been repointed in a cement mortar that has itself been overlaid with a paler mortar. The result is that the pointing no longer acts as a path for water evaporation. The appearance of the wall is now dominated by pointing, rather than by the close-fitting stone blocks.

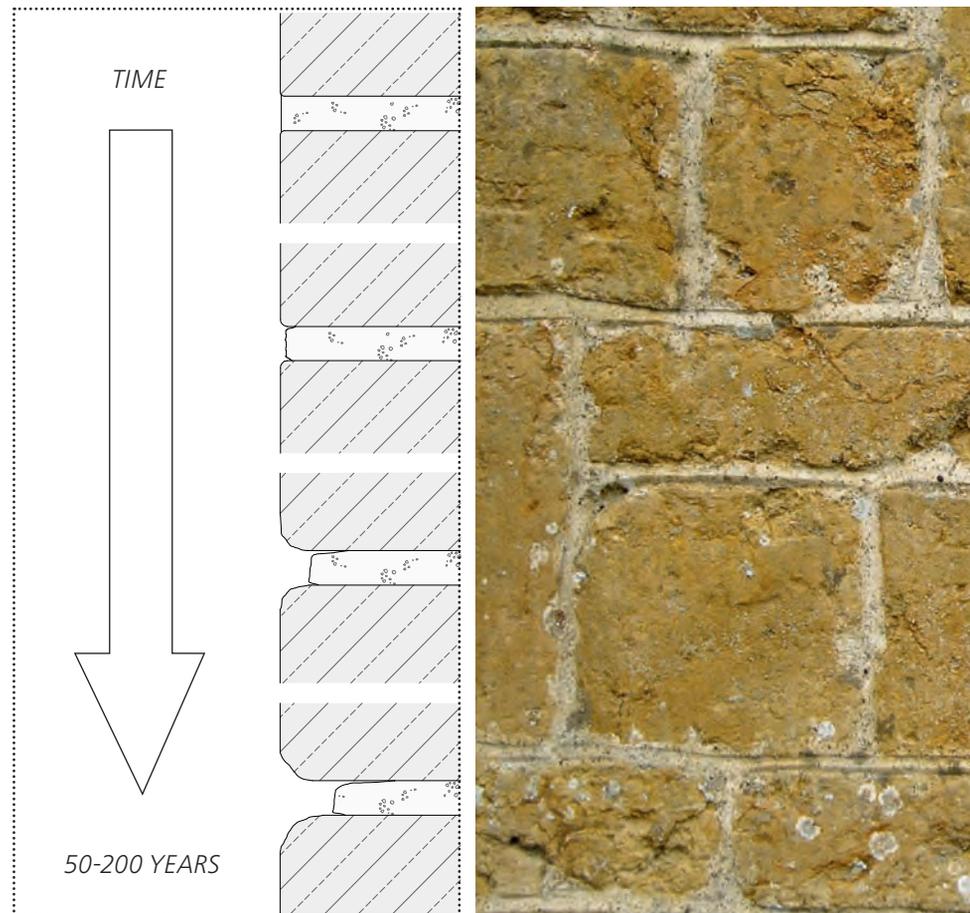
### Typical weathering of a lime- mortar joint

*Left:* Most joints in squared rubble or ashlar were finished flush with the face of the stone. Over time, frost action and cycles of wetting and drying will have caused the mortar and surfaces of stonework to decay. The exposed arrises are particularly vulnerable, and will have tended to become rounded.

*Right:* Historic 'bird's beak' pointing on 17th century stonework: this has a distinctive projecting V-shaped profile.

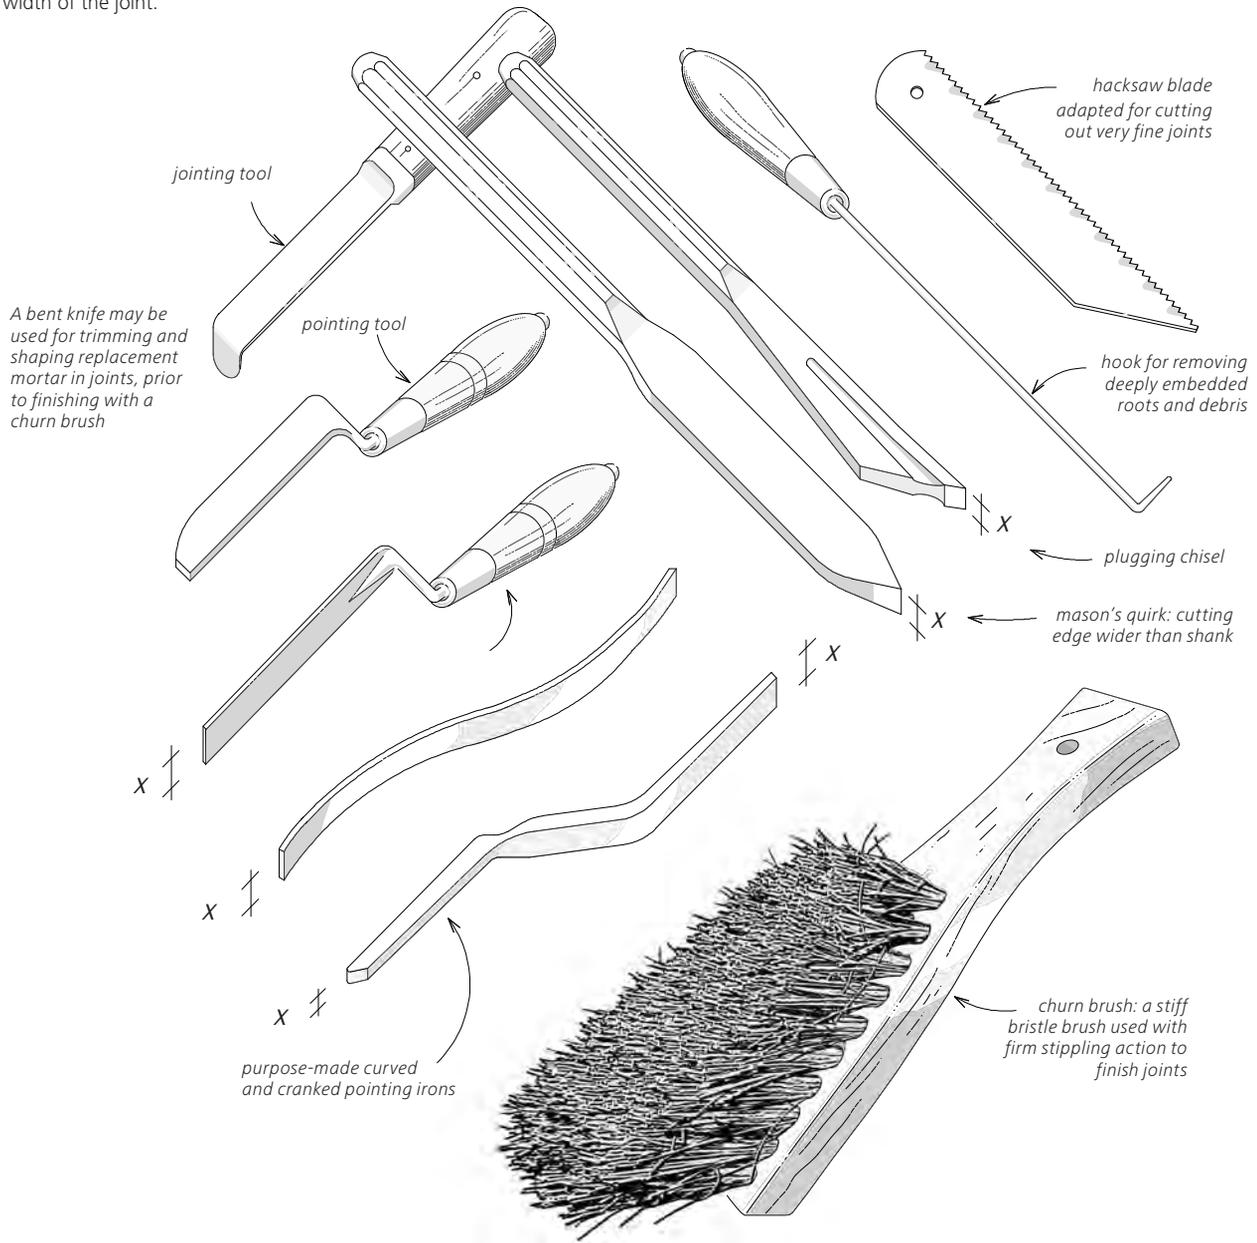
## POINTING TOOLS

The correct tools are essential for good pointing. This diagram shows a range that would be suitable for most situations; the 'X' dimensions need to be just less than the width of the joint.

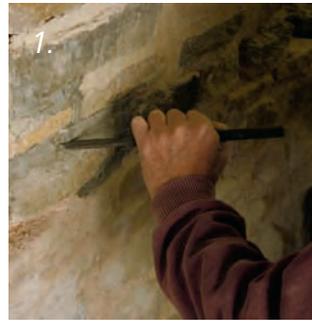
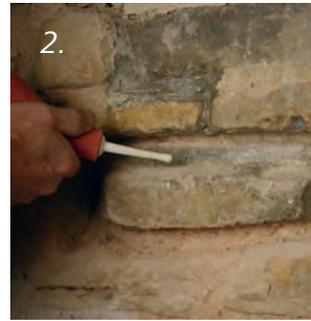
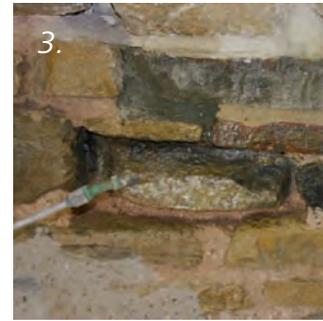
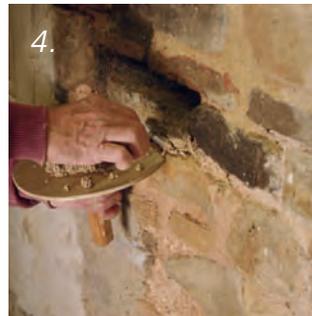
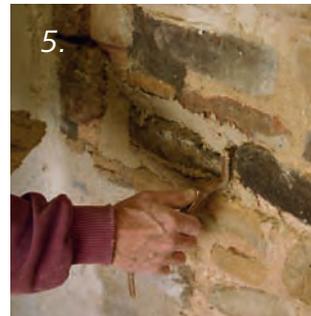
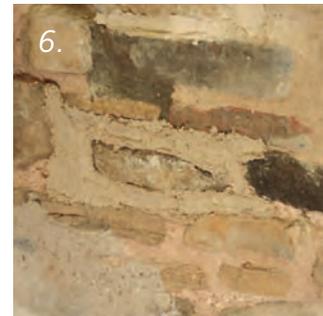
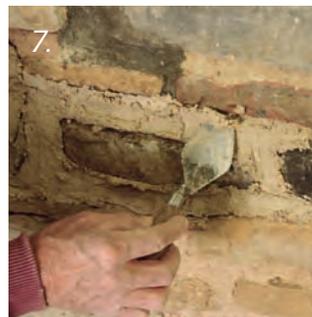
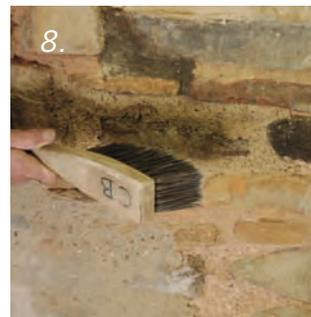
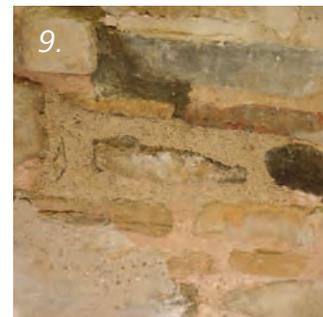
The main stages in successful repointing

1. Removal of old pointing using a quirk.
2. Cleaning out the joint using a hand-held blower (this helps prevent debris being washed down the wall).
3. Thorough wetting of the joint.
4. Applying the pointing.
5. Compressing the pointing with a pointing key of suitable width.
6. Allowing the mortar to take an additional set.
7. Cutting back mortar to slight recess.
8. Stippling the surface with a churn brush.
9. The finished joint.

The joint must be kept damp both during the process, and for some time afterwards.
