RESEARCH INTO THE THERMAL PERFORMANCE OF TRADITIONAL BRICK WALLS

ENGLISH HERITAGE
RESEARCH REPORT

Soki Rhee-Duverne and Paul Baker

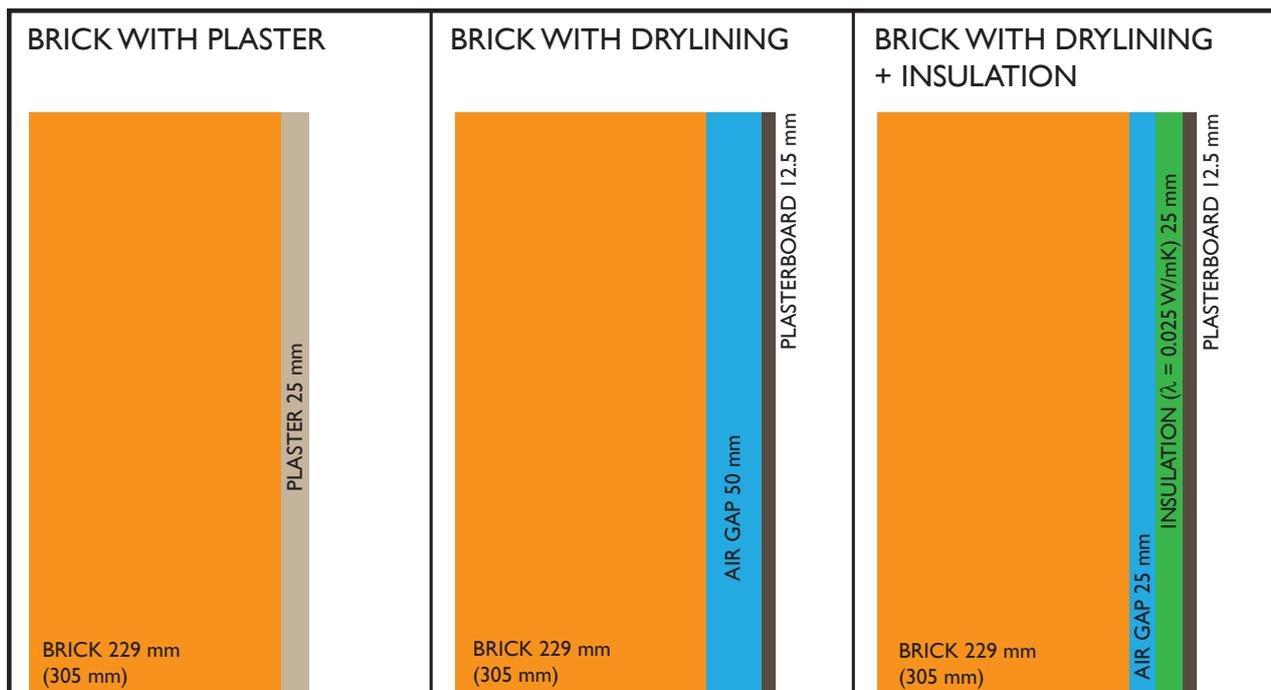
Figure 3: The three basic configurations used for modelling the walls using BuildDesk.

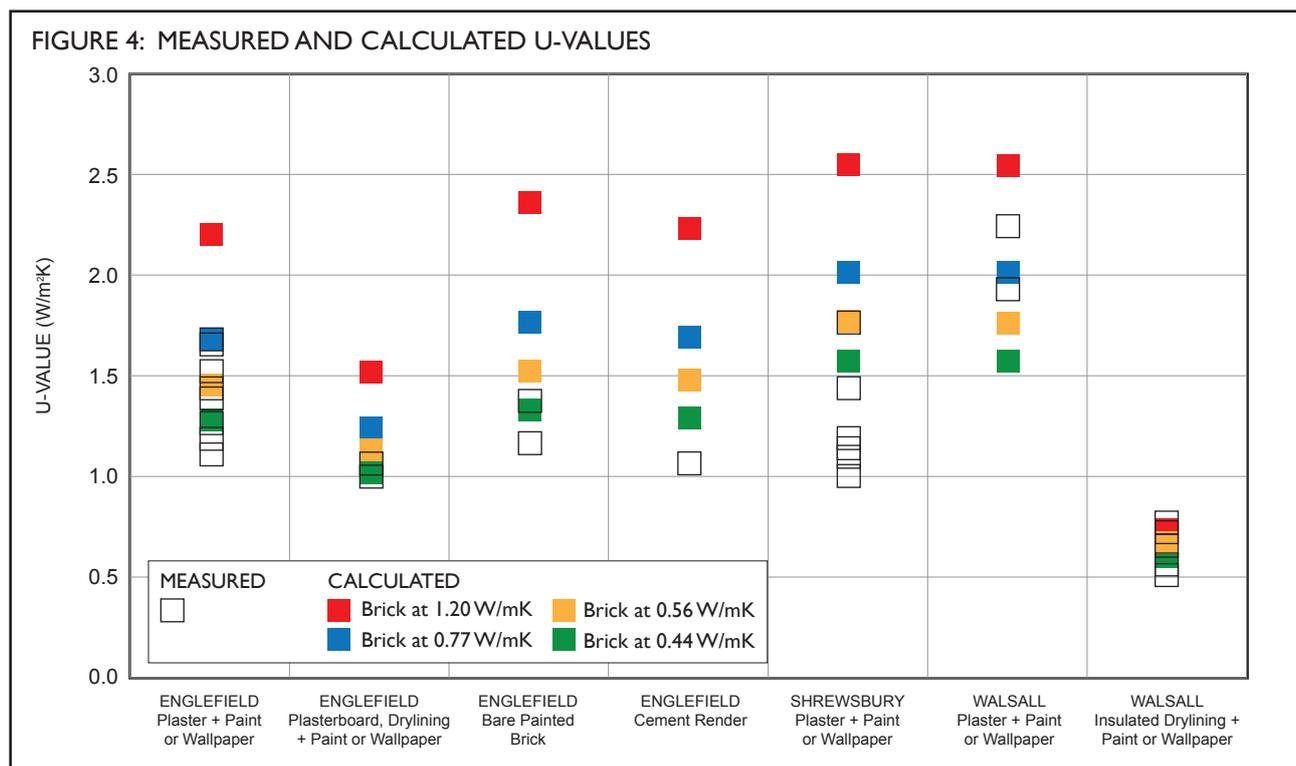
The calculated values are also compared with the measured results in *Figure 4*. The calculated values assume that the plastered walls use lime, and the insulation in the Walsall drylined walls is phenolic insulation.

Most of the measured values for the Englefield houses are in reasonable agreement with the low to mid-range calculated values.

The measured values for the Shrewsbury walls are generally lower than the lowest calculated result assuming a brick thermal conductivity of 0.44 W/mK.

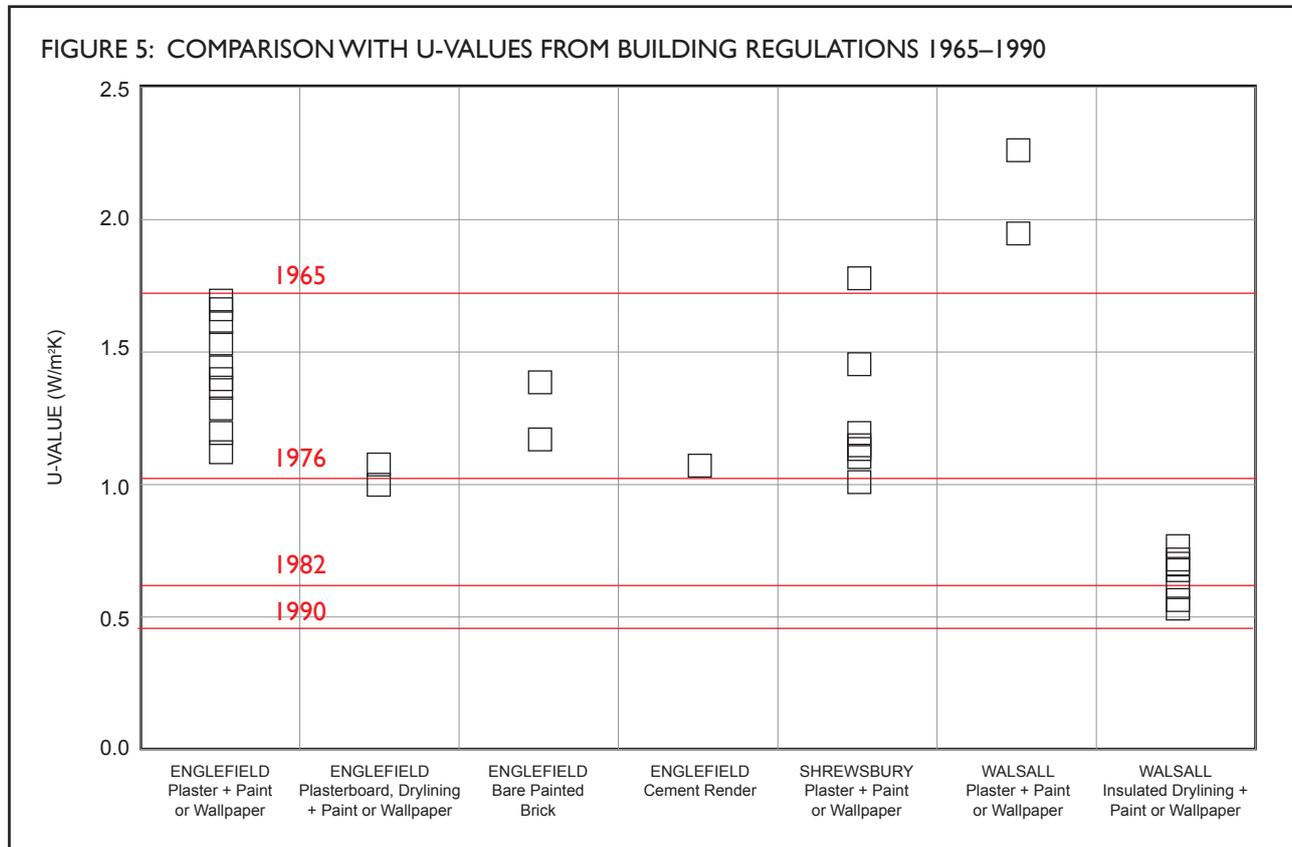
Table 4 gives the maximum U-values for walls for the English and Welsh Building Regulations from 1965 to 1990. The measured results are compared with these values in Figure 5.

Of the total of 35 *in-situ* results, 22 of the measurements fit in the U-value range 1.0–1.7 W/m²K: i.e. better than the 1965 value, but not meeting the standard introduced in 1976. Only three measurements are worse than the 1965 value. Two of these results (W2) were made on a wall constructed from hard, dense brick which is likely to have a high thermal conductivity. The third (S2/HF2) is the highest result for the Shrewsbury sample. All walls with insulated drylining in the Walsall sample of houses exceed the requirements of the 1976 Regulations, and three meet the requirements of the 1982 regulations.

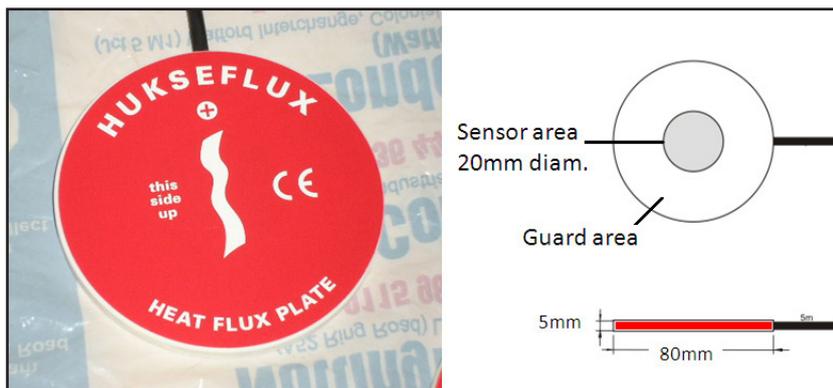
Figure A1: Heat flux sensor

This arrangement was generally satisfactory for two or more weeks monitoring on painted surfaces only. Wallpapered surfaces were not generally used in case of damage. Sensor locations were chosen to avoid probable thermal bridge locations near to windows and corners, with the

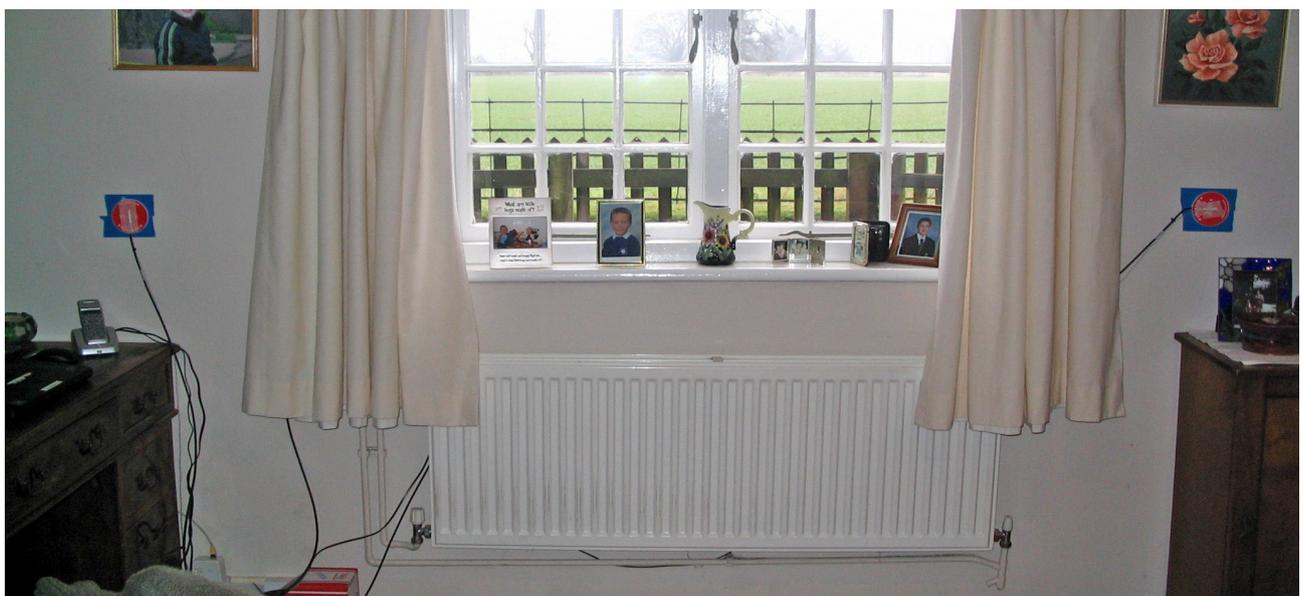
Figure A2: Typical heat flux sensor and room temperature measurement locations.

sensor ideally located about half-way between window and corner, and floor and ceiling (*Figure A2*). Where possible a north-facing or sheltered elevation was selected to reduce the influence of solar radiation on the wall.

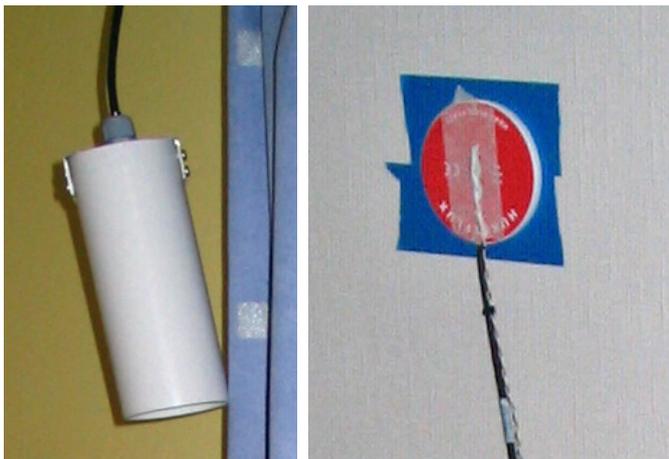
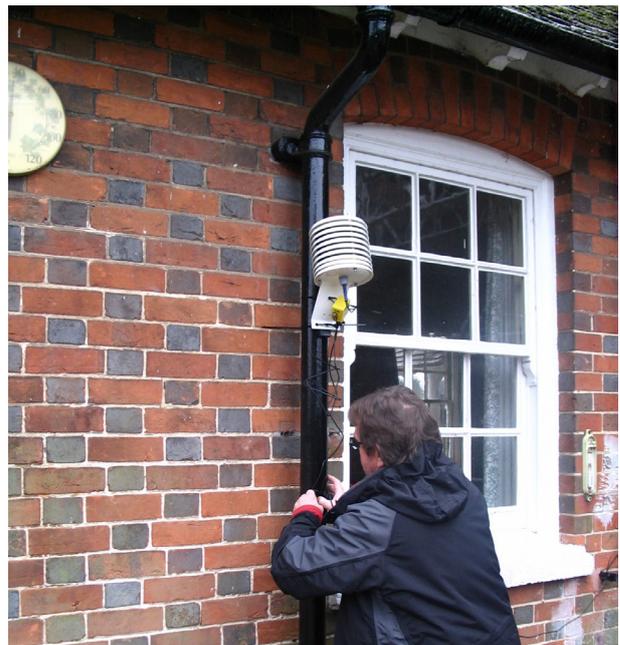
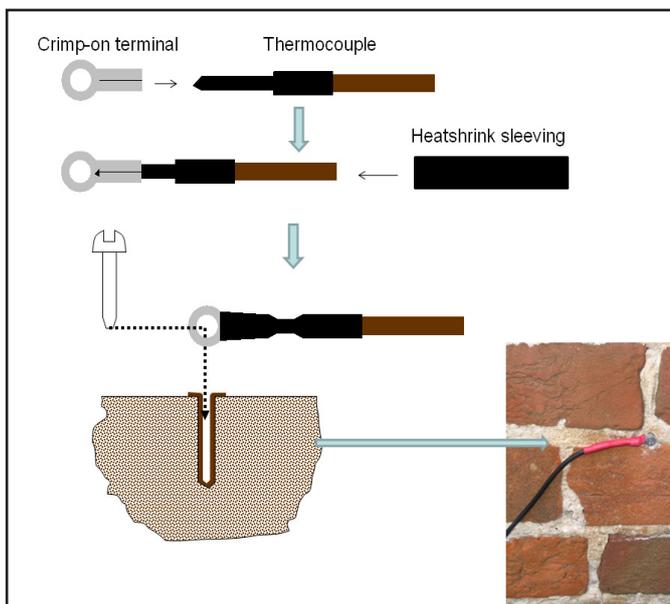
Figure A3: Room air temperature shield

Stainless steel-sheathed thermistors, Campbell Scientific type 107, were used internally to measure room air temperature, mounted within a simple radiation shield in order to minimise the influence of solar radiation and other heat sources (*Figure A3*). The surface temperature of the face of each heat flux sensor was measured using type-T thermocouples taped onto the surface of the heat flux sensor (*Figure A4*).

Dual channel Gemini TinyTag Plus 2 TGP-4520 loggers were used with thermistor probes to measure external air temperature and, generally, external wall surface temperature. Each external temperature sensor was placed in a radiation shield which was generally tied, for example, onto a drainpipe (*Figure A5*). Crimp-on terminals were used to secure surface temperature sensors to mortar joints, by drilling and plugging joints (*Figure A6*).

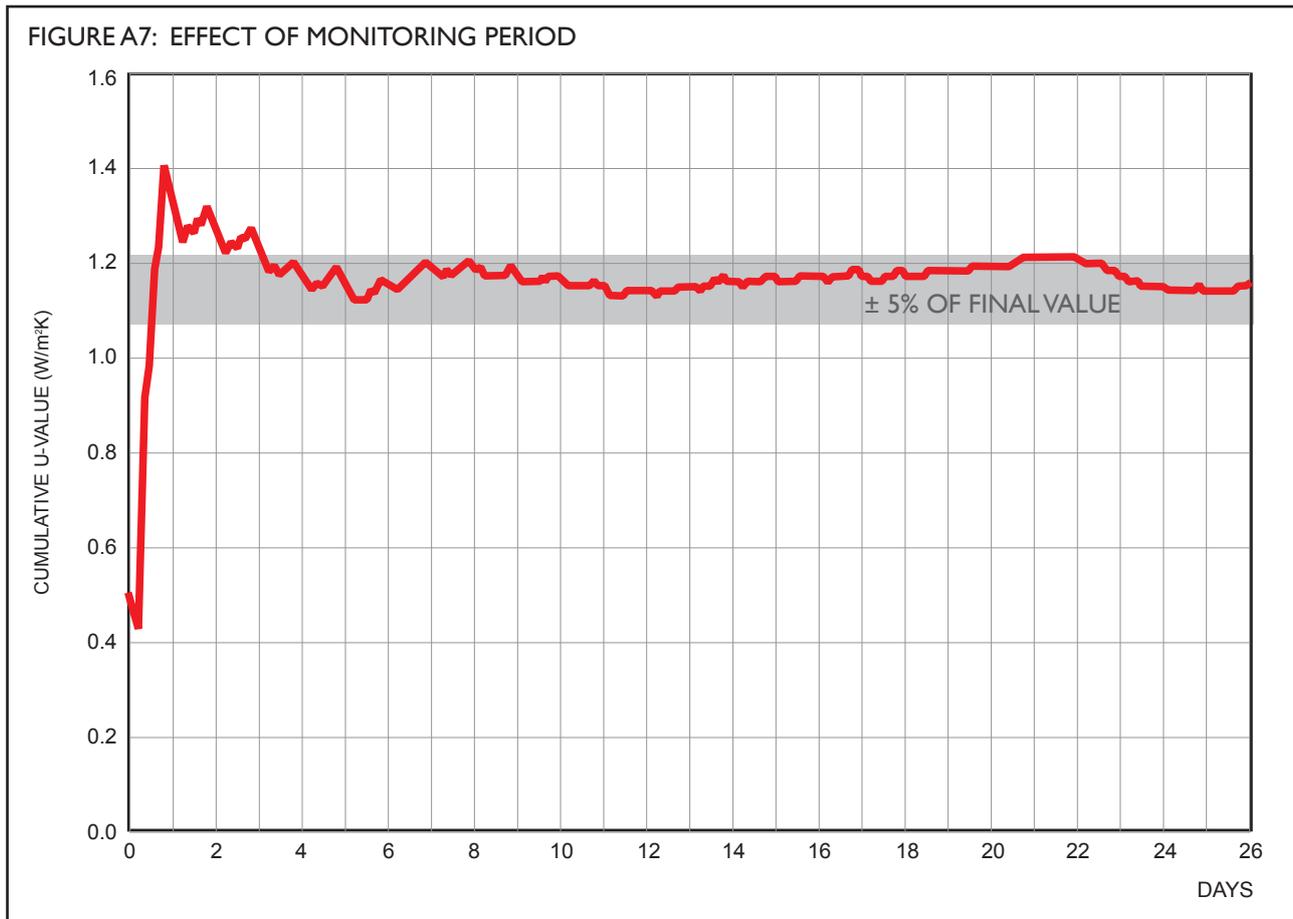
Figure A7: The effect of increasing the monitoring period.

Given that the monitoring conditions are non-steady state, it is considered necessary to monitor for about two weeks, or preferably longer, in order to collect sufficient data to estimate *in-situ* U-values. The period should be sufficient to take into account the thermal capacity/inertia of the wall. *Figure A7* shows the effect of increasing the length of the monitoring period on the estimate of the U-value using a simple averaging procedure as described below. A period of at least a week is required before the U-value estimate stabilises to within $\pm 5\%$ of the final value determined from about 27 days data.

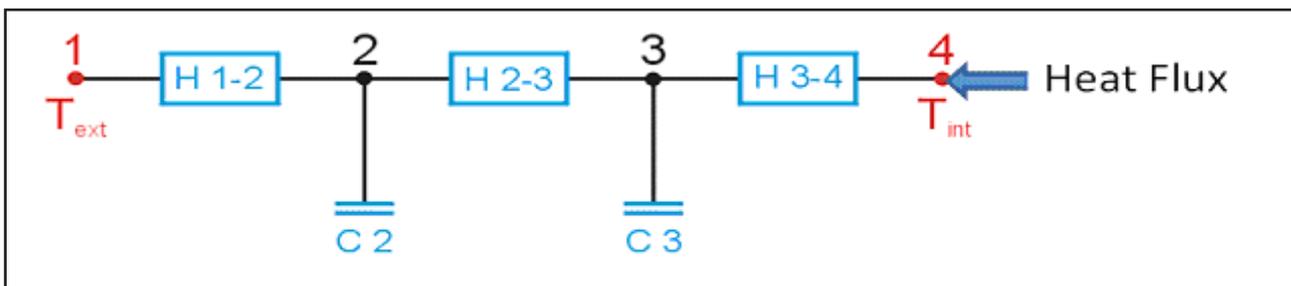
The wall is modelled with four nodes: the boundary conditions of the network at Node 1 and Node 4 are the measured temperatures (at Node 1 the outside temperature T_{ext} , and at Node 4 the inside temperature T_{int}). The measured heat flux is applied at the interior node 4. The nodes are connected by thermal conductances (H 1-2, etc.). Each node has a certain thermal capacity (C2, etc.). Storage of heat is only possible at the nodes.

Figure A8: Example of a wall modelled as a network of conductances and capacitances

An alternative to the averaging method is to use a dynamic analysis method which explicitly takes into account the thermal capacity of the wall. Such a method may be more appropriate if for example there are large diurnal swings in external conditions as may be experienced during spring, or changes in the weather pattern during the test period. An example of such software is the LORD program (2004) which models the wall as a network of conductances and capacitances, analogous to an electrical circuit. *Figure A8* shows an example of this for a simple wall.

The program calculates the best fit values for the conductances and thermal capacitances. The number of nodes used to model the wall depends on its thermal mass; however the selection of the optimum number of nodes may require a process of trial and error, and can be somewhat dependent on the user's experience of interpreting the output of the program.

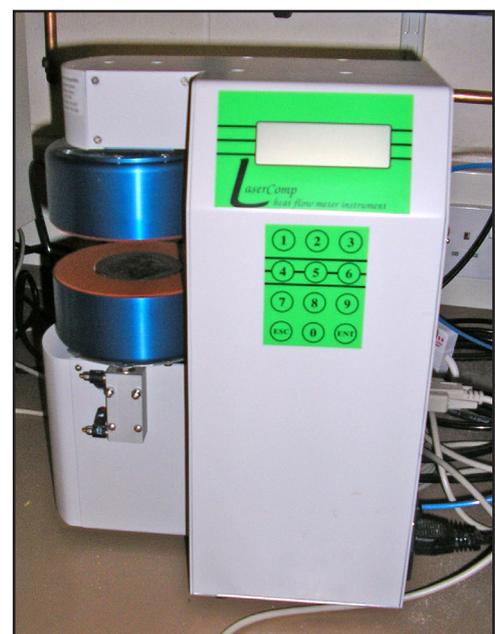
Figure 1: Lasercomp Fox 50 thermal conductivity apparatus

The measurements were carried out in a Lasercomp Fox 50 apparatus (Figure 1). The principle of operation of the apparatus is to apply a temperature gradient across a sample and measure the heat flow through the sample using heat flux transducers.

Tests were carried according to BS EN 12667:2001 (BSI, 2001) for a mean temperature of 10°C, with a temperature of 20°C on the warm face and 0°C on the cold face of the sample.

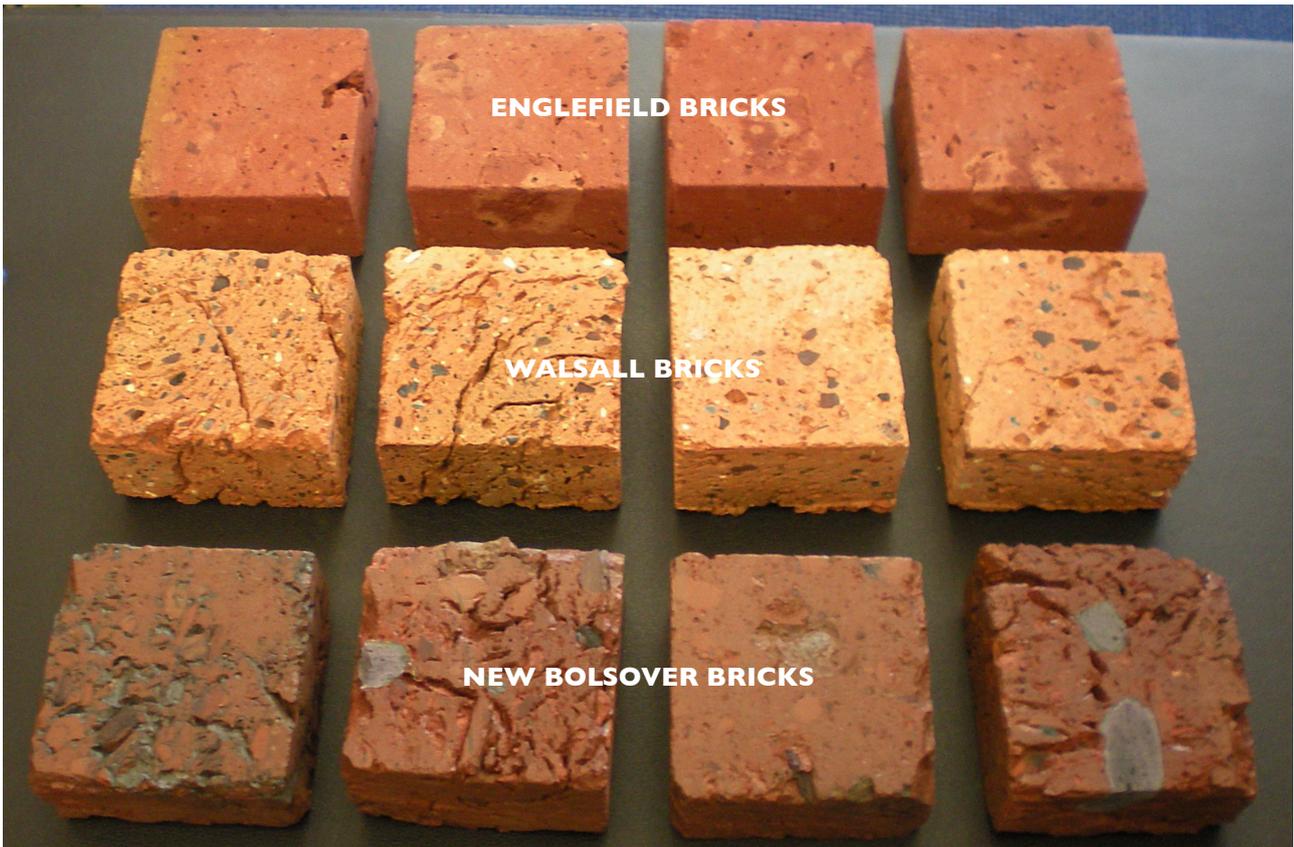
Figure 2: Thermal conductivity samples.

Each set of brick sample shows a spread of values of, which may be due to the variation in texture, porosity and composition of each brick type (*Figure 2*). The Englefield brick has a fine, homogeneous structure and shows the lowest variation in thermal conductivity. It has the lowest density and average thermal conductivity of the three bricks. The Walsall brick samples have a number of striated cracks/voids, which may correspond to folding of the unfired material during processing. The Walsall brick has the highest average thermal conductivity. The New Bolsover samples show the largest variation; they have a coarse grainy structure with some voids. The New Bolsover brick has the highest density of the three bricks.

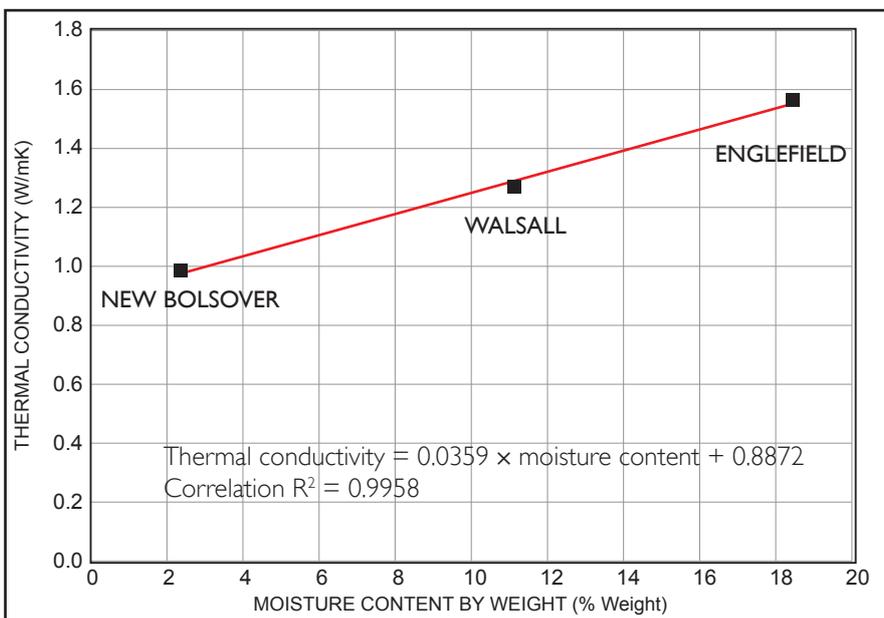
Although the graph in Figure 3 suggests that there is a linear relationship between the capillary-saturation moisture content by weight and the thermal conductivity, this may be fortuitous: it may not be the case that all bricks fit this relationship.

Figure 3: Thermal conductivities of bricks at capillary saturation.

Wetting to achieve capillary saturation produces a significant increase in the thermal conductivity of all the bricks, and there is a clear relationship between the moisture content by weight and thermal conductivity if all three types are considered (Figure 3). The Englefield brick has the highest capillary moisture content and wet thermal conductivity, almost three times greater than its dry thermal conductivity. In comparison the New Bolsover brick has a low capillary moisture content and a wet thermal conductivity about 1.5 times its dry value.

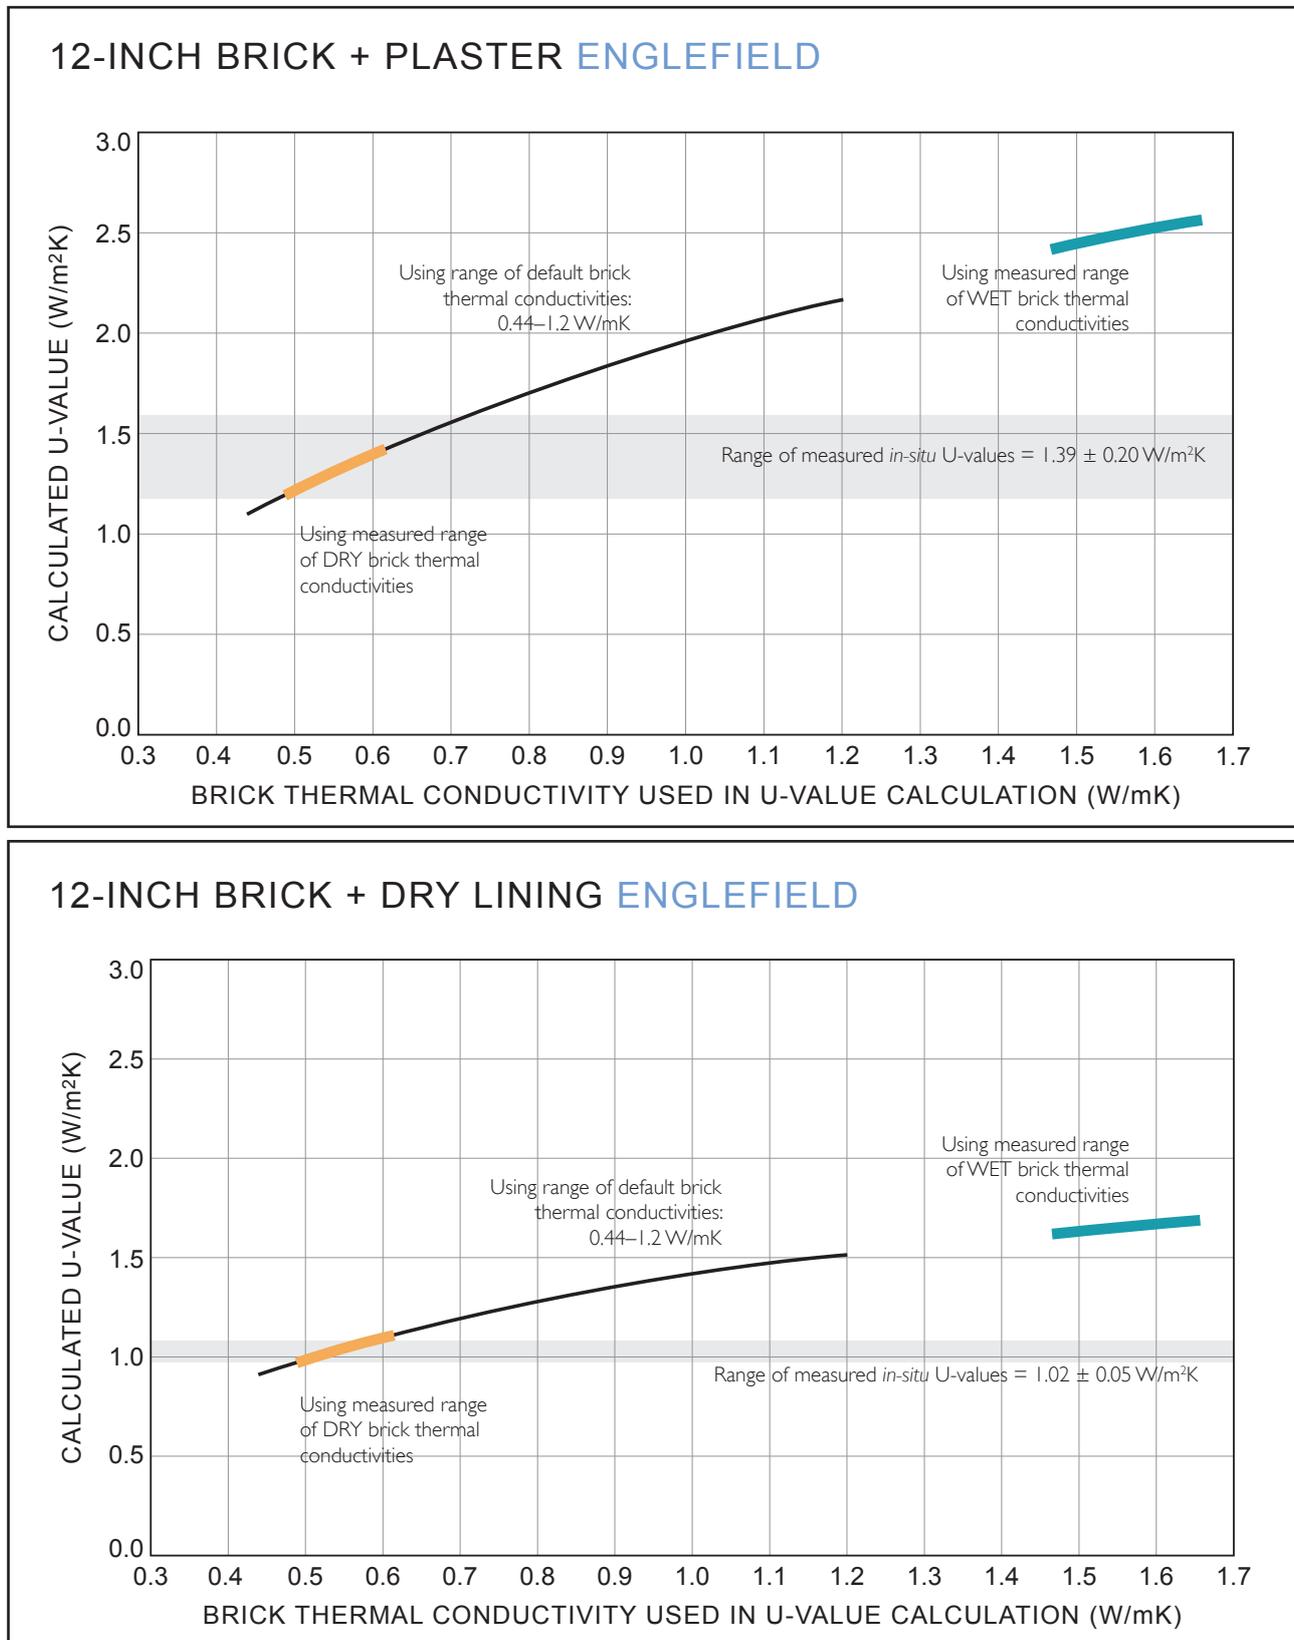
Figure 4a: Comparison of measured U-values with calculated values using the BuildDesk software with measured dry and wet brick thermal conductivities of the Englefield brick sample.

The four graphs in *Figure 4a* and *Figure 4b* compare measured U-values to U-values calculated with the BuildDesk software using the measured dry and wet brick thermal conductivities of the Englefield sample.

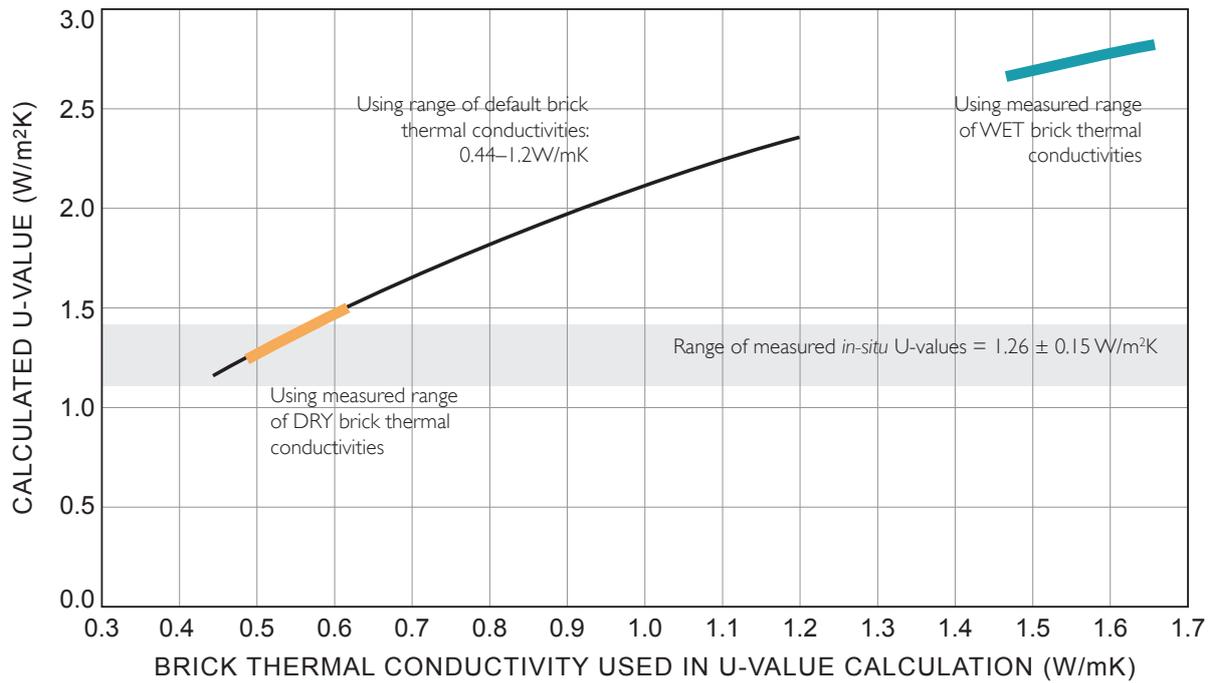
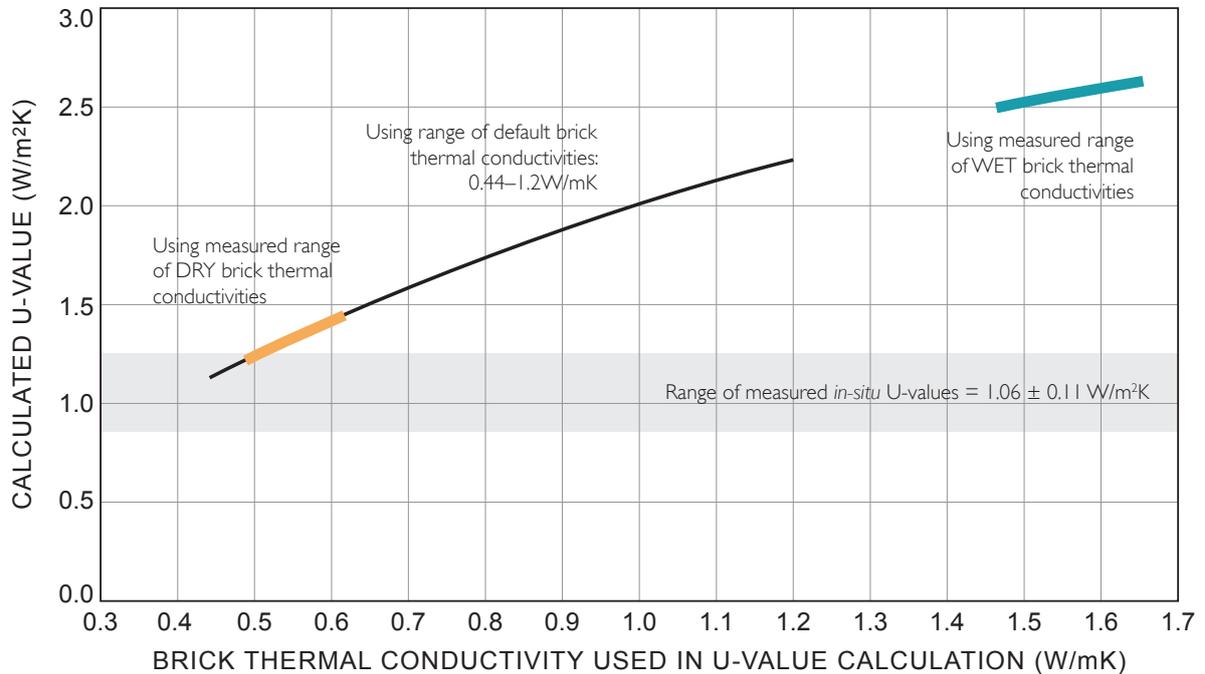
12-INCH BRICK + PAINT ENGLEFIELD

12-INCH BRICK + CEMENT ENGLEFIELD

Figure 4b: Comparison of measured U-values with calculated values using the BuildDesk software with measured dry and wet brick thermal conductivities of the Englefield brick sample.

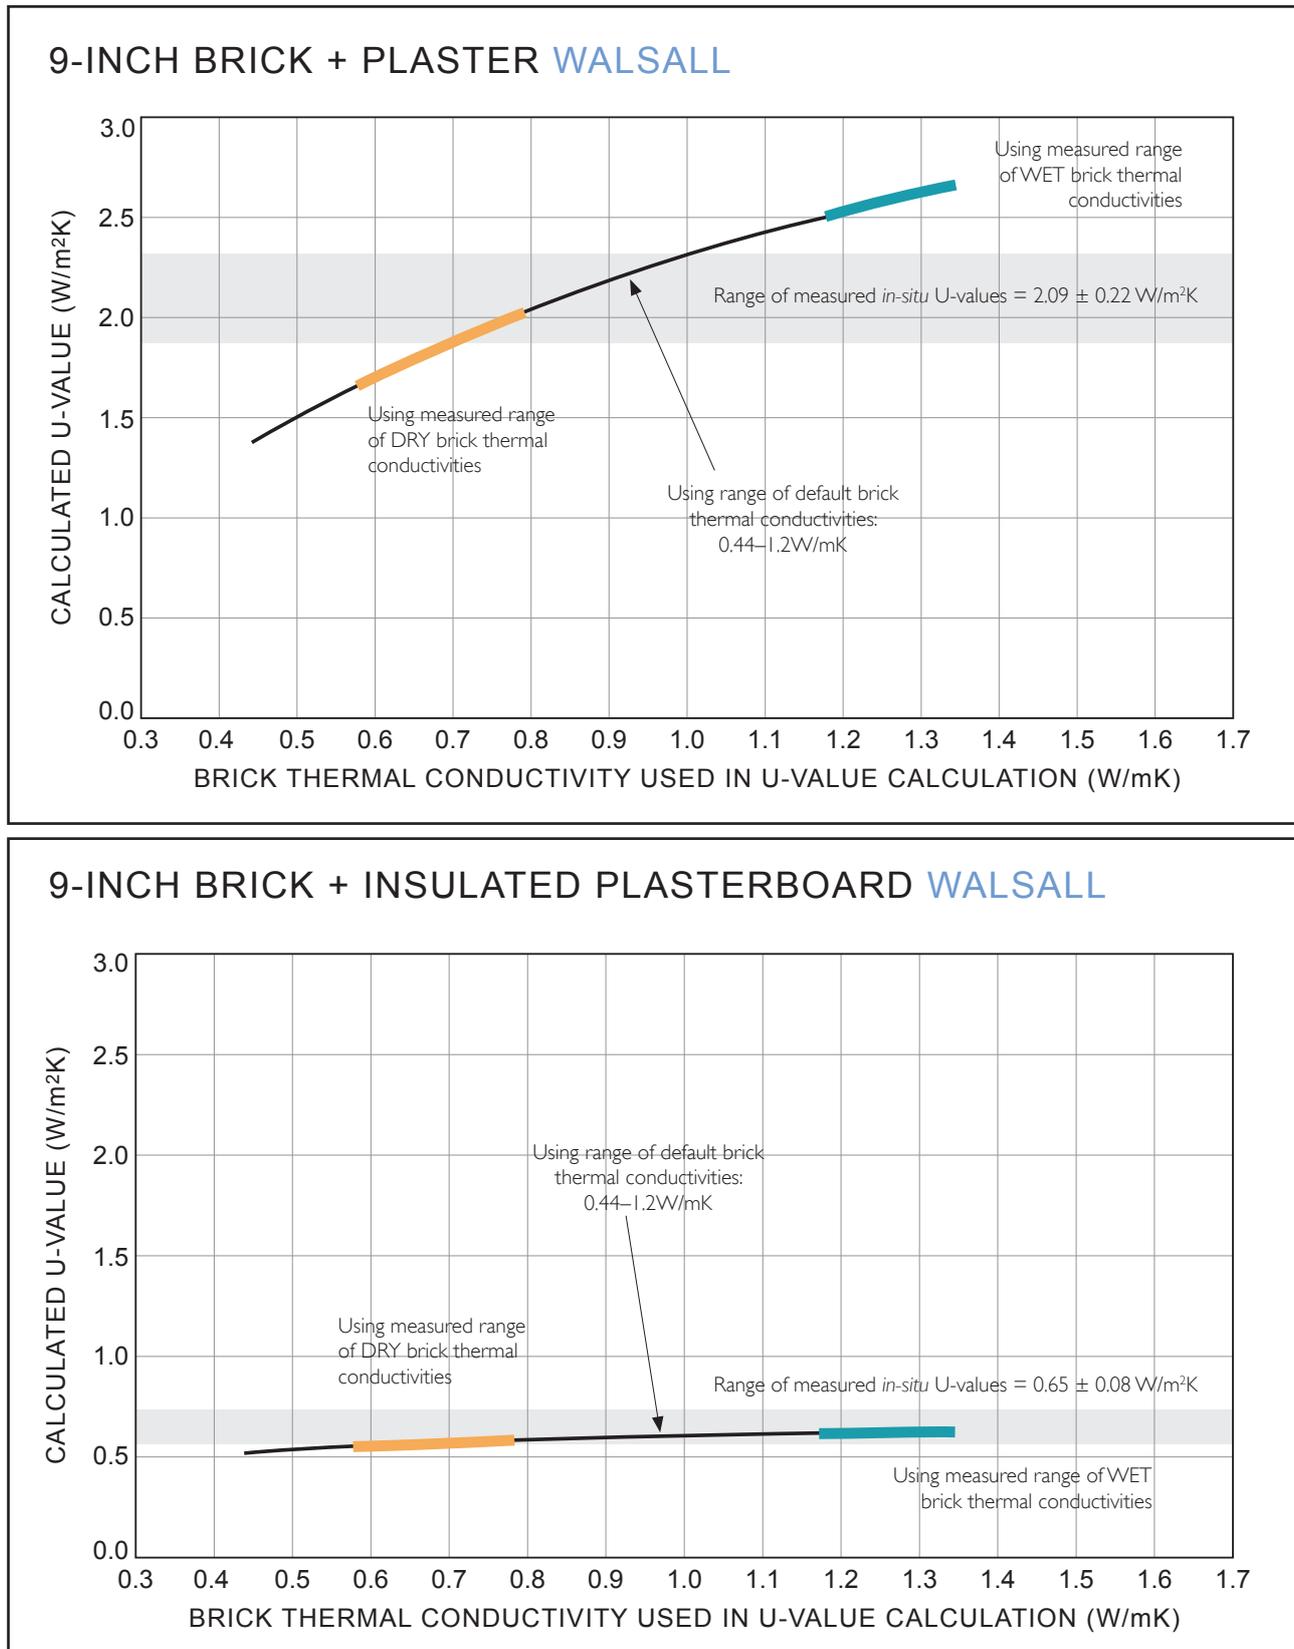
Figure 5: Comparison of measured U-values with calculated values using the BuildDesk software with measured dry and wet brick thermal conductivities of the Walsall brick sample.

The two graphs in *Figure 5* compare measured U-values to U-values calculated with BuildDesk using the measured dry and wet brick thermal conductivities of the Walsall sample.

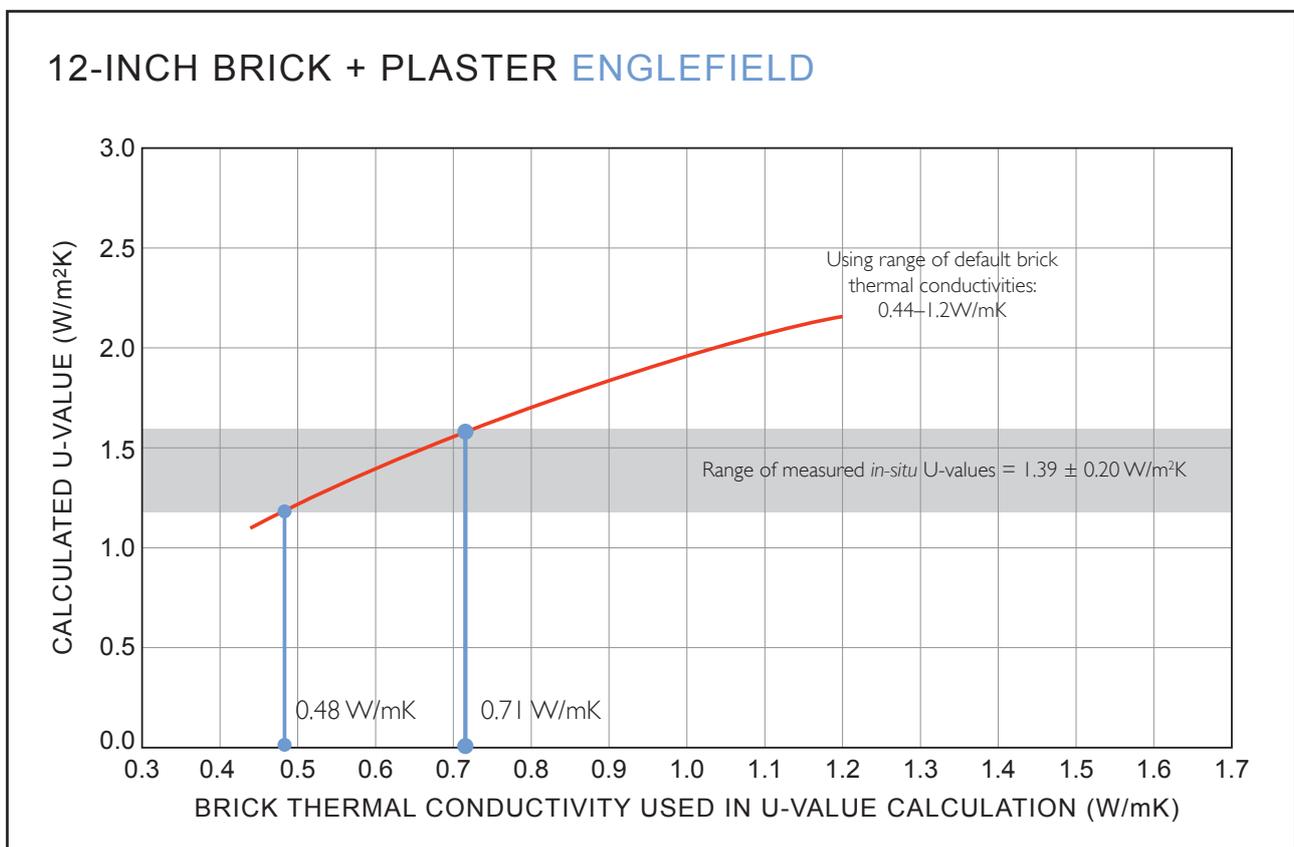
An estimate of the brick thermal conductivity range that would produce the range of measured *in-situ* U-values, if used in the calculation procedure, can be obtained from the U-values derived from the default range of brick thermal conductivities for each build-up. An example is shown in Figure 6: the range of possible brick thermal conductivities can be read off the x-axis of the graph from the intersection of the blue line drawn through the default U-values calculated using the default brick thermal conductivities (0.44-1.2W/mK) with the upper and lower limits of the *in-situ* values (grey band). For the Englefield brick with plaster this range is 0.49-0.71 W/mK: the measured dry conductivities (0.49-0.61 W/mK) are at the lower end of this range.

Following the above example, the range has been estimated for each of the Englefield and Walsall build-ups and compared with the range of measured dry thermal conductivities. *Table 3* gives the estimated range of brick thermal conductivities which, when used in U-value calculation for each build-up, gives agreement with measured *in-situ* U-values and range of measured dry thermal conductivities.

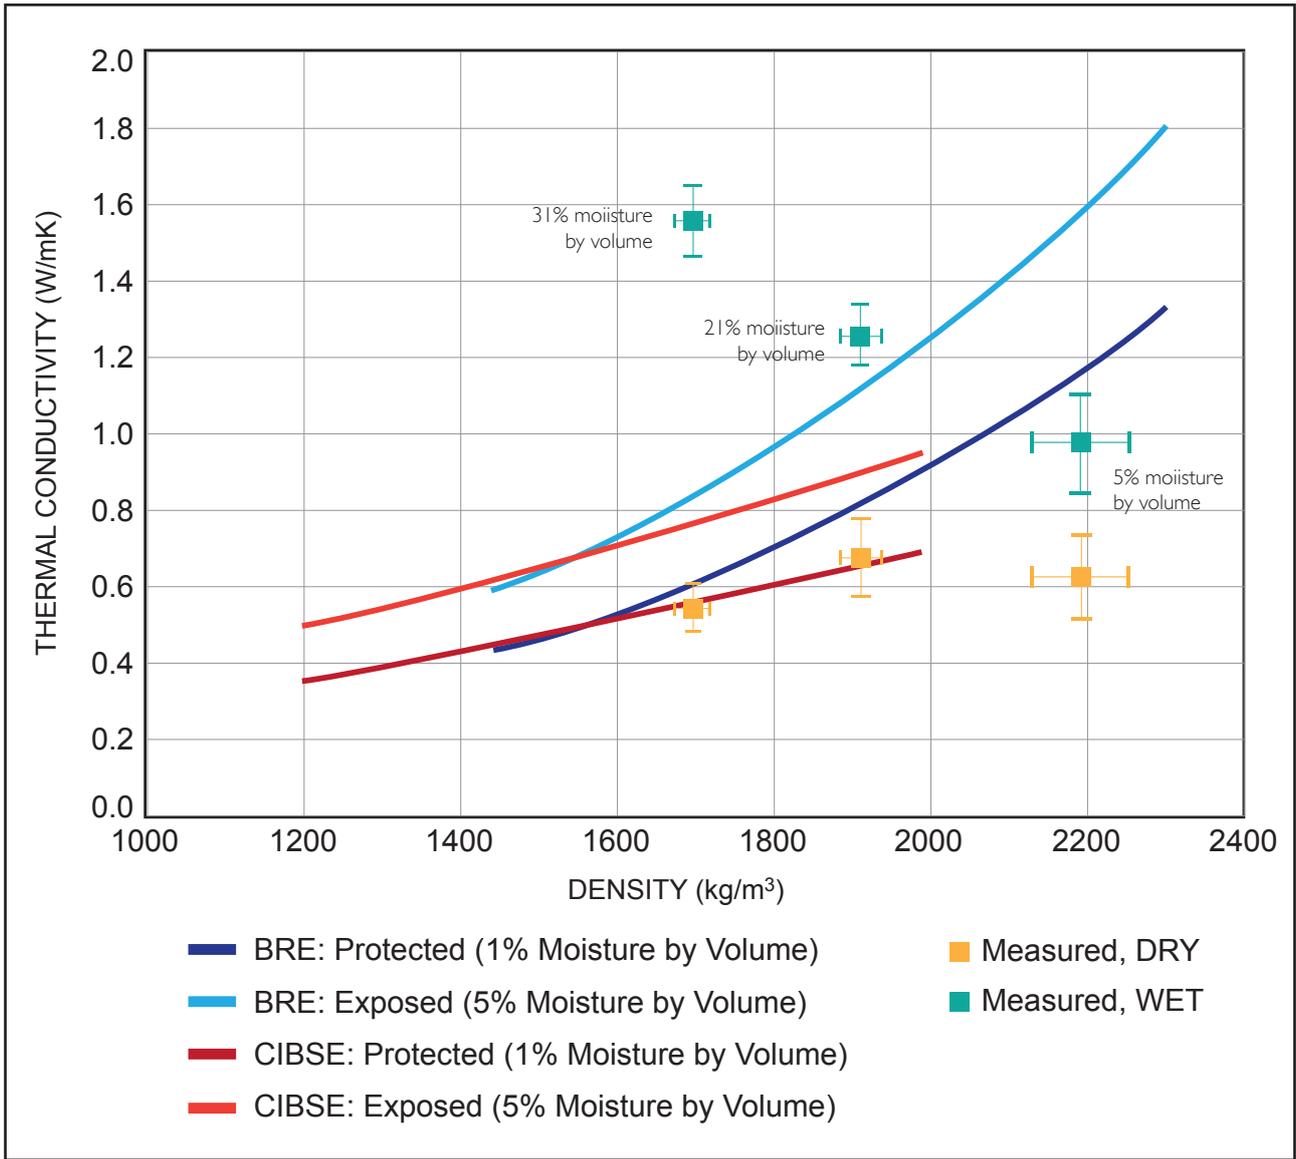
Figure 7: Comparison of measured values with design values from BRE Digest 108 and CIBSE Guide A. Both the Digest and the Guide assume moisture contents of 1% and 5% by volume for protected and exposed brickwork, respectively. The measured wet thermal conductivities range between 5% and 31% by volume.

Design values for the thermal conductivities of fired clay bricks are given by *Everett 1986* from *BRE Digest 108* (1984) and *CIBSE Guide A* (2006) for different densities. Values are given for ‘standard’ moisture conditions: 1% by volume for protected locations (e.g. internal partitions, inner leafs separated from outer leaves by a continuous air space) and 5% by volume for exposed conditions (e.g. directly exposed to rain). The thermal conductivities given in the literature for both protected and exposed conditions are shown in *Figure 7*, with the variation in brick density. The measured values for the bricks tested are shown for comparison.

There is reasonable agreement between the measured dry thermal conductivity results and the design values for protected conditions, although the high density (2191 kg/m³) New Bolsover brick appears to follow the trend for the CIBSE values if extrapolated to higher densities.

As may be expected, the measured wet thermal conductivities of the Englefield brick with a moisture content of 31% by volume and the Walsall brick with a moisture content of 21% by volume are higher than the exposed design values for bricks of the same density. The New Bolsover brick with a moisture content of 5% by volume again tends to follow the trend for the CIBSE exposed brick values extrapolated to higher densities.
